10th PROGRESS REPORT

Seven Mile Beach groundwater monitoring update and recent flooding at the northeast end of Woodhurst Road

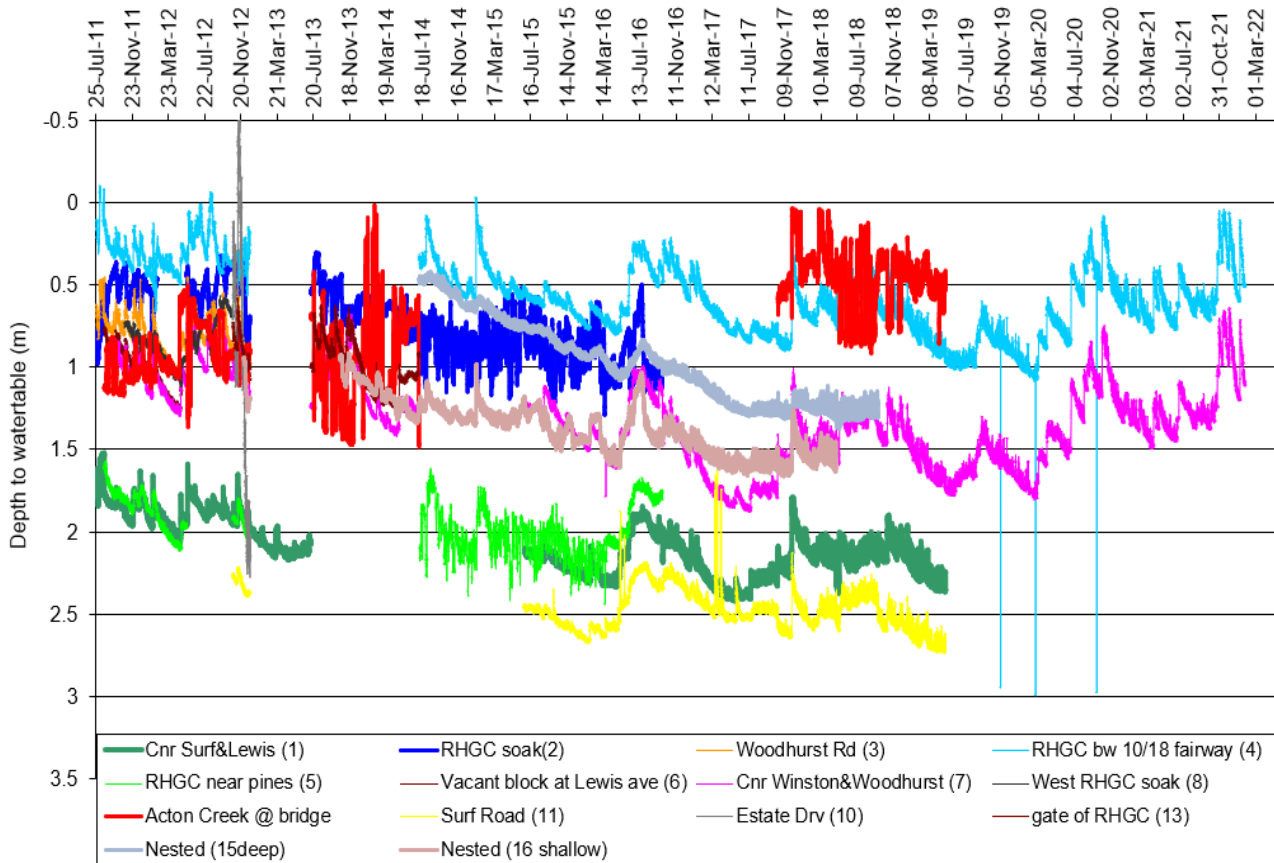
Figure 1. Groundwater logger records since July 2011

- since 2019 there are now only two data loggers which are operational (after 2 more failures & 1 removal/loss of data). The operating loggers are in Winston Avenue, and between fairways 10 and 18 at the Royal Hobart Golf Club (RHGC).

- the barometric logger failed in Jan 2022, which means the data can't be corrected for atmospheric pressure (making the data collection of limited use).

- over the past 11 years, water tables in all loggers fell by about a metre until about mid-2017. Subsequently, the rate of fall tended to flatten out and then start to rise. In the two remaining loggers the rise has been by more than 0.5m, to levels comparable to those pre-2015 (and before Council's 2013 water level management with the pump at Woodhurst Road and the RHGC sump pump, both towards the southwestern end of the street).

- 1) Install a replacement bore and logger along Surf Road (#1).
- 2) Replace the failed barometric logger for Seven Mile Beach.
- 3) Replace additional failed loggers along Surf Road (#11) and in the RHGC sump,
- 4) Water level management/pumping of the RHGC sump be reviewed to help reduce the risk of domestic flooding. The pump should be fitted with a flow device to keep track of discharge volumes). Install other loggers elsewhere over the course, to partly replace the original monitoring system.
- 5) Install extra loggers on either side of the northeastern end of Woodhurst.
- 6) Recommence 6-monthly logger download and annual progress reports.
- 7) Recalibrate the numeric computer model and keep it up to date.
- 8) Consider controlling the whole system remotely. It should be possible to track flood risk on a daily basis.

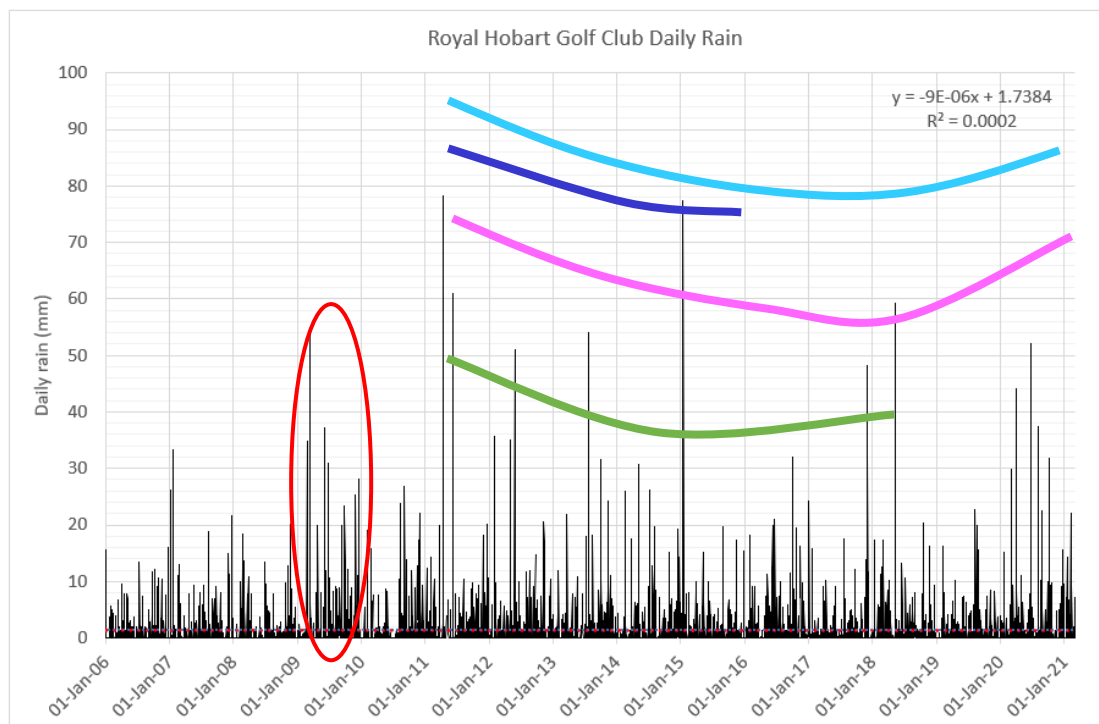
Figure 2 compares the Bureau of Meteorology (BOM) daily rainfall from RHGC since January 2006 with the logger data. It shows the trend lines for some of the coloured loggers graphs, from July 2011, and the group of rain events in 2009 (red oval) which cause extended flooding at the southwestern end of Woodhurst Road.

Note that at least four daily rain events during this 15 year period were higher than the highest rain in 2009, but whether these caused flooding is unclear.

Figure 2. Daily rain at RHGC since January 2006. The coloured lines are the groundwater level trends from Figure 1.

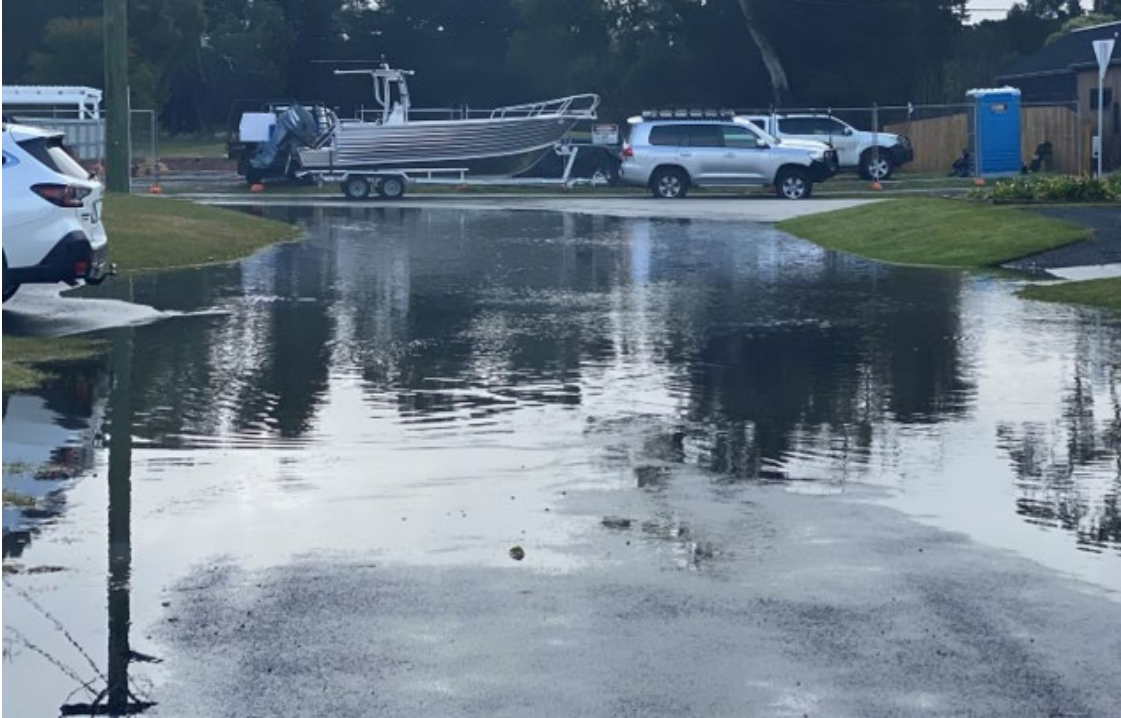
The recent flooding at the northeastern end of Woodhurst Road (Plate 1) was caused by about 46mm rain over 14 and 16 August. Again, it doesn't take a single heavy rain event to cause flooding: the daily rain records (mm) for the first 26 days of the month (records for 1, 4 and 5 August were missing) were:

Plate 1. Flooding at the northeastern end of Woodhurst Road, August 2022.
Photo sent to CCC by the resident at 26 Loudon Street.

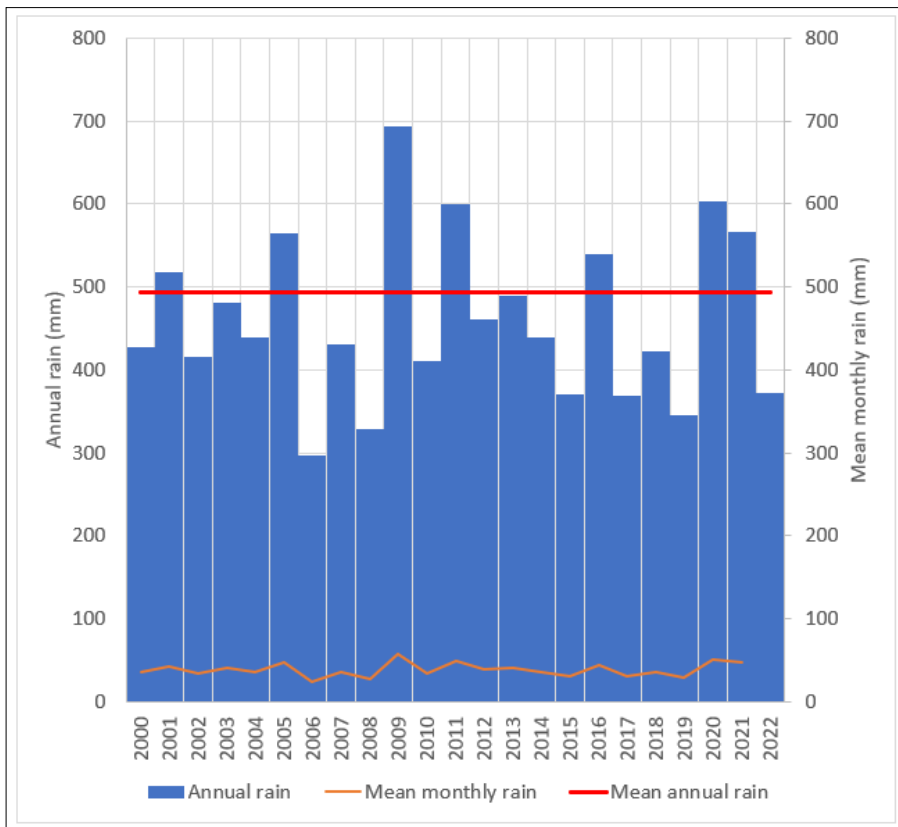
Figure 3. Annual rain and mean monthly rain compared to mean annual rain at Hobart Airport for the period 2000 - 2022. Above-average annual rain occurred in seven years: 2001, 2005, 2009, 2011, 2016, 2021 and (already) 2022. Source: Bureau of Meteorology.

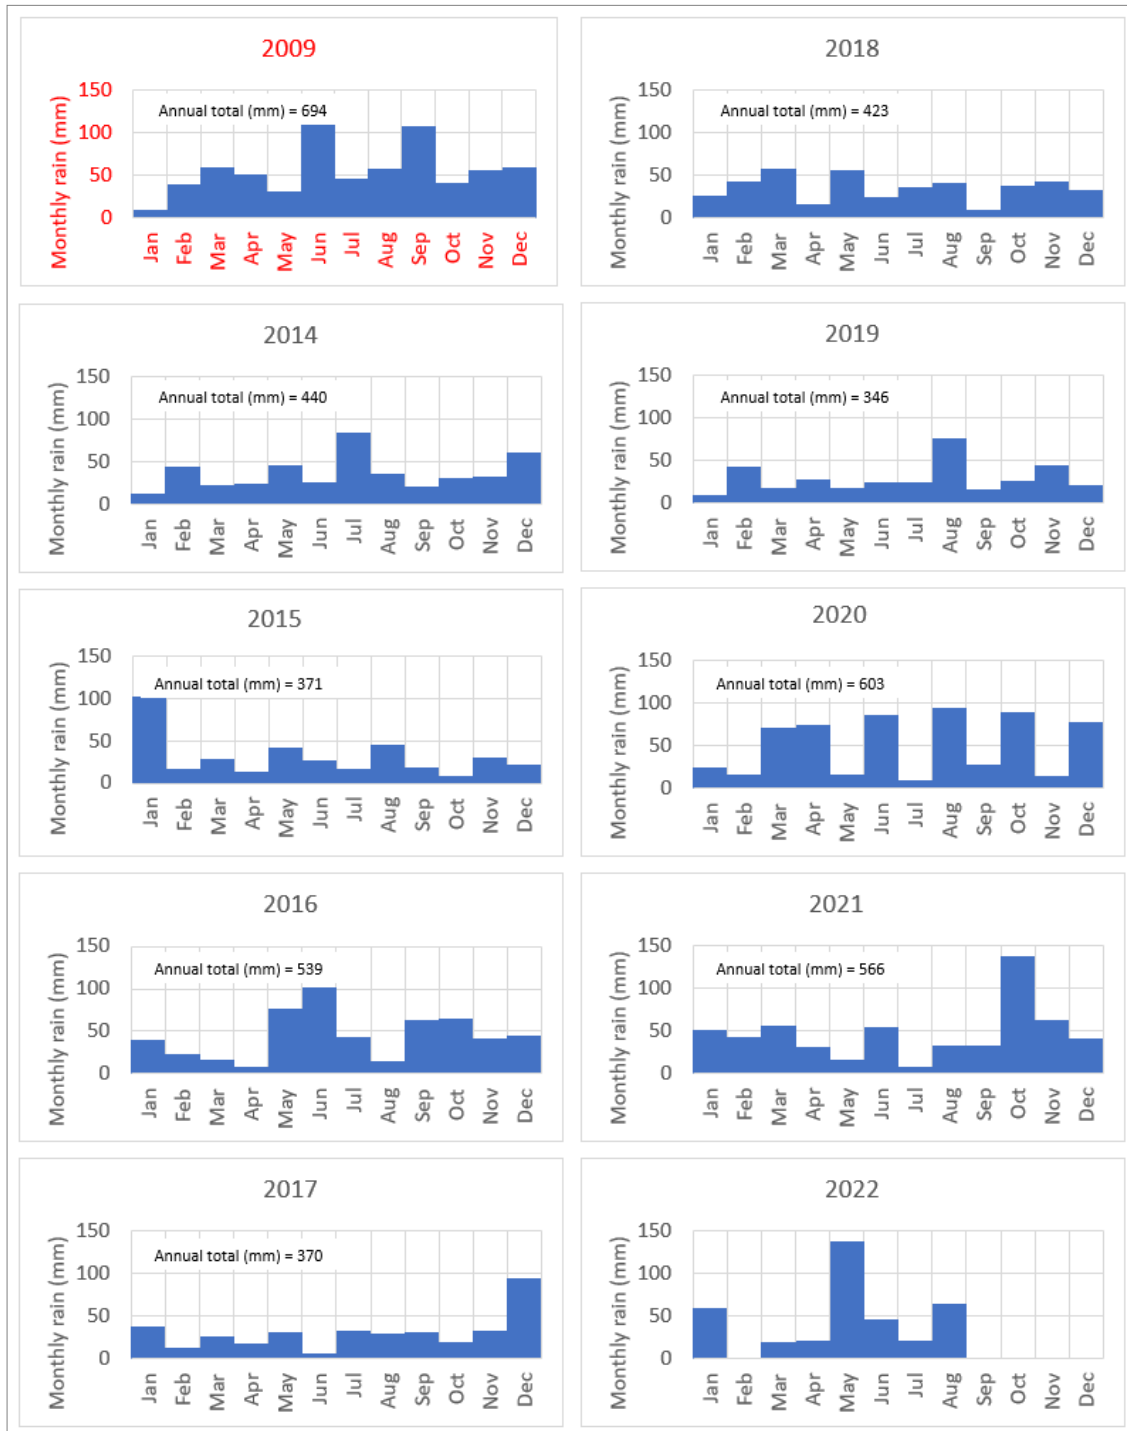
Figure 4. Monthly rain at Hobart Airport for 2009 (red type) and the years 2014 - August 2022). The June to September 2009 period spanned the months when the southwestern end of Woodhurst Road was flooded. The rains in August 2022 which caused the flooding of the northeastern end of Woodhurst Road were not particularly unusual. Monthly rain in May 2022 (136mm) and October 2021 (138mm) were much higher but its not clear whether they caused flooding. Source: Bureau of Meteorology.

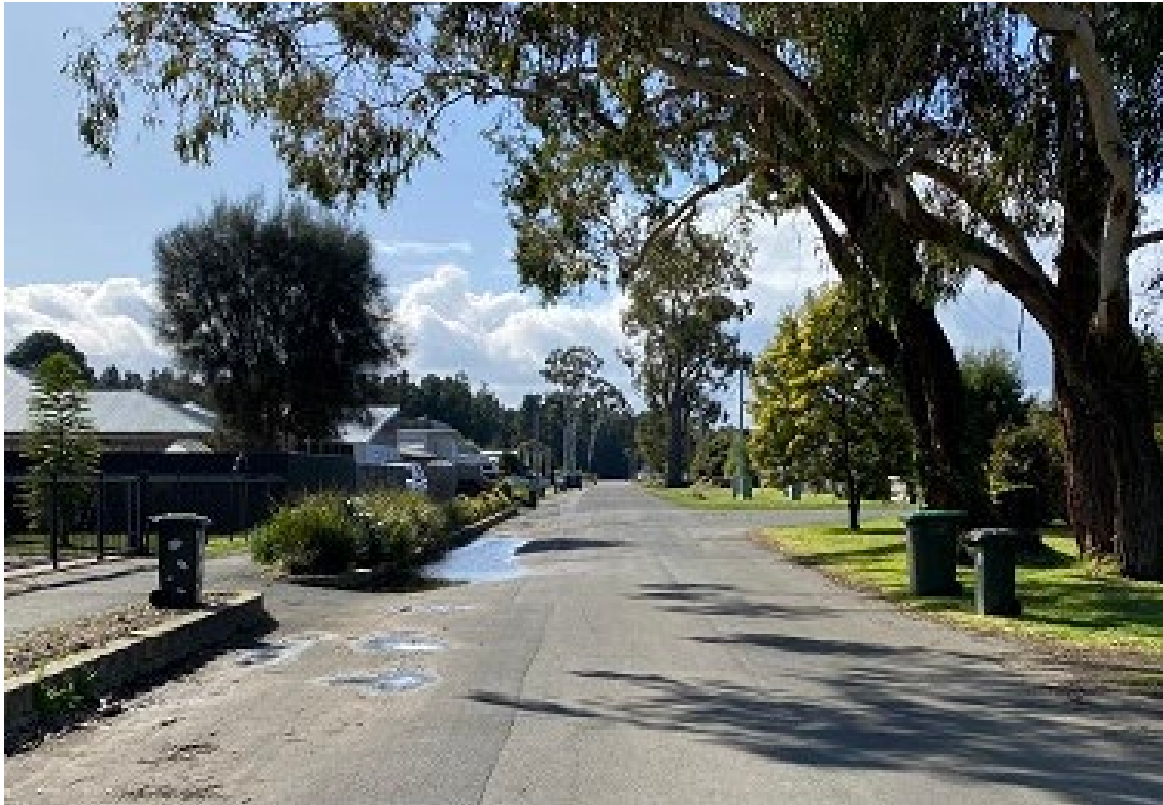
- It is understood that the stormwater system of unconnected gratings along the roads is designed to allow direct infiltration of rain runoff from the roads to the water table. As the water table rises close to road level, this system becomes progressively ineffective (Plate 2).

Plate 2. Looking northeast along Woodhurst Road past Leyden Avenue (right middleground) on 20 August 2022 after most of the flood waters had evaporated, and slowly infiltrated the subsoil via stormwater gratings. Compare with Plate 1. The water level in the gratings was at ground level, indicating the water table in the immediate vicinity of the line of gratings is at surface, but it may not be at surface further from the road.

- 9) After reviewing the renewed monitoring program, consider groundwater (and stormwater system) management options.
