Richmond Bridge Vegetation Management Plan

Site Analysis for Vegetation Management Plan

Arboricultural Survey – Richmond Bridge February 2015

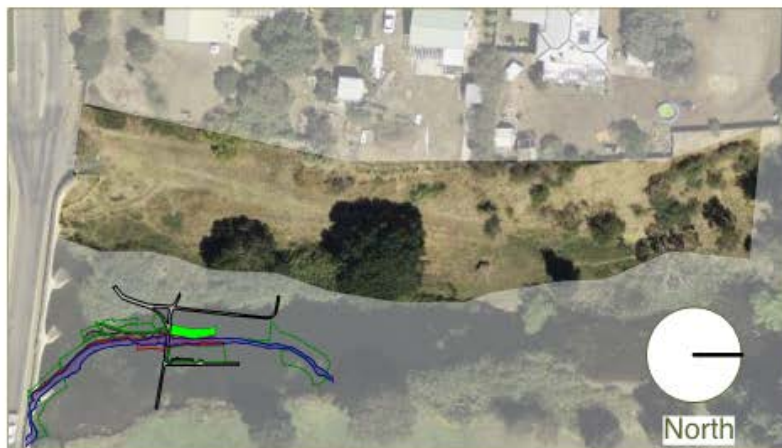
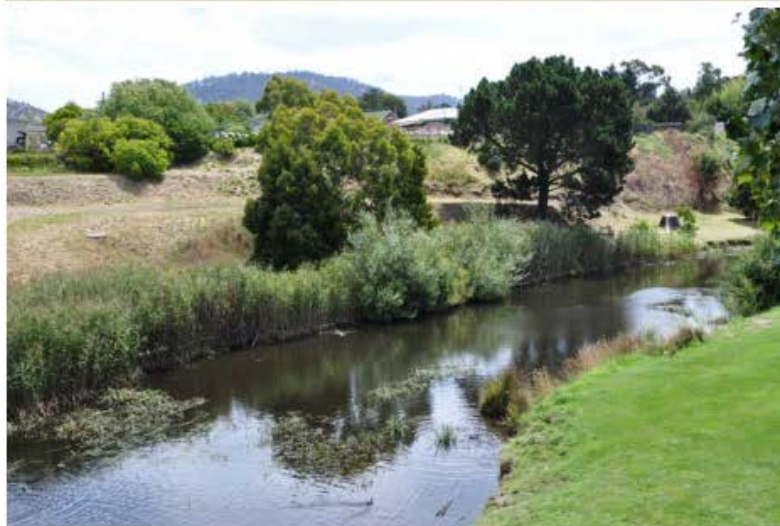
Zone F Priority: High

- The bank along the western section of this Zone is too steep to mow and brush-cut.
- Annual grasses and weeds dominate the site, including marshmallow, fennel, hawthorn, boxthorn and other weeds.
- Vegetation management difficulties have resulted in the perceived need to burn off large parts of the bank, which is not well received by some residents.
- Will become over-run with woody weeds over time due to difficulties mowing/slashing due to steep slope.
- Toe of bank along track needs stabilisation.

- Remove annual grasses, weeds. Install hessian mulch/weed mat to all slopes steeper than 1:3 (18°). Plant native grasses - wallaby grass (*Austrodanthonia spp.*) and kangaroo grass (*Themeda triandra*). Plant *Bursaria spinosa* (native box) in informal 'copses' as shown on the planting plan.
- Remove boxthorn, marshmallow, hawthorn, gorse, yucca, blackberry and other weeds as per 'Weed Management Guidelines'.
- See also specific actions listed in the Action Plan (Appendix 2).
- See also Riparian Zone 3 for actions relating to riverbank management.

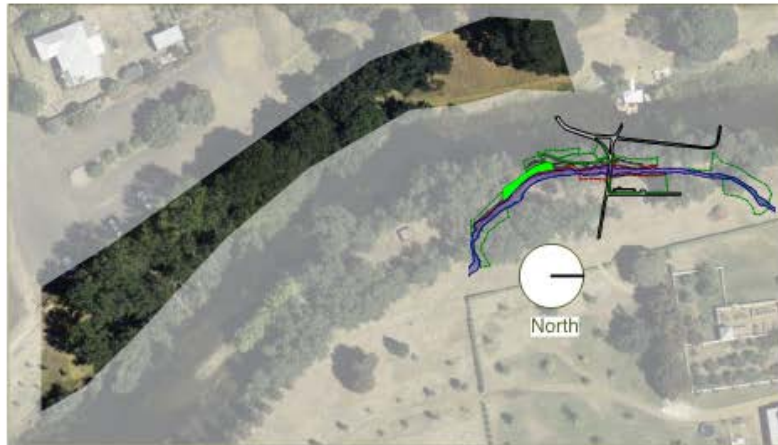
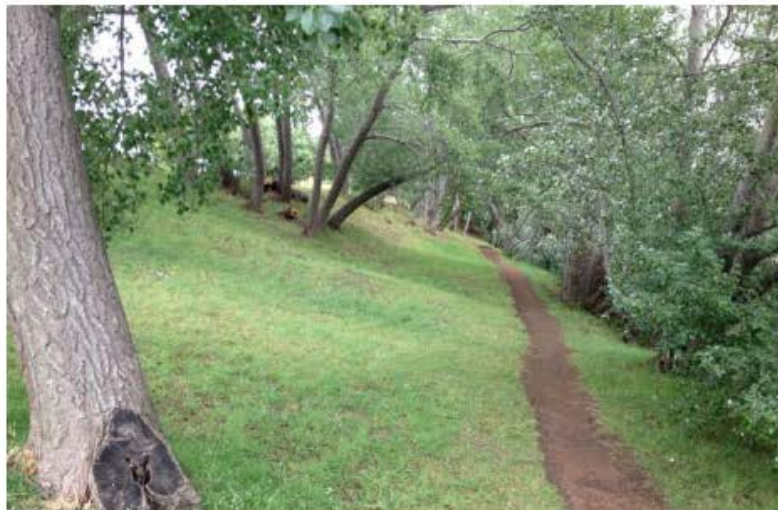
Zone I

- Arborist recommends removal of specific white poplar specimens which are structurally defective (Tree Ref's: 25, 27, 28, 29, 30, 36, 37, 38).
- The elms are currently in good condition and should be allowed to continue to form 'natural' copses through suckering.
- Over the long-term, the gradual removal of the white poplars and the extension of elms (with some planting of oaks) is recommended. This will preserve the character of this zone whilst minimising maintenance.

- Removal of specified trees identified in Arboricultural Assessment (Feb. 2015).
- Every 5 years, remove 3-4 white poplars, working from each of the northern and southern ends of the white poplar copse, and replace with oak and elm trees, as per the Planting Schedule.
- Locals enjoy the informality of the pathways through this area. It is recommended that they are kept informal.
- Specific stump grinding and other actions as per the Action Plan (Appendix 2).

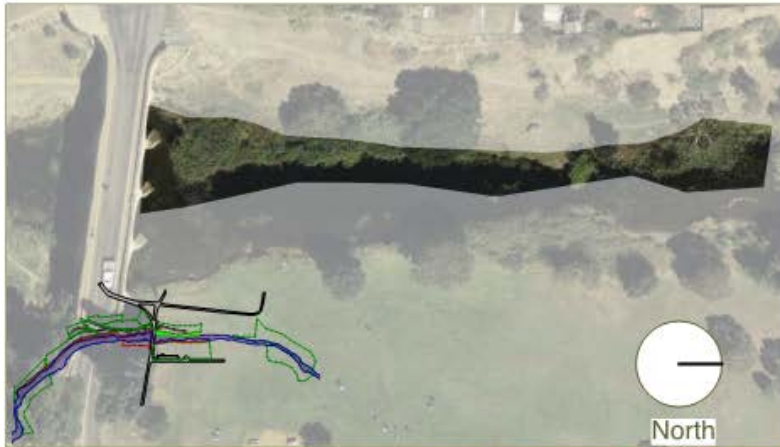
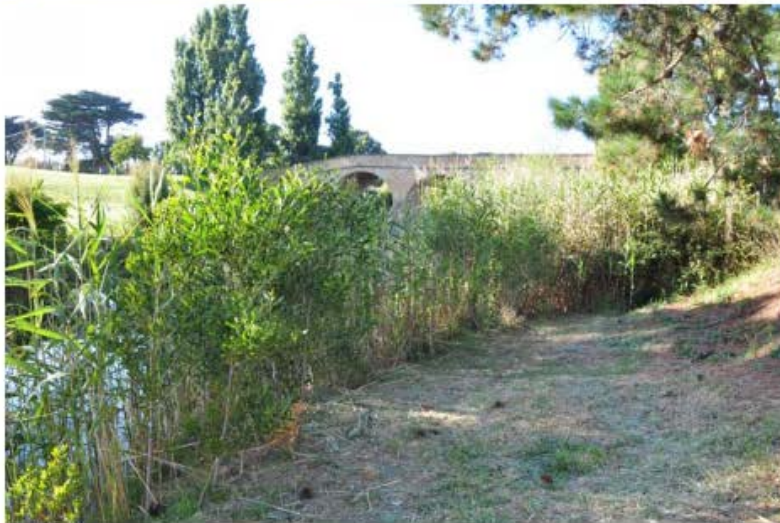
Zone R3 Priority: High

- Crack willow suckers/re-growth from previously controlled trees is occurring through this site.
- Large expanses of *Phragmites* could spread as sedimentation up-stream of the bridge continues.
- Isolated specimens of weed such as boxthorn, gorse, marshmallow, blackberry, fennel.
- Good regeneration of blackwood (*Acacia melanoxylon*) on banks. This may need to be thinned and/or some trees removed if their density increases to the extent that views are blocked.

- Some trimming of *Phragmites* is required to 'open up' views to the bridge from the bank near the old Cypress tree (a key vantage point for views to the bridge).
- Weed control required including boxthorn, gorse, marshmallow, blackberry, fennel.
- Thinning of Blackwood seedlings.

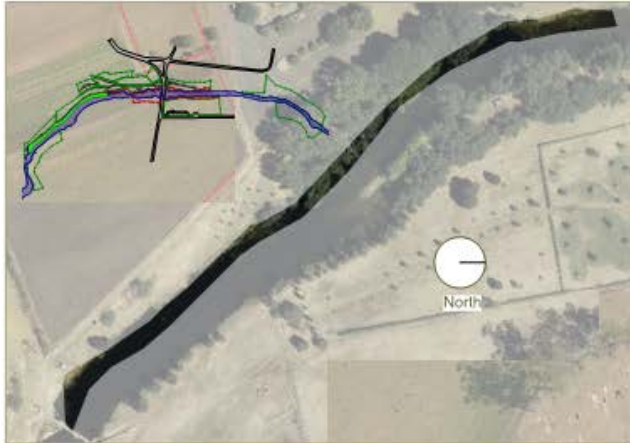
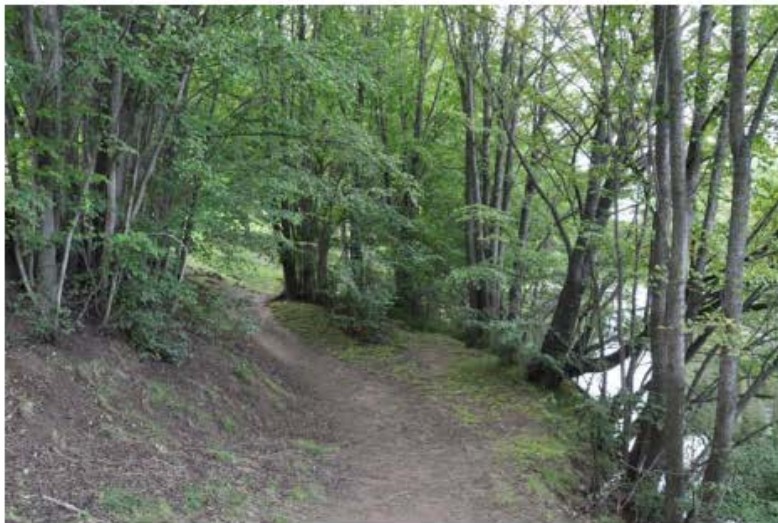
Zone R5 Priority: Mod

- Low overhanging branches of white poplar impede use of the river by paddle boats and canoes.
- Low overhanging branches may cause a build up of debris and exacerbate flooding and flood impacts both upstream and downstream.
- Ducks are impacting on grass cover on some areas of the banks, contributing to erosion.
- Some isolated crack willow suckers are establishing themselves.

- Gradual removal of all white poplars from the riparian zone.
- Allow the gradual replacement of white poplars with Elm suckers.
- Adjacent to Zone J, plant new Elm and Oak trees (to continue the 'English woodland' theme of Zone J).
- Adjacent to Zones B and K, establish indigenous reeds and rushes on banks to minimise erosion.
- Control suckers of white poplars.
- Ongoing weed control throughout this Zone, prioritising the control of crack willow, gorse, hawthorn, prunus sp., fennel, blackberry.

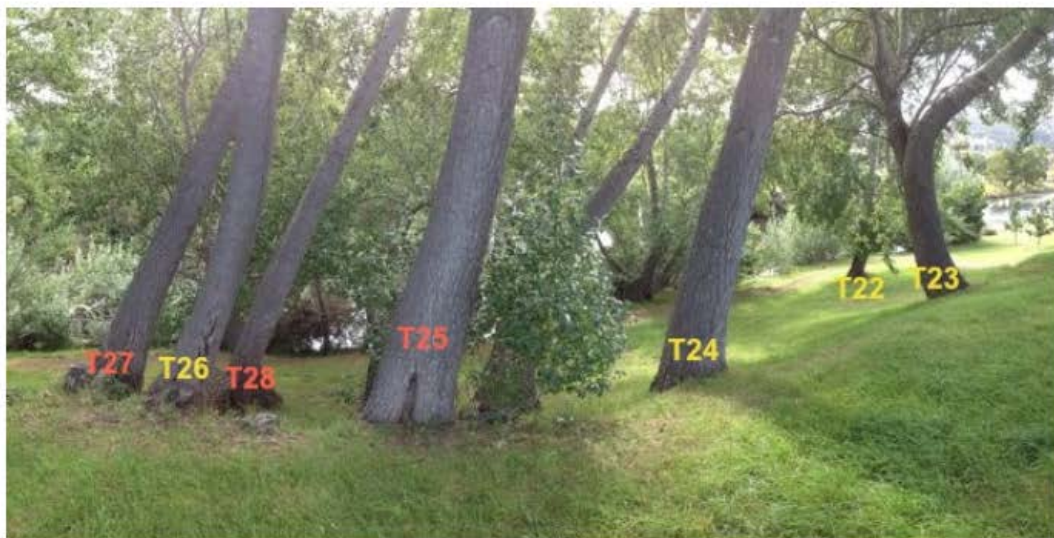
Photo 1: Trees T22-T28 within group T22A. Trees numbered in red are to be removed

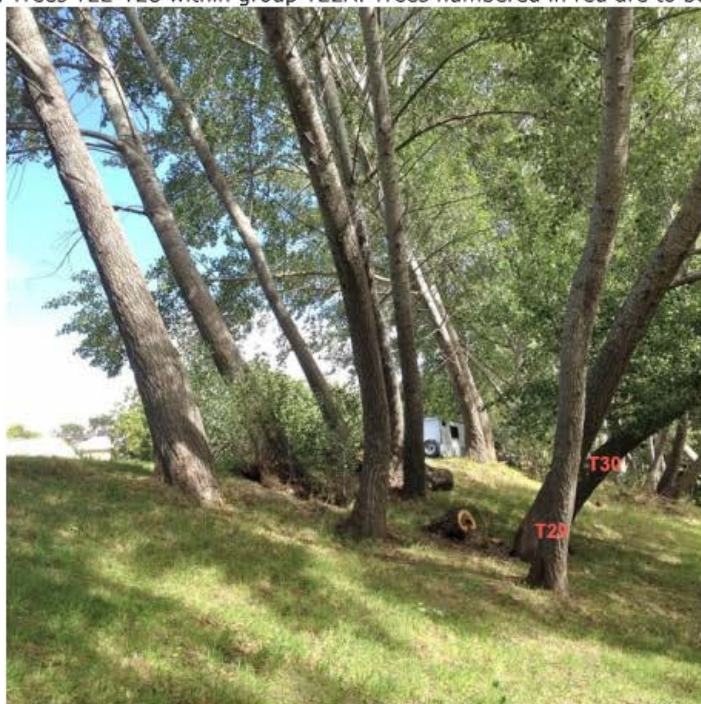
Photo 2: Trees T29 & T30 within group T22A. Both trees are to be removed

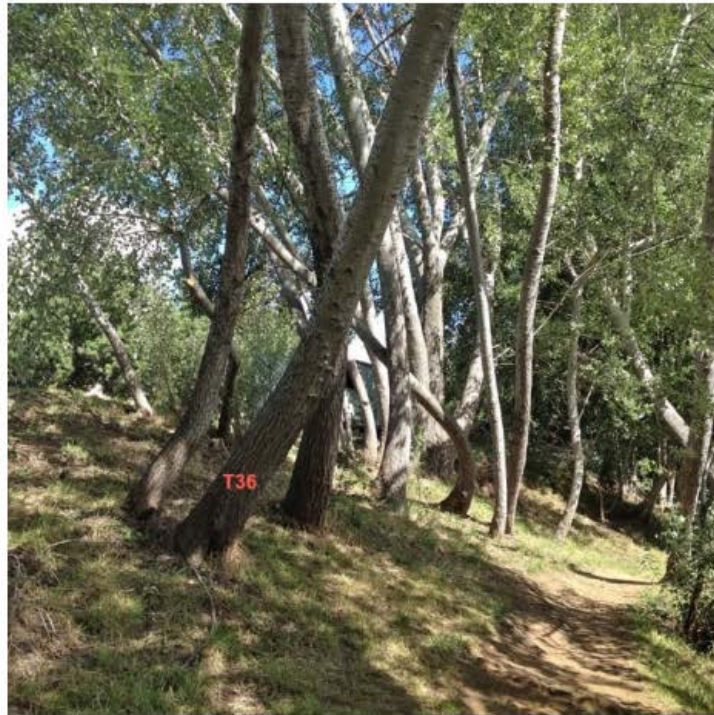
Photo 3: Tree T36 within group T22A. Tree to be removed

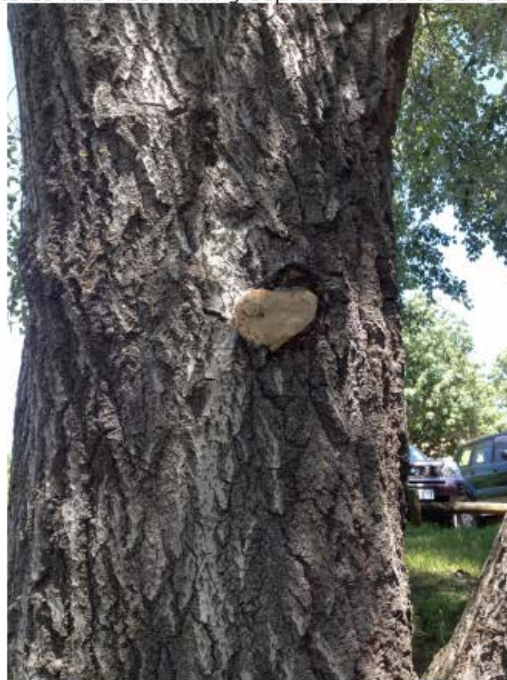
Photo 4: Tree T37 within group T22A. Tree to be removed

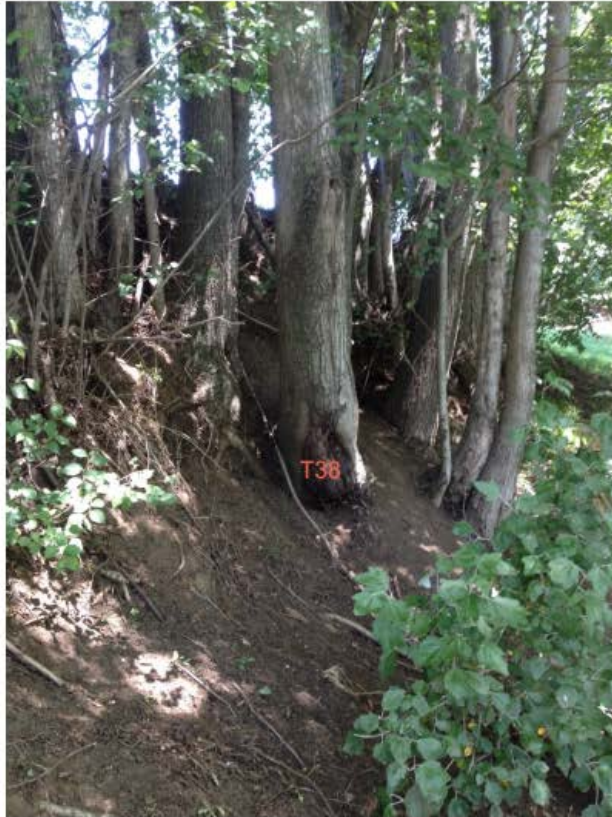
Photo 5: Tree T38 within group T22A. Tree to be removed
