BEACH SAND PROFILE AT ROCHES BEACH, TASMANIA

Prepared by Aquenal Pty Ltd
Marine, Estuarine and Coastal Analysts

Clarence City Council

May 2010

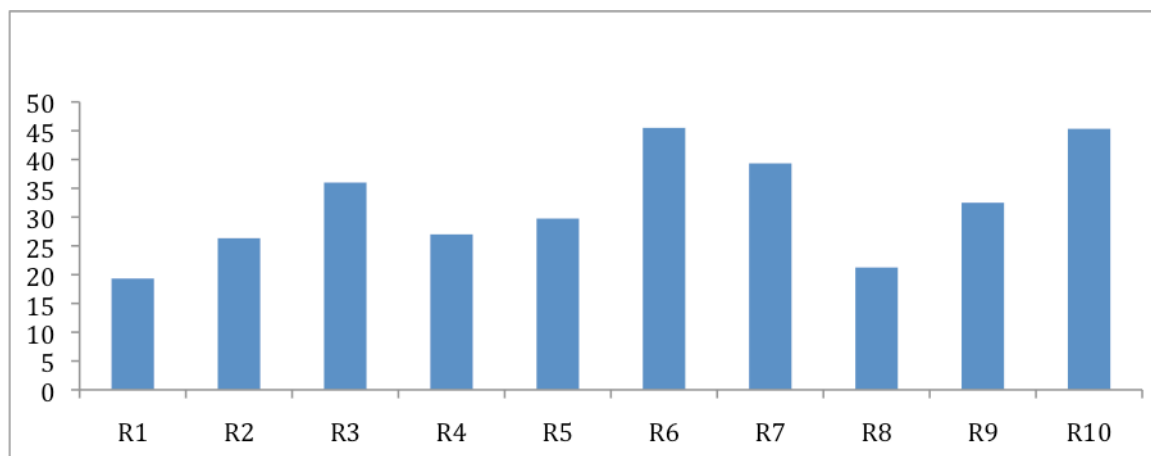
Figure 2 Average depths to shell grit (cm) at Roches Beach

Data averaged over sites within locations demonstrated no clear patterns with regard to latitude, or expected exposure. The lowest average depth to shell grit was at location R1 (19.33cm) while the greatest occurred at location R6 (45.5cm). The adjacent location R7 also possessed sand to a reasonable depth (39.33cm). All high-water mark sites (0 m) possessed at least 50 cm of sand except location R1 (the southern most location), where the rock retaining wall extends to high-water mark.

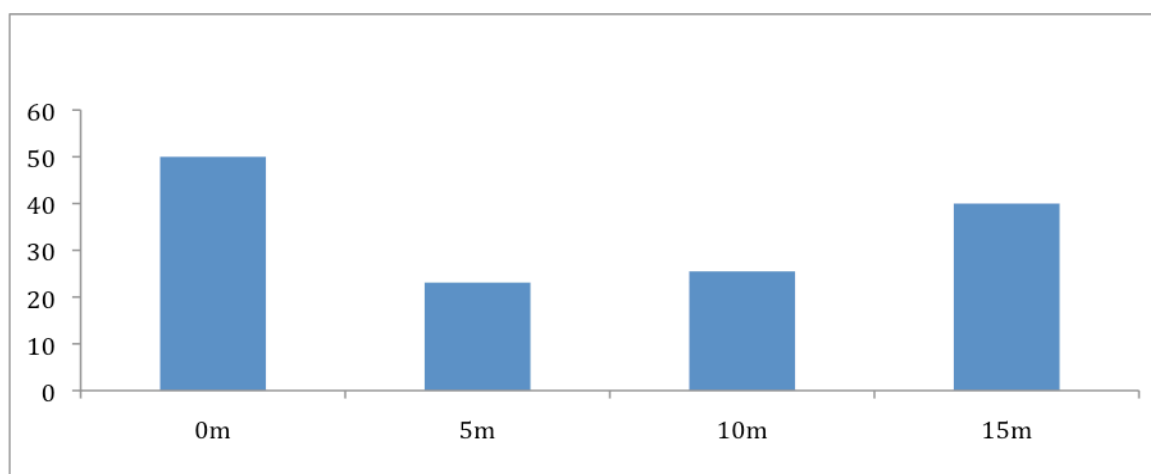
Figure 3 Average depth (cm) with distance from high water mark (m) at Roches Beach

Depth profiles were conducted at ten locations along Roches Beach, from high water mark (0 m), every five metres throughout the intertidal zone. In most locations the intertidal zone extended 10 m horizontally from high water mark. At four locations, mostly in the northern end of the beach the intertidal zone extended 20 metres. Data averaged over all locations showed sand depth to be greatest at the high-water mark (0 m), and lowest at 5 m, with depth increasing at 10 m and 15 m.

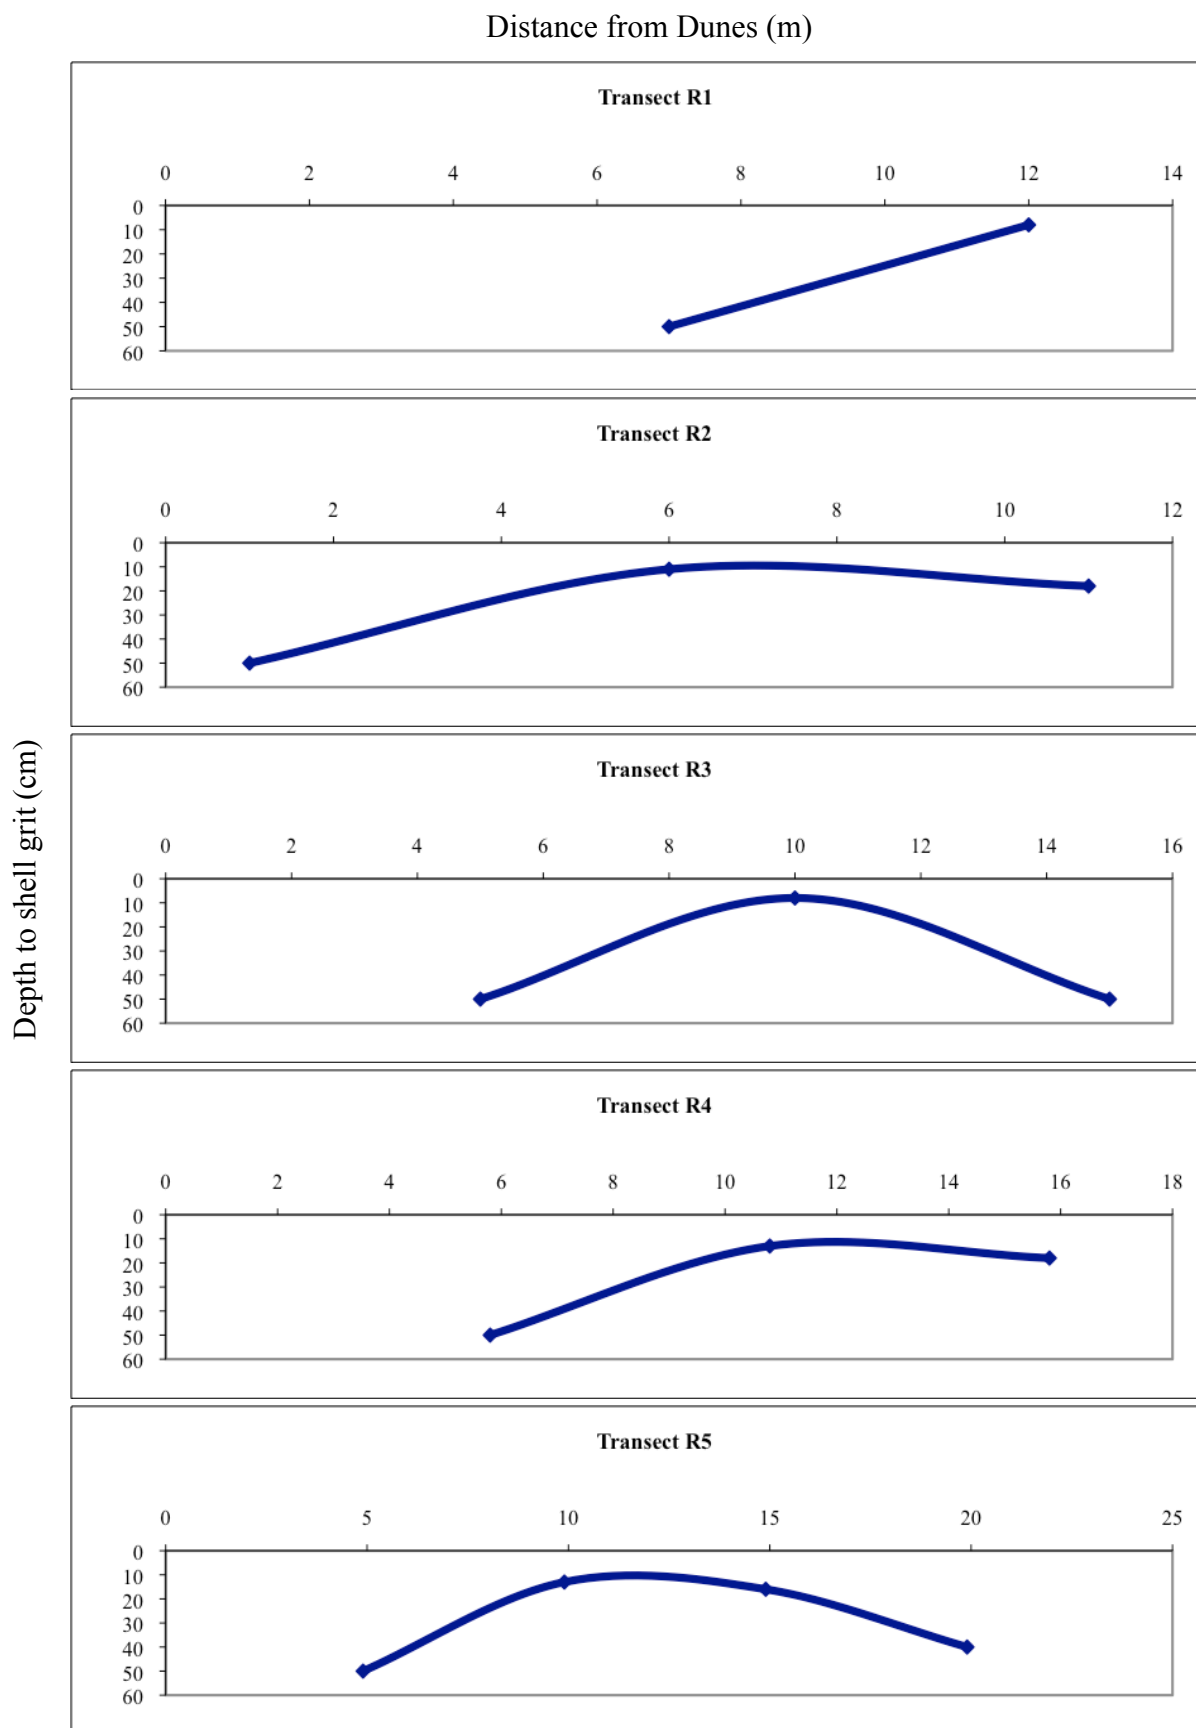
Figure 4 Depth profiles for beach sediments at Roches Beach, sites R1 – R5

Location	Profile depth (cm)			
	0m	5m	10m	15m
R1		50	8	
R2	50	11	18	
R3	50	8	50	
R4	50	13	18	
R5	50	13	16	40
R6	50	50	34	48
R7	50	18	50	
R8	50	4	7	24
R9	50	14	18	48
R10	50	50	36

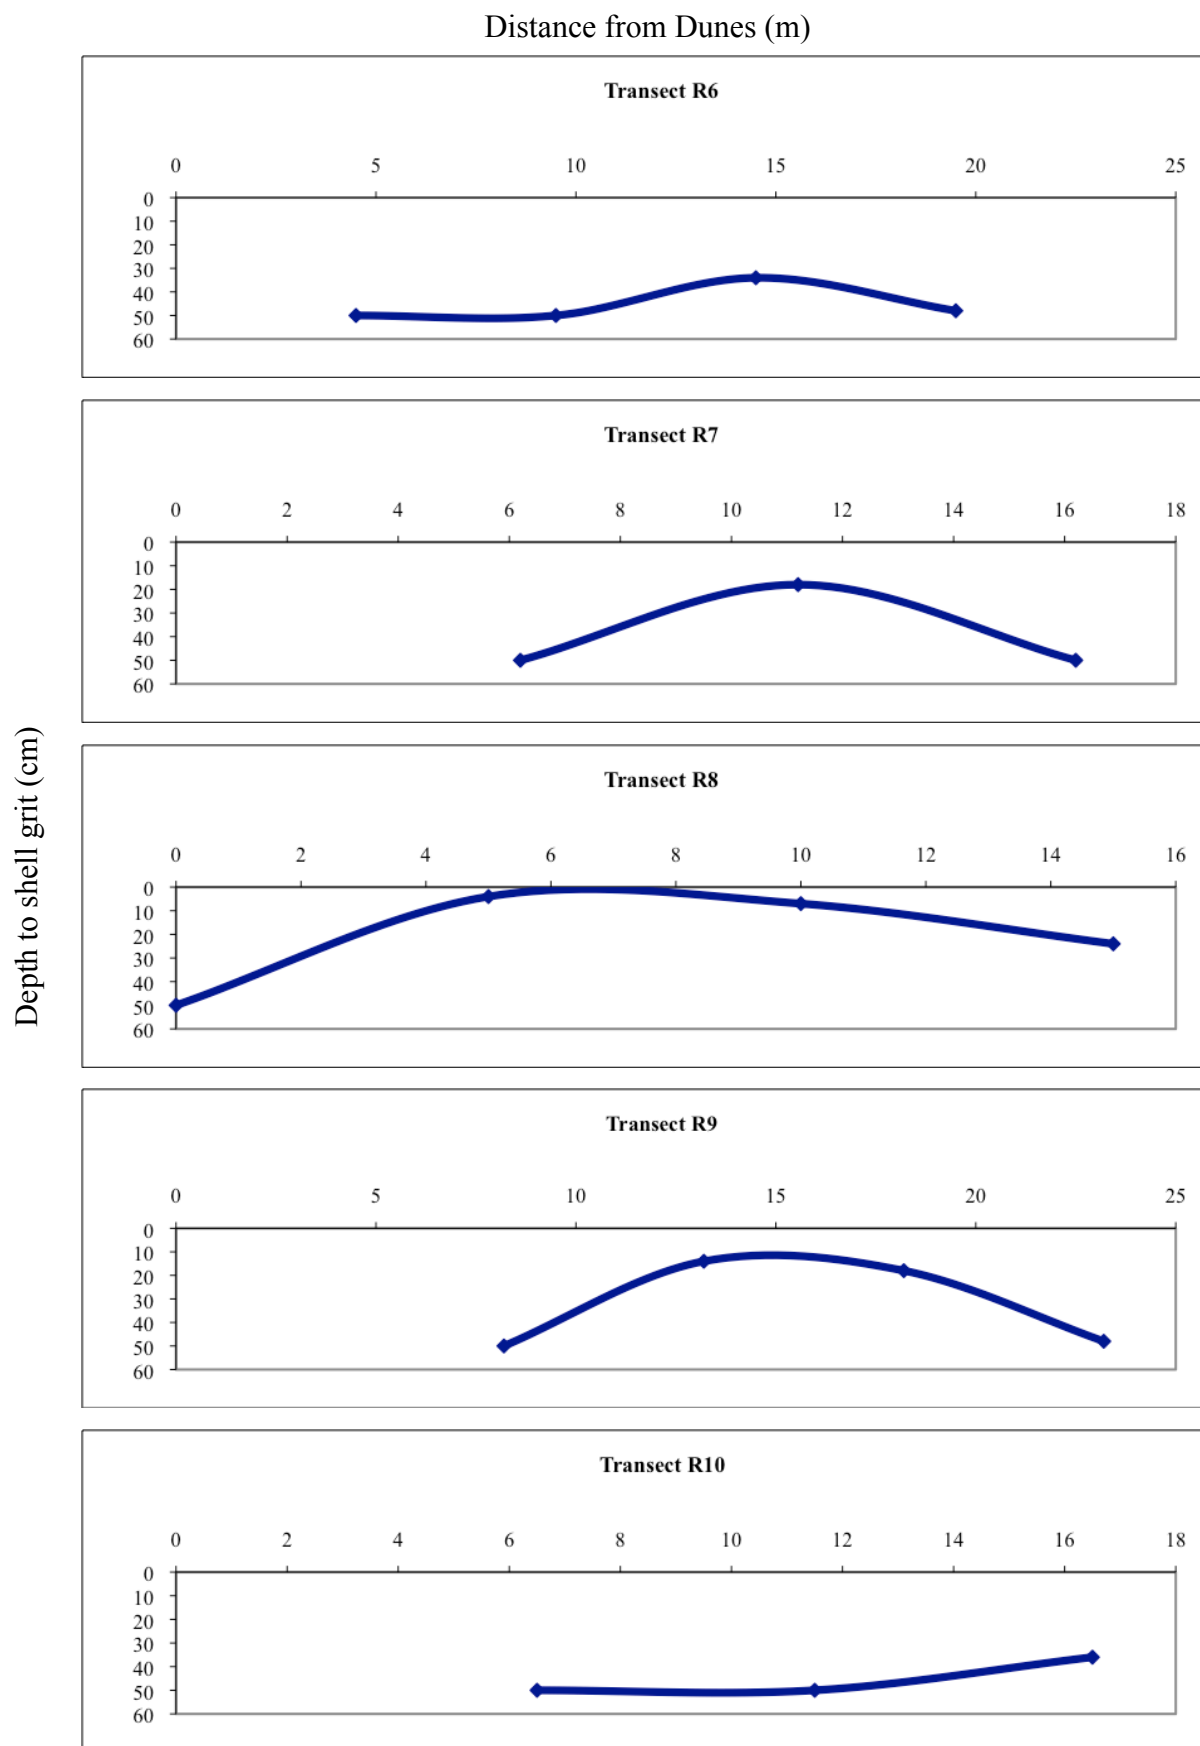
Figure 5 Depth profiles for beach sediments at Roches Beach, sites R6 – R10
