**WILLIAM C. CROMER PTY. LTD.**

**Clarence City Council  
Seven Mile Beach township**

**REVIEW OF 2009  
FLOODING AND DRAINAGE ISSUES**

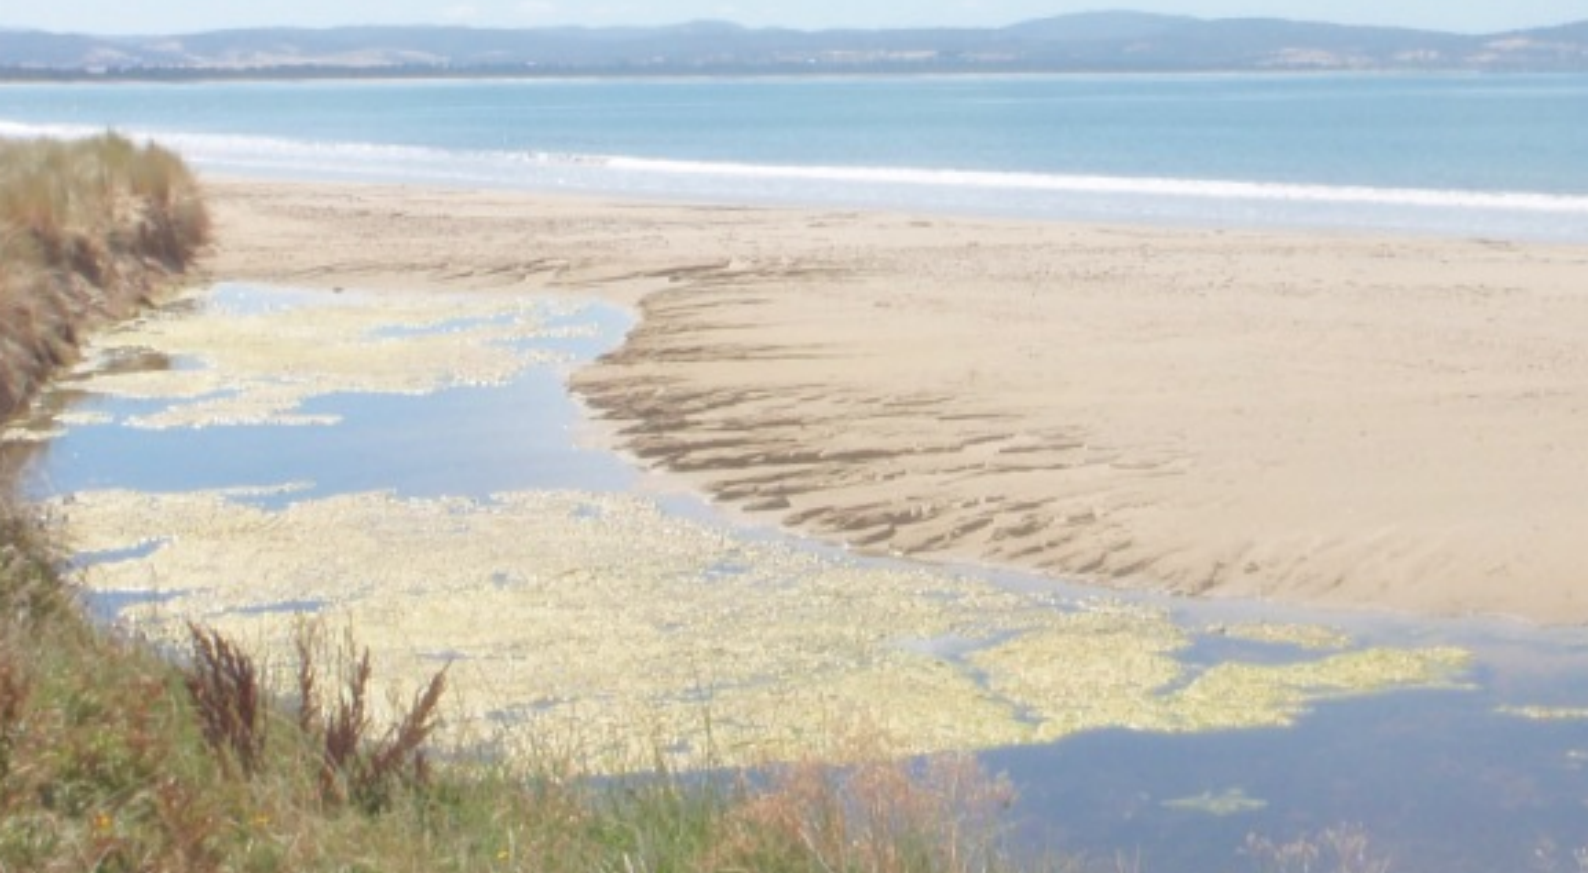
Cover photo: The mouth of Acton Creek at Seven Mile Beach, 24 February 2010, looking northeast. The creek has not flowed to the sea for at least three months. Its dammed water extends inland for about 500m, and after heavy rain events has hindered upstream drainage as far as the western corner of the Royal Hobart Golf Club.

Currently, Acton Creek is not flowing at its mouth, where it is blocked by beach sand (formed by natural processes; cover photo). The barrier will be breached if and when wave conditions erode it, or sufficiently heavy rain falls in the catchment, or both. In the meantime, the channel of the creek is flooded as far inland as point K at least. Parts of the channel from K to J are also now under water, but it is not clear whether the ponded water is a continuous body at the same level over the distance J-K-L. It is noted that recent clearing by Clarence City Council has temporarily removed some obstructive vegetation in the channel between J and K.

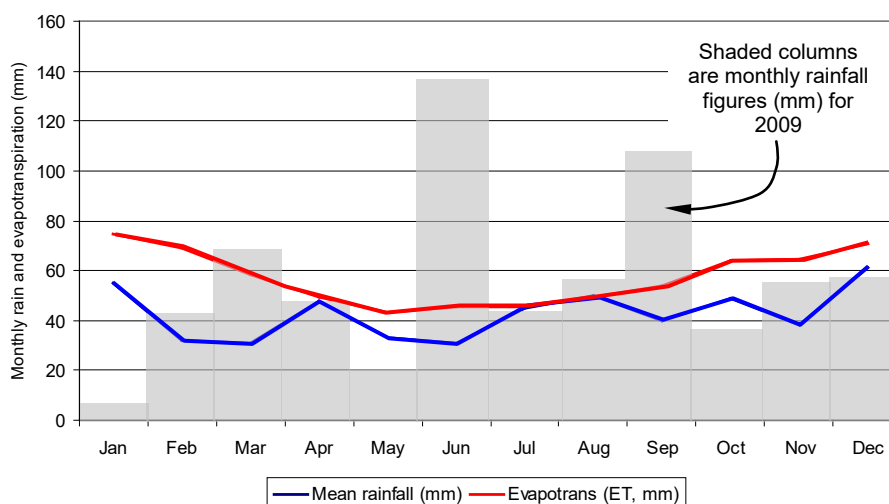
**Figure 1. Mean monthly rainfall and evapotranspiration at Seven Mile Beach**

Figure 1 summarises mean monthly rainfall and calculated evapotranspiration<sup>5</sup> at Seven Mile Beach. The rainfall is the mean monthly rainfall for the period 1985 – 2009 recorded by the Royal Hobart Golf Club<sup>6</sup>. Two points are important:

- Monthly evapotranspiration exceeds mean monthly rain in essentially every month (the two are about equal in April, July and August). Annual evapotranspiration is estimated at about 700mm and exceeds mean annual rain (514mm) by almost 200mm.
- Evapotranspiration varies seasonally: it is a minimum (say, 45mm/month or 1.5mm/day) in the winter months, and a maximum (up to about 75mm/month or 2.5mm/day) in the summer months. On any day, the rain available to infiltrate to the subsurface is reduced by the evapotranspiration for that day.

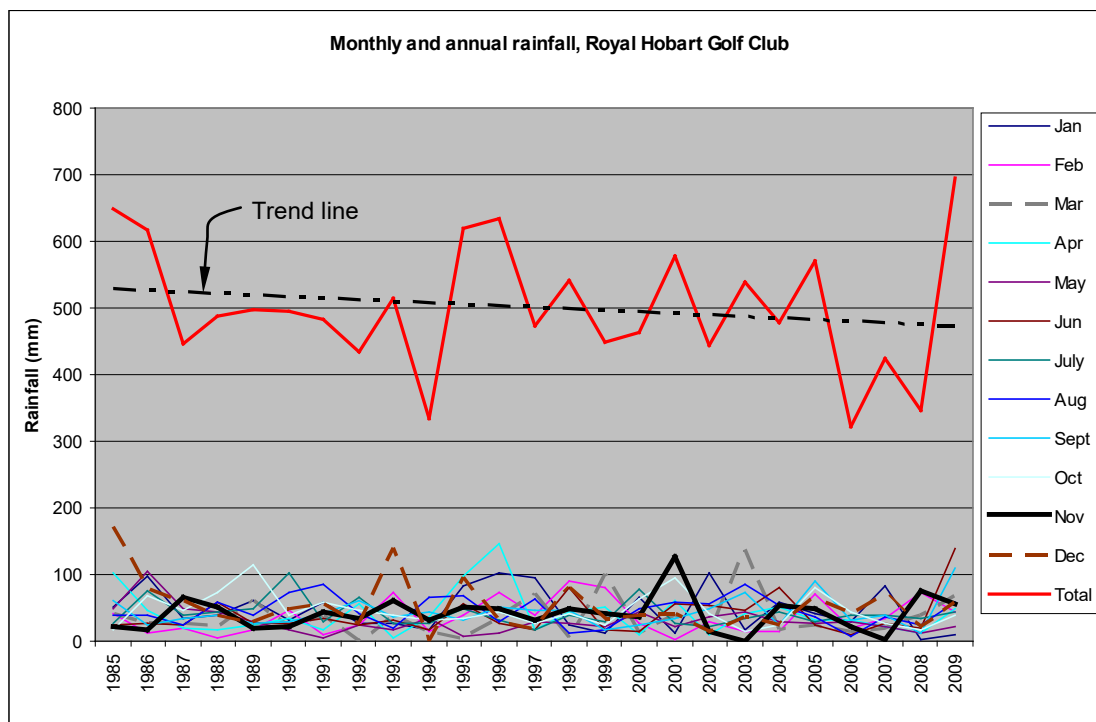
**Figure 2. Monthly and annual rainfall at the Royal Hobart Golf Club 1985 – 2009**

Rainfall in 2009 at 694mm was the highest recorded (35% higher than average) for the last 25 years, and was twice the 2008 total. The June 2009 monthly rainfall of 139mm was the fourth highest recorded for the same period, and was more than four times the June average. More significantly, the four month period June – September was the wettest in at least 25 years, and possibly much longer (the club recorded 349mm for the four months; the next highest rainfall for the same period was 237mm in 2003).

Unusually high rainfall, particularly for the June – September period, is established. Moreover, it was associated with a larger than average number of rain days (Figure 3).

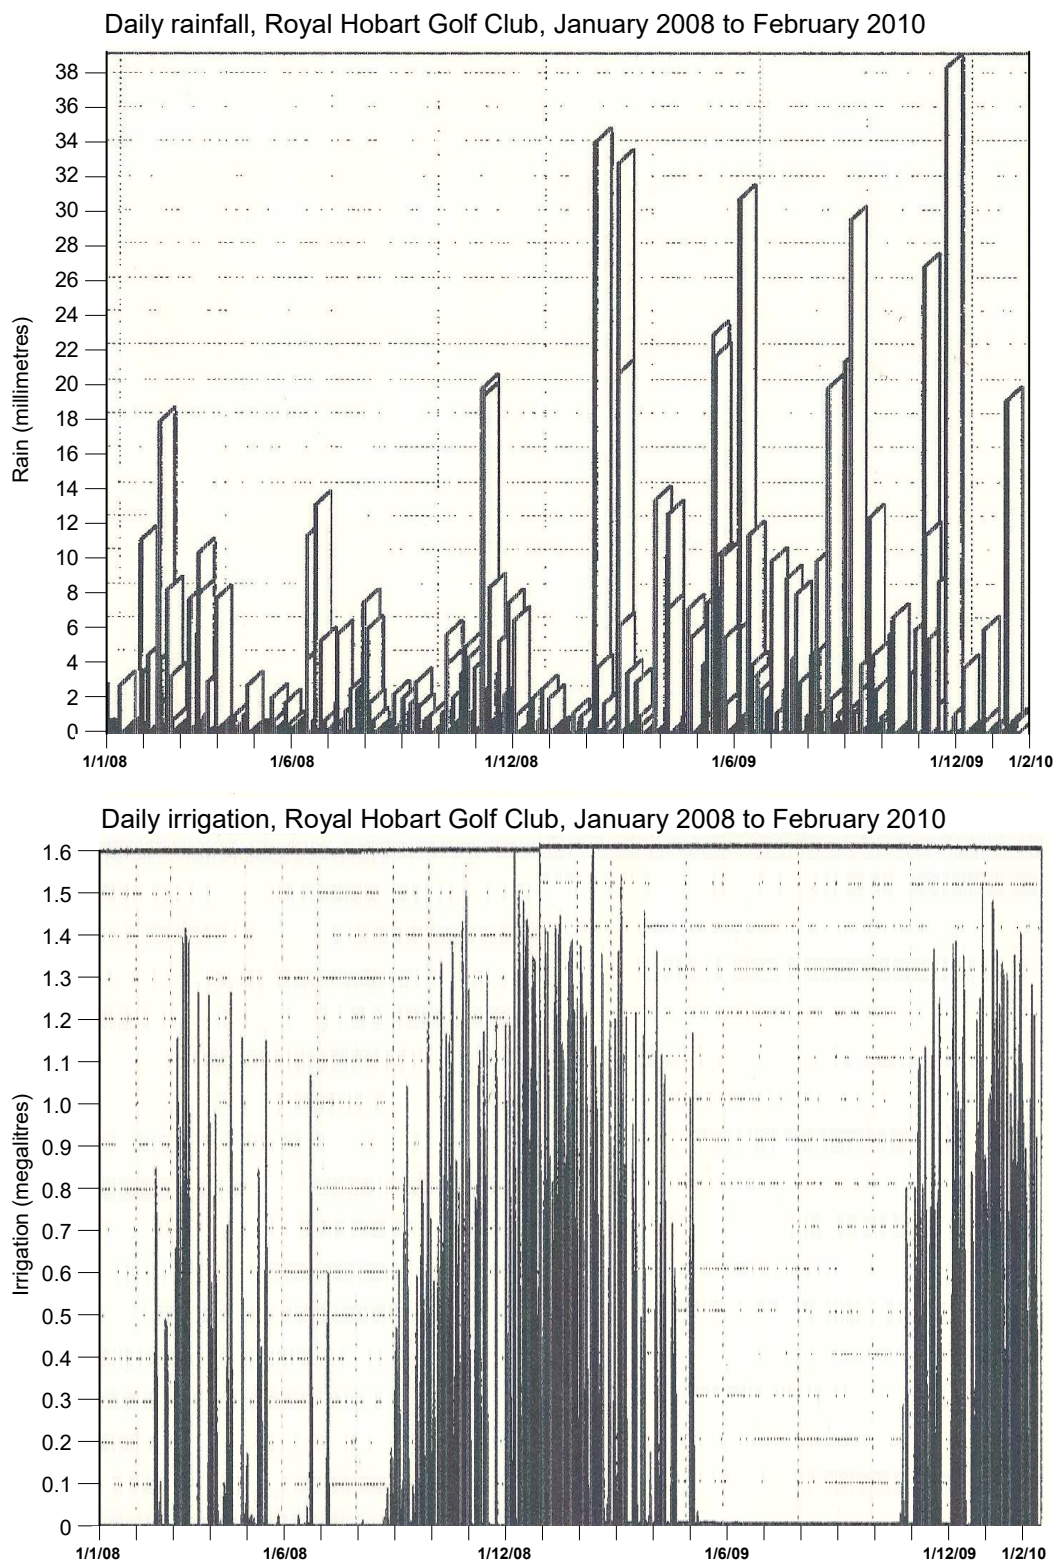
**Figure 4. Computerised records of daily rainfall and irrigation at the Royal Hobart Golf Club, January 2008 to February 2010**

The golf club has irrigated its course since the 1960s. The procedure has been computerised since late 2007, and the irrigation water volume applied during any period is determined by rainfall and evapotranspiration. If the net rain (after evapotranspiration) exceeds grass requirements, irrigation does not occur. Further, should more than 5mm of rain<sup>9</sup> be received during an irrigation period, the system shuts down. Figure 4 shows, at the top, daily rainfall recorded at the club since January 2008, and at the bottom, the daily volume of irrigation water applied during the same period. (The number and intensity of rain days from June 2009 to the end of the year contrasts with the same period a year earlier.)

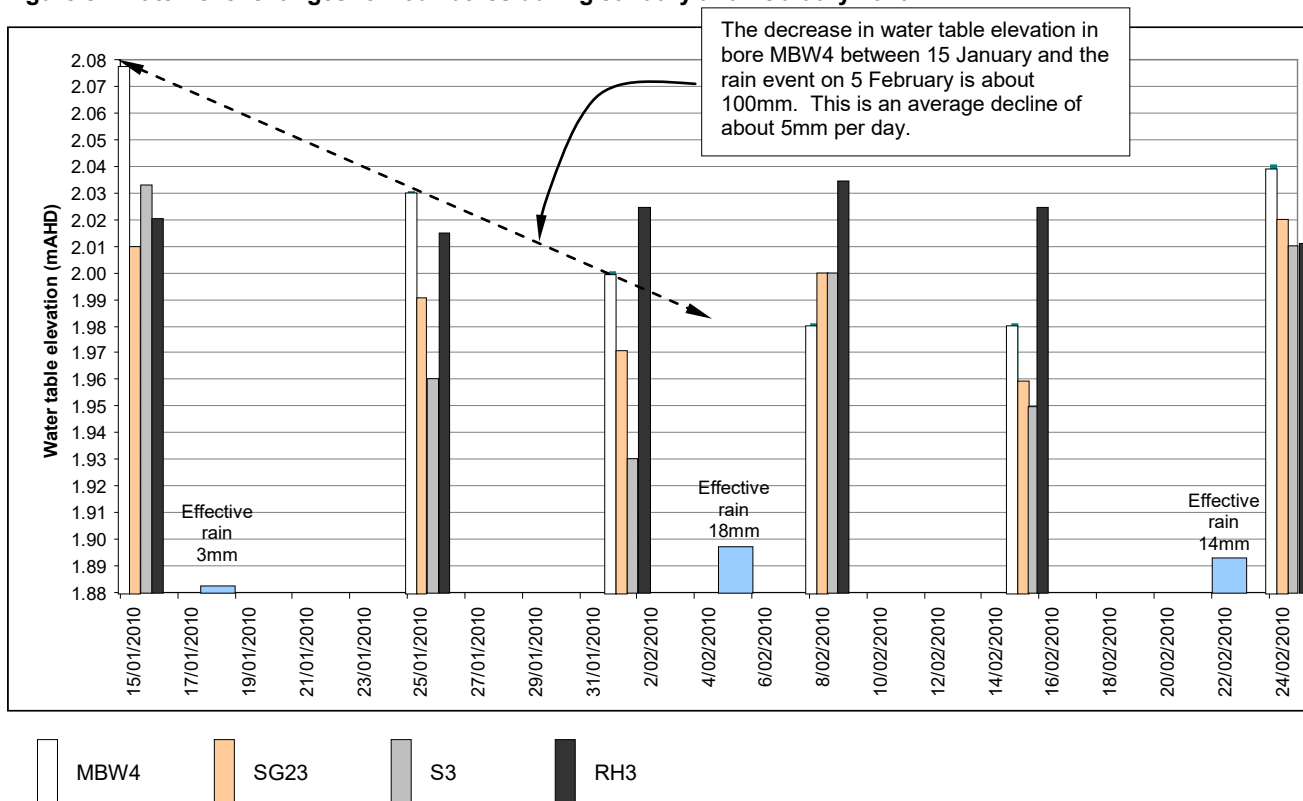
**Figure 8. Water level changes for four bores during January and February 2010**

- **Bore RH3:** The water table averages about 1m below ground. The water table defied the obvious trends of the other three, falling by 5mm and then rising by 10mm slightly in a period of no rain. The 16mm of effective rain on 5 February raised it by about 5-10mm. 12mm of effective rain on 22/23 February had no measureable effect. This bore is surrounded by mature radiata pines, the foliage of which would have intercepted some of the rain, and the roots of which would have done the same to the rain which infiltrated the soil. So it is to be expected that the water table variability would be more subdued compared to more exposed bores.

As a general comment, the water table decline in periods of no rain, and its response to infiltrating rain, are complicated processes which differ areally across the aquifer. Response to rain is also influenced by antecedent rain conditions. Nevertheless, the data in Figure 8 are not inconsistent with the following:

- In periods of no rain, the summer water table decline across the monitored bores is a few millimetres per day, and
- Isolated small rain events have no measureable effect on the water table elevation; several or many small events have a measureable effect; rainfall events of more than about 10mm of effective rain have clear effects, during and after which the water table rises by several times the effective rain.

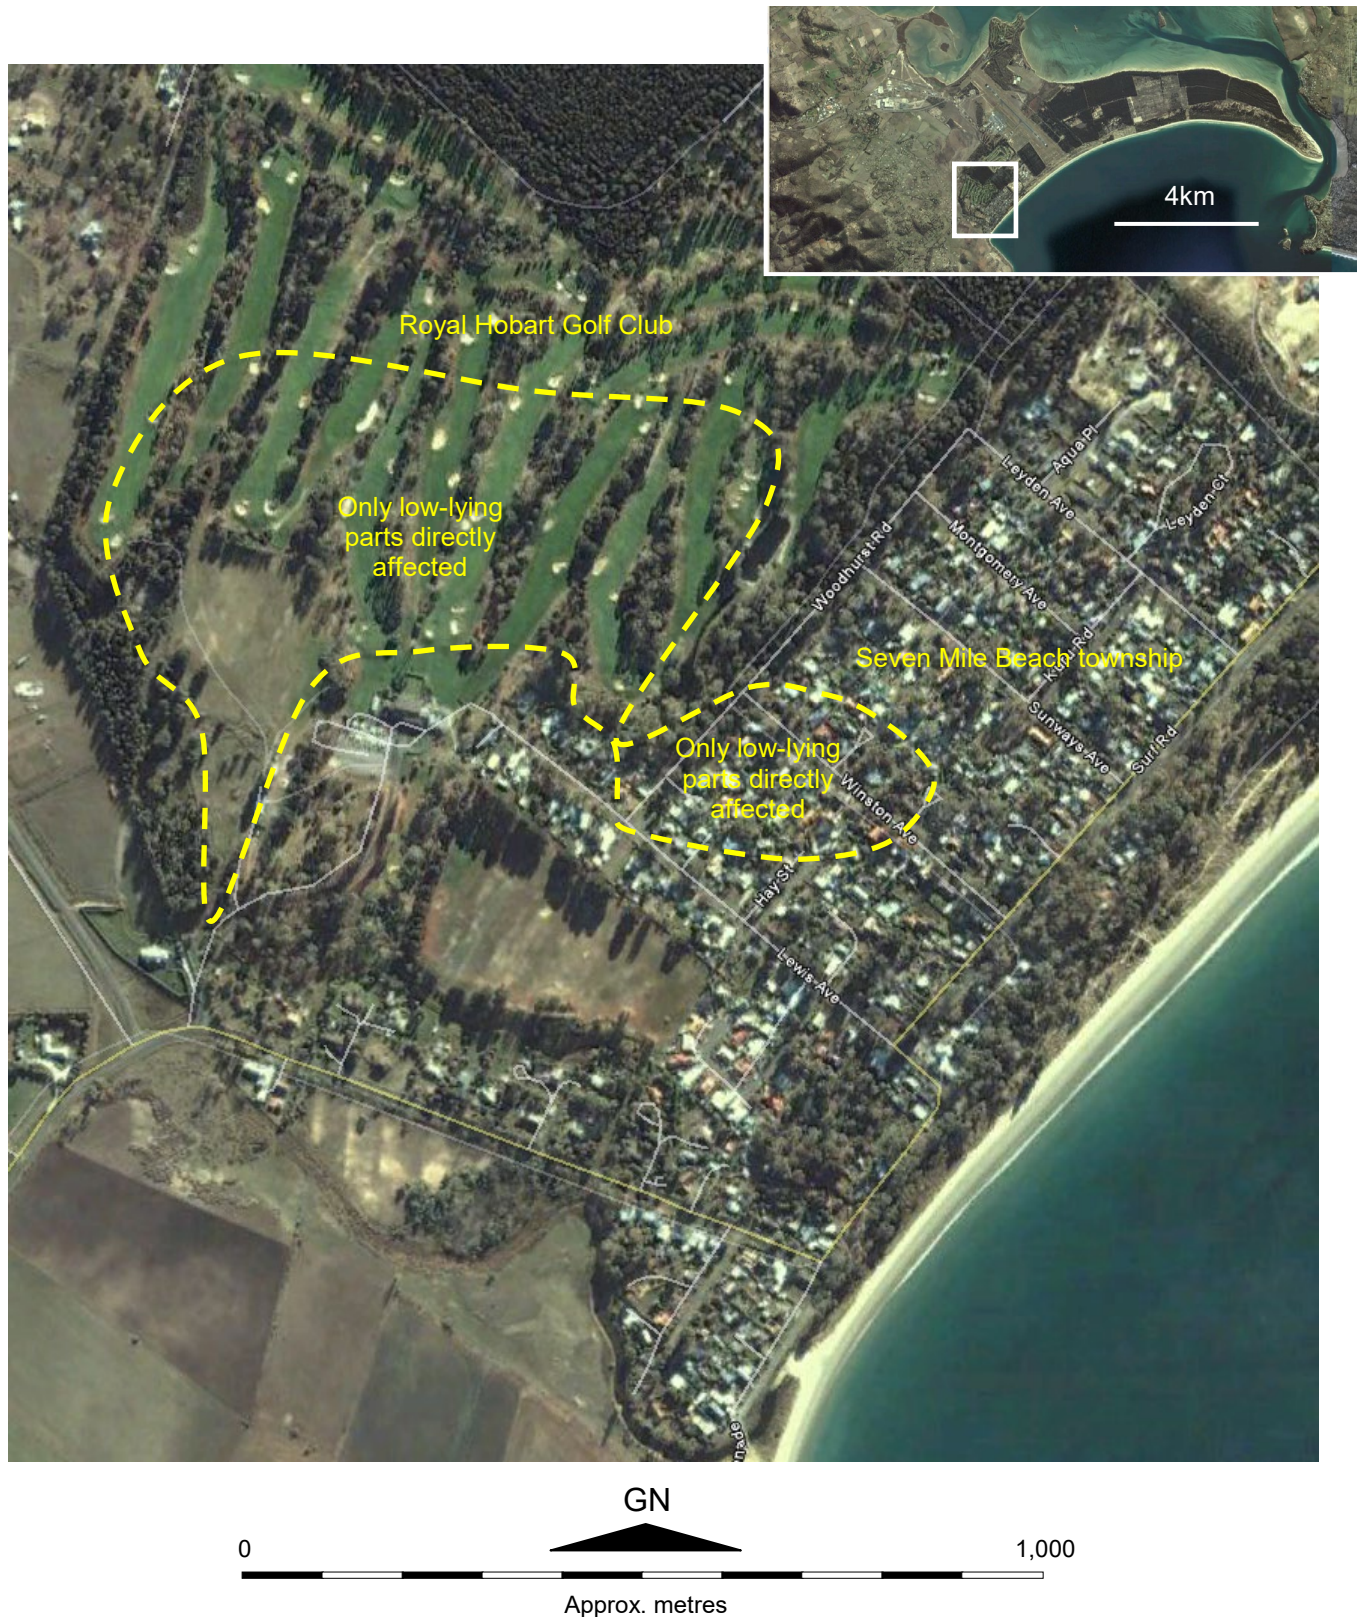
Affected areas are enclosed by dashed yellow line (approximate only)

Compare with Attachment 2.

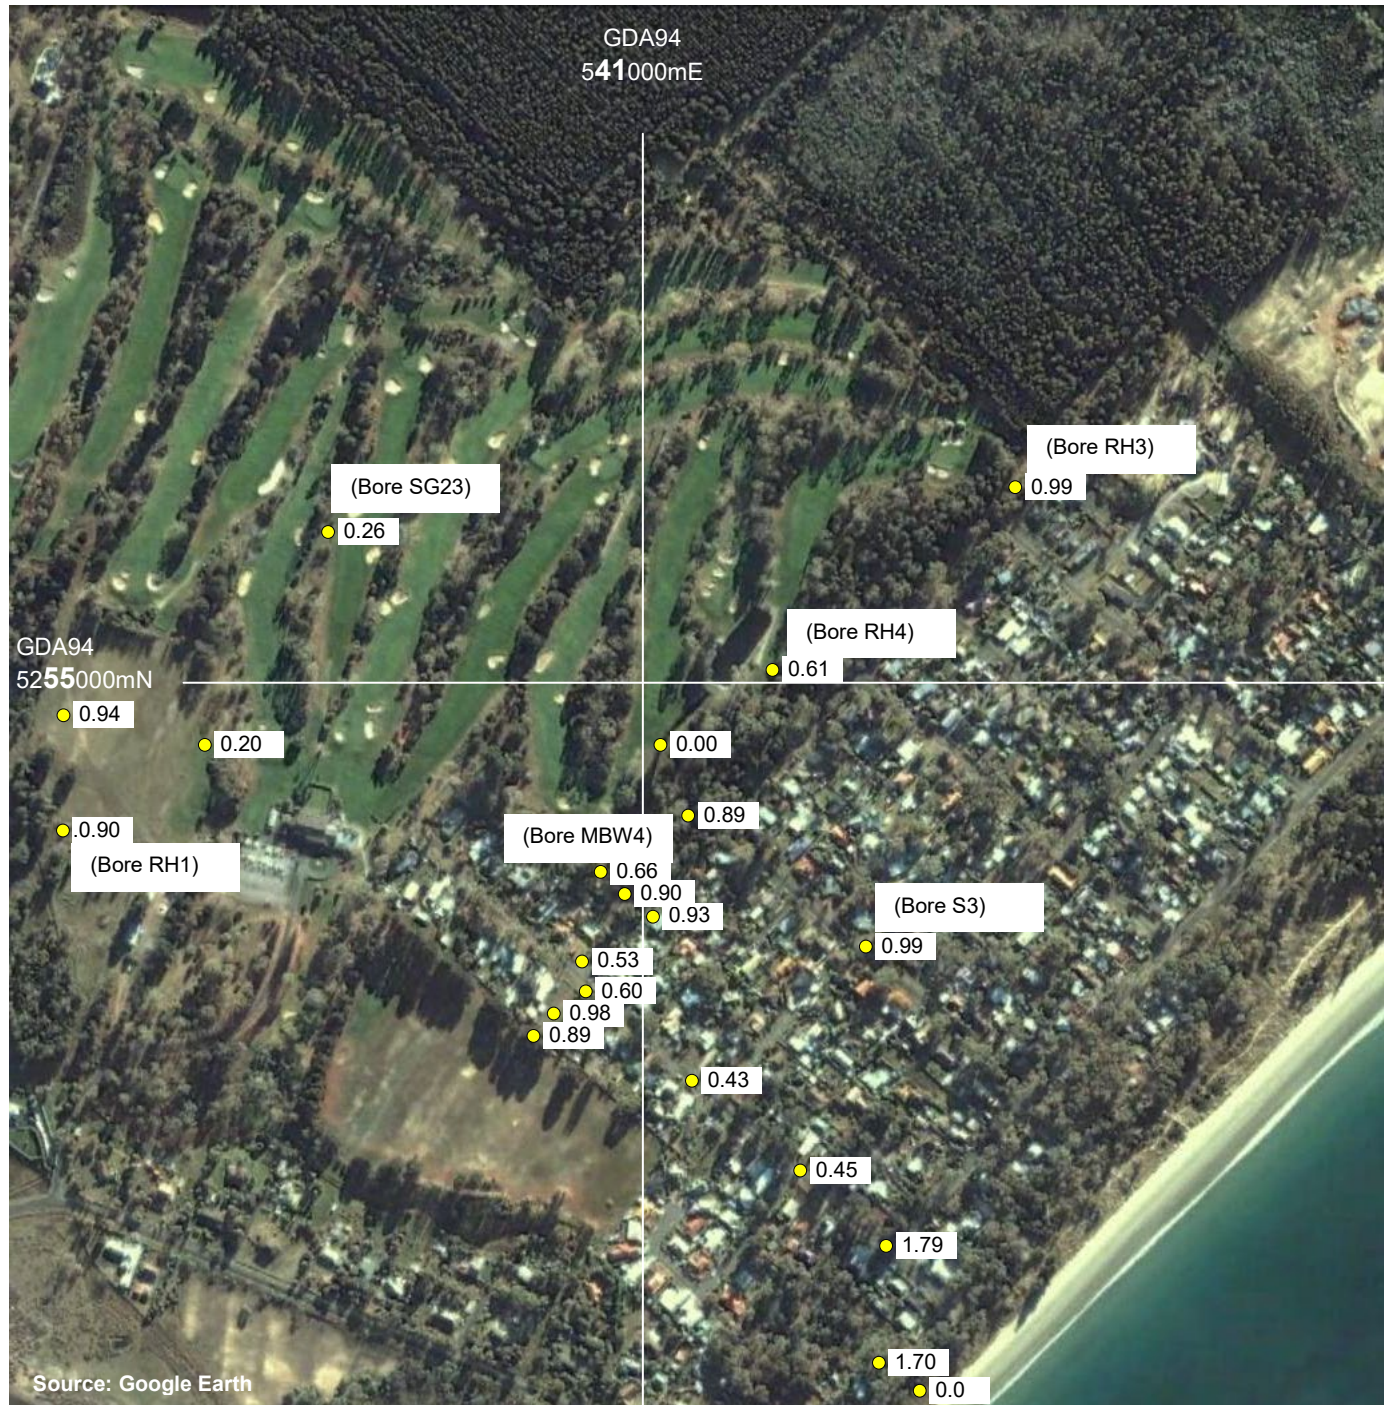
Depth to the water table (m), Seven Mile Beach township and golf course, January 15 2010

Figures are the thickness (in metres) of sand above the water table. Selected bores mentioned in the report are shown.

The first satellite image in Attachment 3 shows the depth to the water table at various monitoring points on 15 January 2010. The lowest value (of course), is 0.00m in the soak on the golf course. The highest values are near the coast where the water table height decreases towards mean sea level. The western end of Woodhurst Road, which was under at least 0.3m of water during the flooding, was some 0.5m above the water table by mid-January, and ground either side of the road was about a metre or so above the water table. On the golf course, monitoring bore SG23 showed the water table at about 0.25m; this area was flooded several times in 2009 by stormwater from drain F-H-I-J.

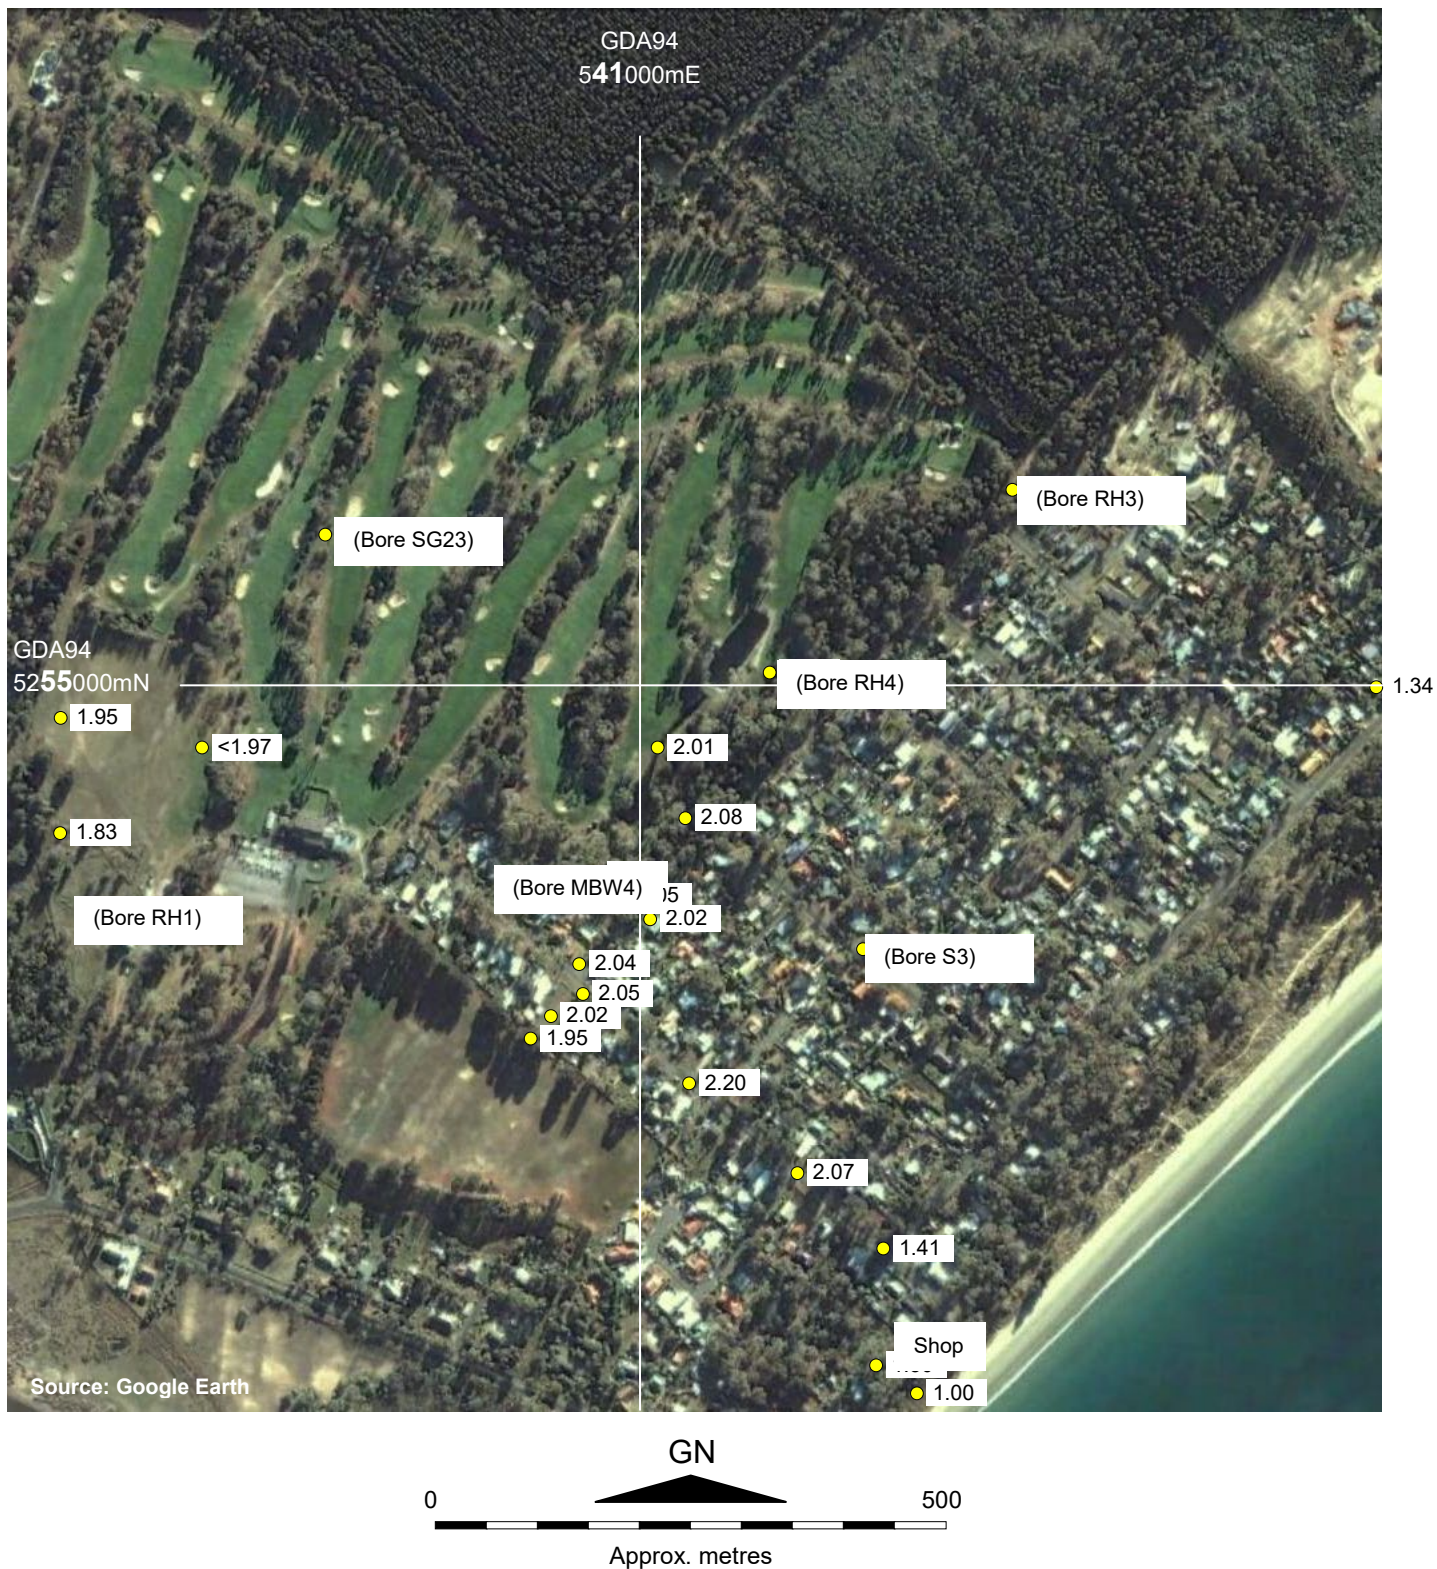
Water table elevations, Seven Mile Beach township and golf course, 15 January 2010  
Figures are water table elevations in mAHD. Selected bores mentioned in the report are shown.

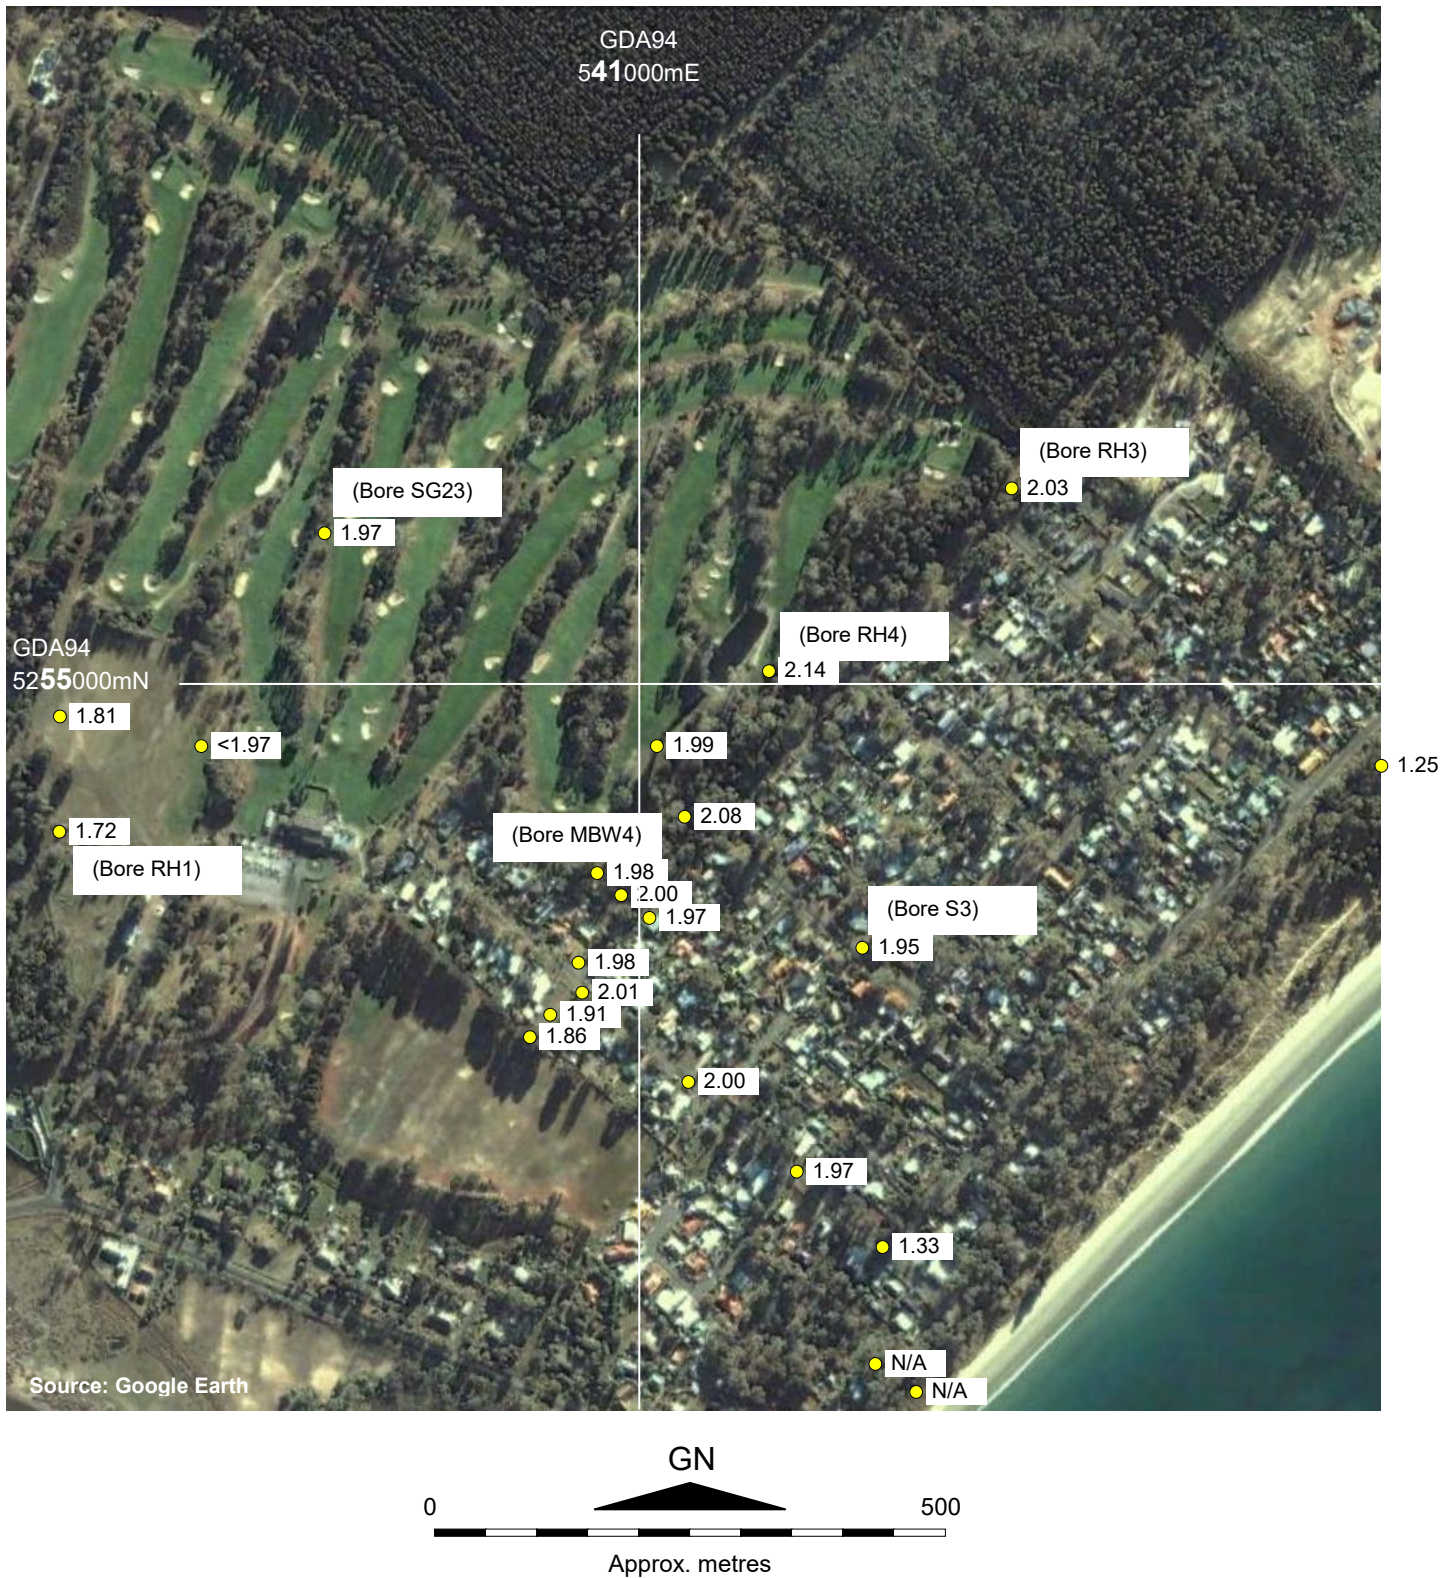
Water table elevations, Seven Mile Beach township and golf course, 15 February 2010  
Figures are water table elevations in mAHD. Selected bores mentioned in the report are shown.

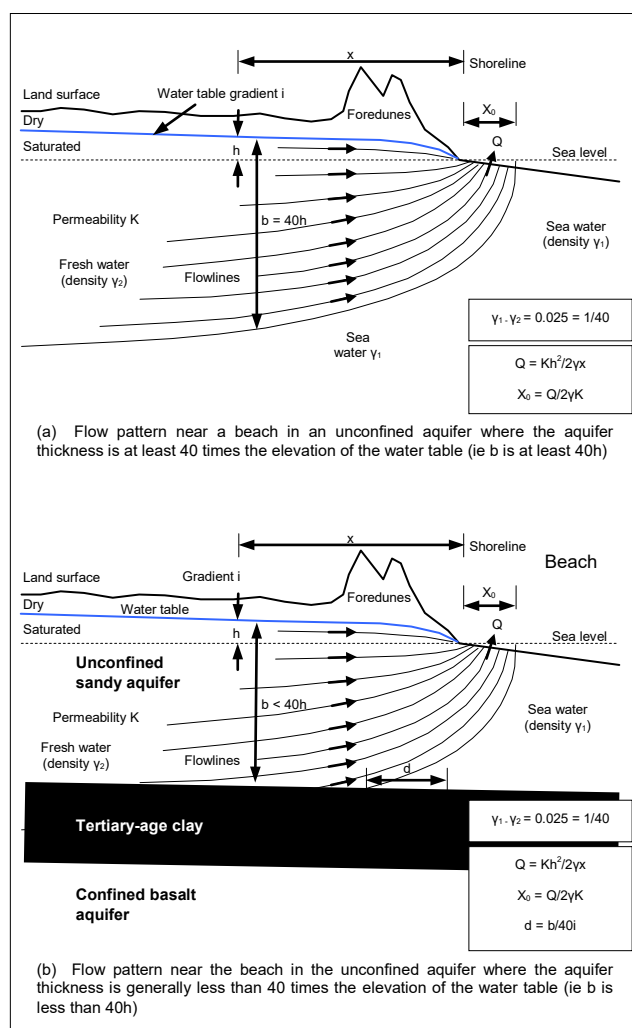
**Figure 1. Cross sections showing the water table, groundwater flow patterns (arrowed lines) and the fresh water – sea water interface in unconfined coastal sands aquifers. The bottom cross section is a schematic for most Tasmanian coastal sand aquifers where a relatively shallow impermeable base is present, and the aquifer is full of fresh water.**

Figure adapted from Figure 23 of Cromer 1979, in turn from Glover, 1964)

In a static situation, one metre of fresh water above sea level will support a 40m high column of fresh water below sea level<sup>22</sup>. If the aquifer at any point is at least 40 times thicker than the elevation of the water table, then sea water will exist beneath the fresh groundwater body (Figure 1). At Seven Mile Beach, and all other Tasmanian coastal sands bodies which have been investigated, the aquifer is thin enough, and the elevation of the water table is sufficient, so that more than a short distance inland, the aquifer is completely filled with fresh water.

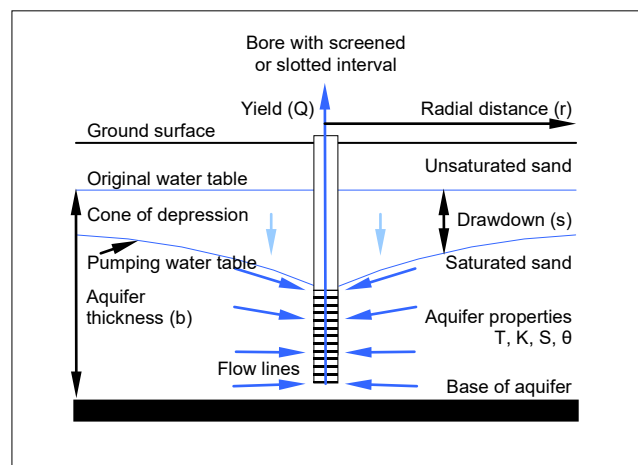
**Figure 2. The formation of the cone of depression in an unconfined aquifer. The size and shape of the cone are determined by the aquifer properties of transmissivity, specific yield and porosity.** Reproduced from Figure 16 of Cromer (2003).

When any bore, including a spear, is pumped, the water table around the bore is lowered, creating a gradient and inducing further flow towards the bore. The drop in the water level in the bore, and in the aquifer around it, is called the drawdown, and the shape so formed in the water table is called the cone of depression (Figure 2). As pumping continues, the cone widens to encompass more aquifer. The horizontal distance from the bore to the cone's outer edge is called the radius of influence, beyond which pumping has yet to have a noticeable effect on the original water table. Neighbouring bores interfere if each is located within the other's radius of influence (Figure 3).

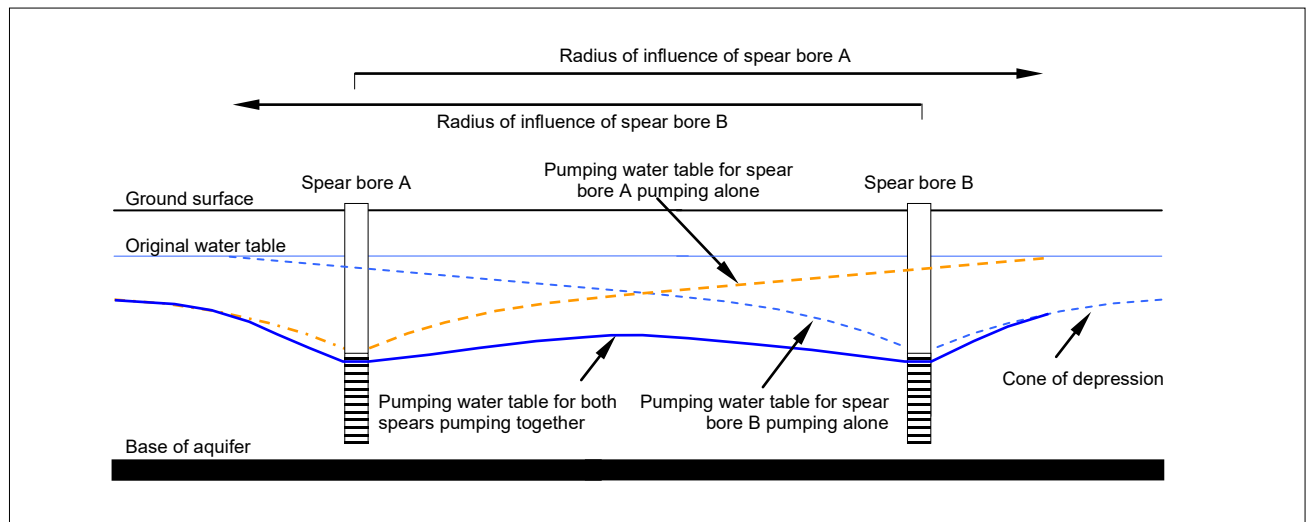
**Figure 3. Overlapping cones of depression from neighbouring bores causes additional drawdowns in each.** Reproduced from Figure 20 of Cromer (2003).

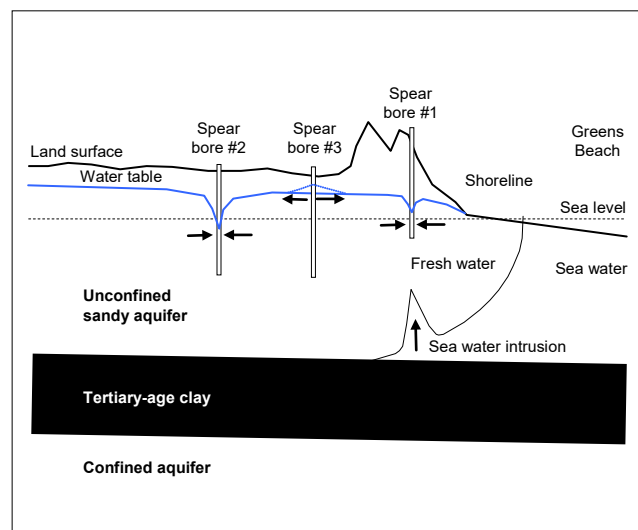
**Figure 4. Sea water intrusion and its mitigation**

Spear bore #1 produces sufficient drawdown sufficiently close to the coast to induce sea water intrusion into the base of the aquifer. Spear bore #2 produces less drawdown than #1 and is sufficiently distant from the coast not to induce the effect. Spear bore #3 is an injection bore which raises the water table and so prevents the effect.

Sea water intrusion is the physical movement of sea water into an aquifer, caused by a lowering of the water table so that its reduced elevation supports a decreased column of fresh water beneath (Figure 4).
