# Reserve Activity Plan 2013 – 2017

## For Thoona Bushland Reserve, Geilston Bay

November 2013

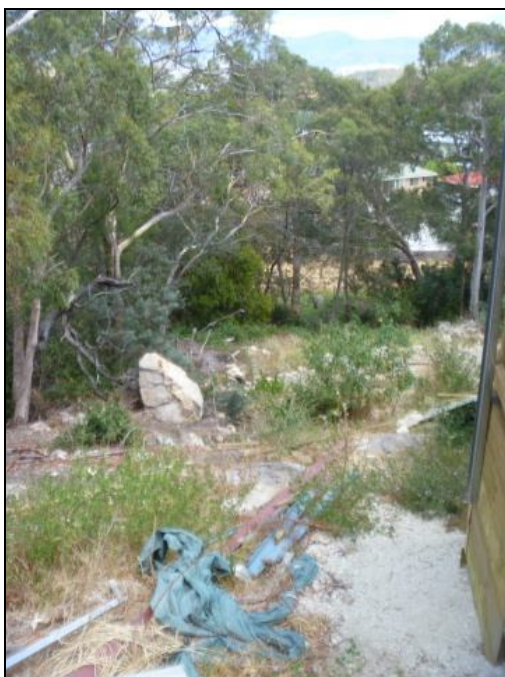
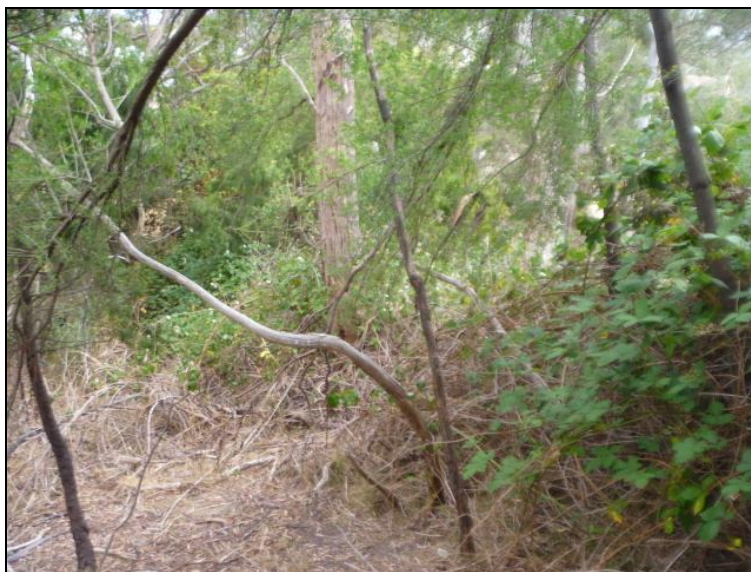
Figure 4 – Photos of degraded area of reserve off the end of Takone Street.

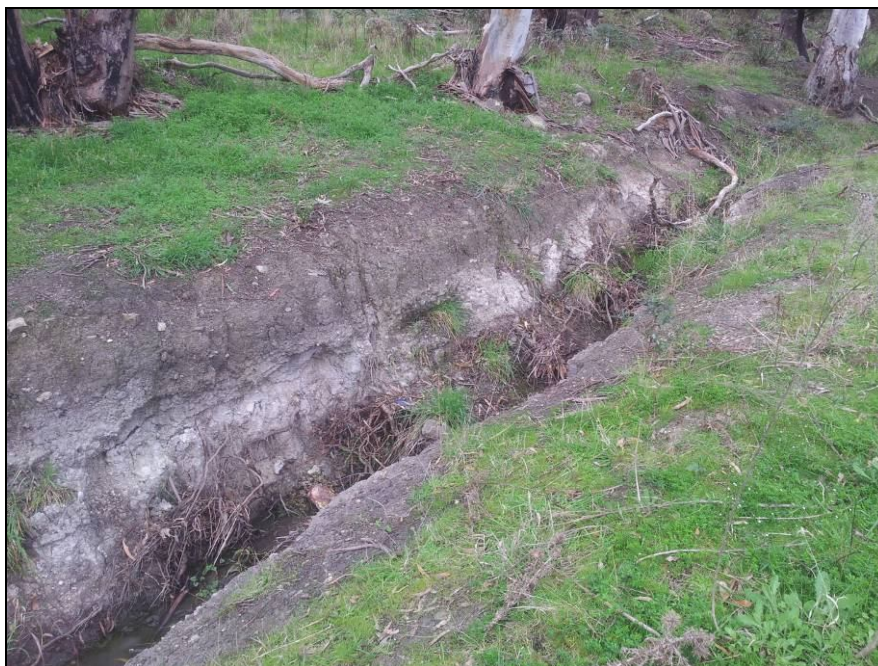
*Figure 7 – Photo of erosion of creek bank in lower half of reserve.*

The condition of the creekline that bisects the Thoona Bushland Reserve *'has deteriorated over time as the composition of its catchment has changed. Several decades of residential development in the catchment has resulted in native vegetation being replaced with impervious, hard surfaces such as roads and buildings. The increased imperviousness of the catchment alters the natural hydrologic regime. Runoff volume increases, while travel time decreases which inturn increases runoff flows. Higher flows in the creek have resulted in erosion in some segments of the creek (Figure 7). Some residential properties have also experienced minor inundation during major events.*

*Water quality in the creek has decreased as the composition of the catchment has changed. Runoff water quality from residential areas differ from pristine native vegetated environments due to soil dispersion during subdivision and building construction activities, hydrocarbons and metals from car use on the roads and increased nutrient loading from typical suburban gardening practice.*

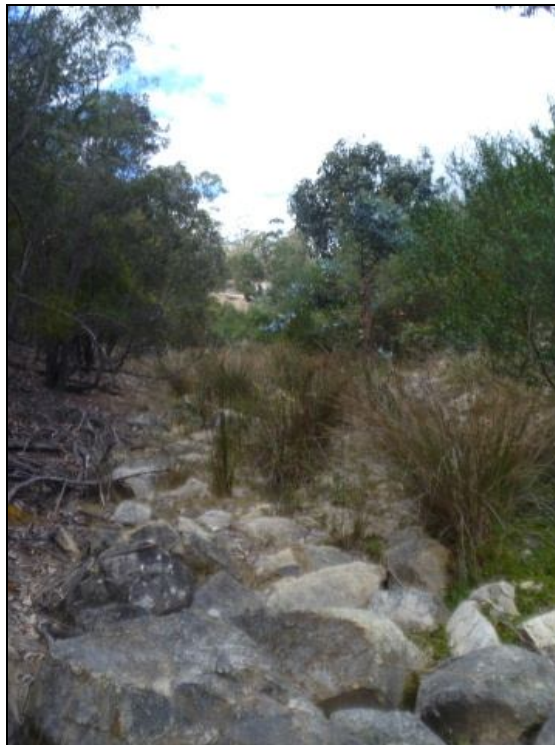
*Figure 8 – photo of rock battered creek bed and revegetation at top end of Thoona Bushland Reserve.*

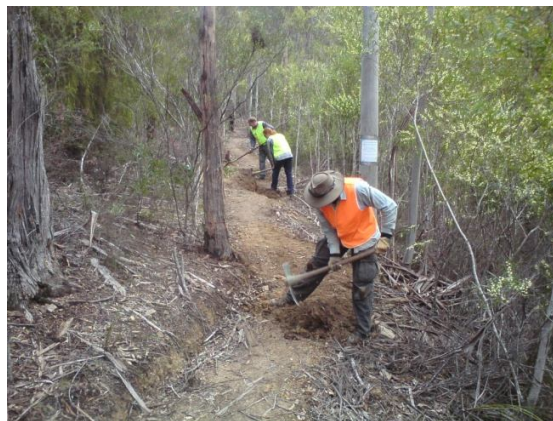
**Figure Two. Benched track**

Where the route traverses hill slope the track will need to be benched. For this grade of walk the track surface should be fully benched into the slope. The down slope fill batter should have cut vegetation pulled over it to the short term of the slope and will assist in vegetation re-establishing. The upslope cut batter should be shaped at an approximately uniform angle leaning back slightly into the slope. All exposed root material should be trimmed flush.

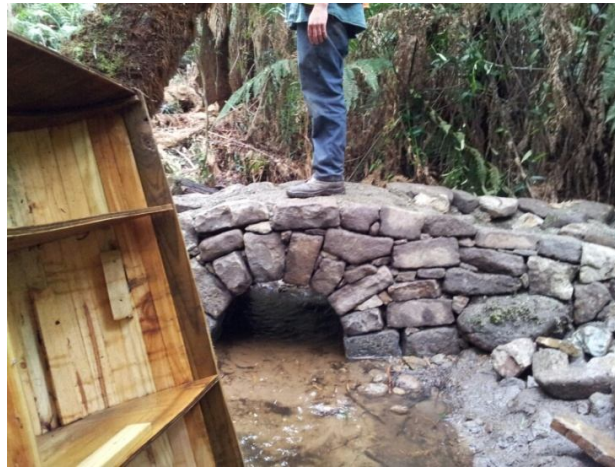
**Figure Three. Arched Bridge**

A small arched bridge is constructed of rock. Paving on top allows for flooding

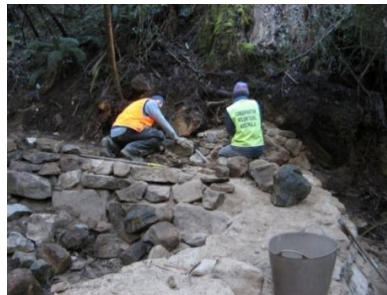
**Figure Four. Rock Retaining wall**

This benching will be 1200 mm wide. Where there is a steep side slope, the use of rock edging is required. To retain the lower edge of the bench construction, 3 to 4 tiers of rock are placed.

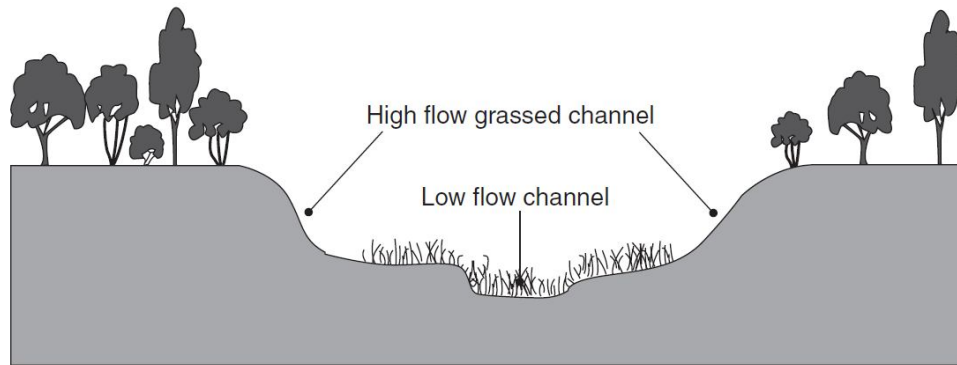
However there is limited scope for increasing the capacity of the creek in Zone B due to the presence of high voltage electricity cables laid under the creek. Council has recently undertaken some minor works that help to drain the flat land adjacent to creek after a rainfall event. Further improvements could include changing the shape of the creek to a broad triangular cross section such that the ground falls steadily from the boundary of private properties to the invert of the creek.

**Figure 2. Low flow channel with grassed floodway**

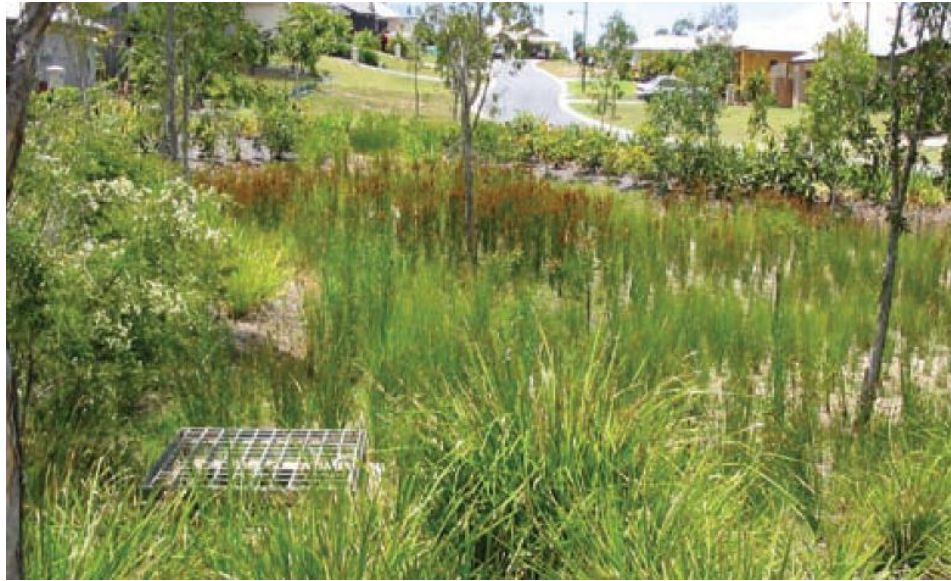
The most appropriate solution would be the construction of bio-retention basins. Bio-retention basins typically consist of a sandy filter/growing media, native vegetation and provision for water storage, or extended detention. The sand filter, while providing a media for plants to grow, filters out particulate matter and sediments, the vegetation will remove some of the nutrients from the flow and the extended detention maximises the volume of runoff that can be treated. An example of a bio-retention basin is shown in Figure 3.

**Figure 3. – Example of a bio-retention basin**

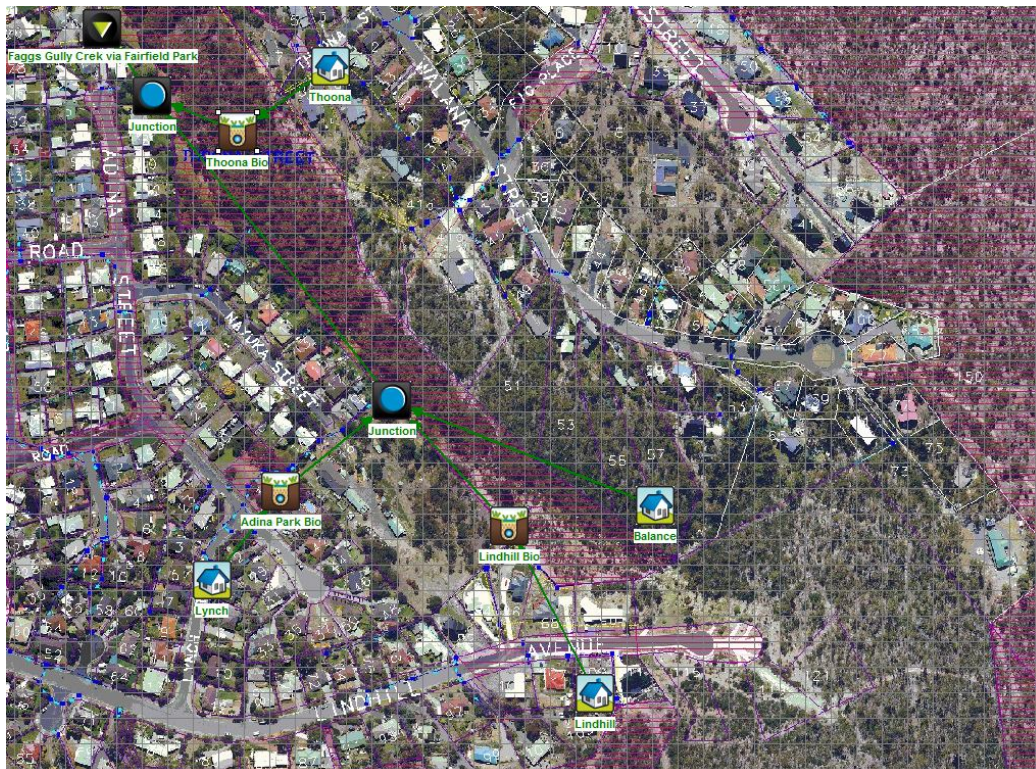
Preliminary sizing of the bio-retention basins has been performed using MUSIC. The conceptual MUSIC model is shown in Figure 4 while the preliminary bio-retention basin sizes are shown in Table 2.

**Figure 4. MUSIC model**

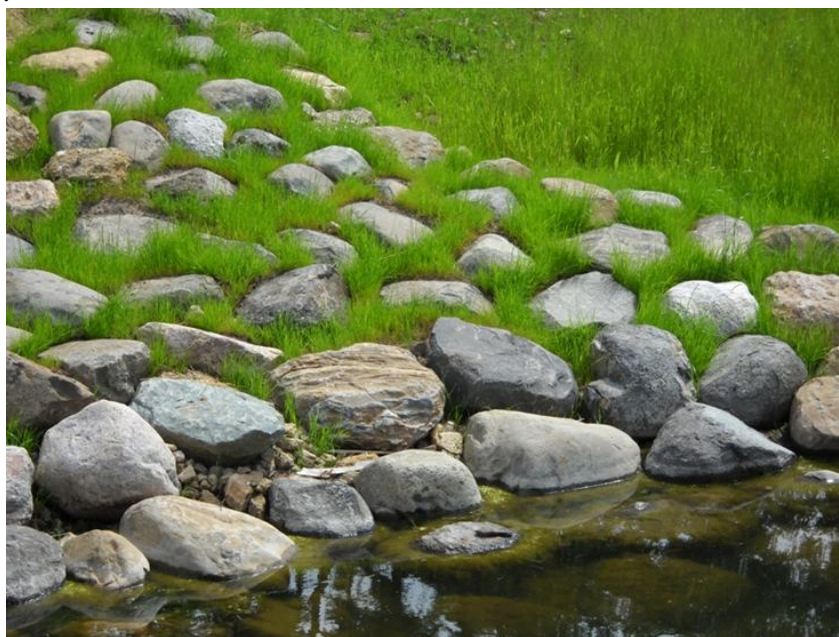
The existing erosion can be controlled by installing rip-rap along the creek banks and creek bed. Rip-rap is typically hard rock, such as dolerite, sourced from a quarry. The size of rock required is dependent on the slope of the creek and the anticipated flow rates. An example of rip-rap stabilisation of a creek bank is shown in Figure 5.

**Figure 5. Rip-rap stabilisation of a creek bank**

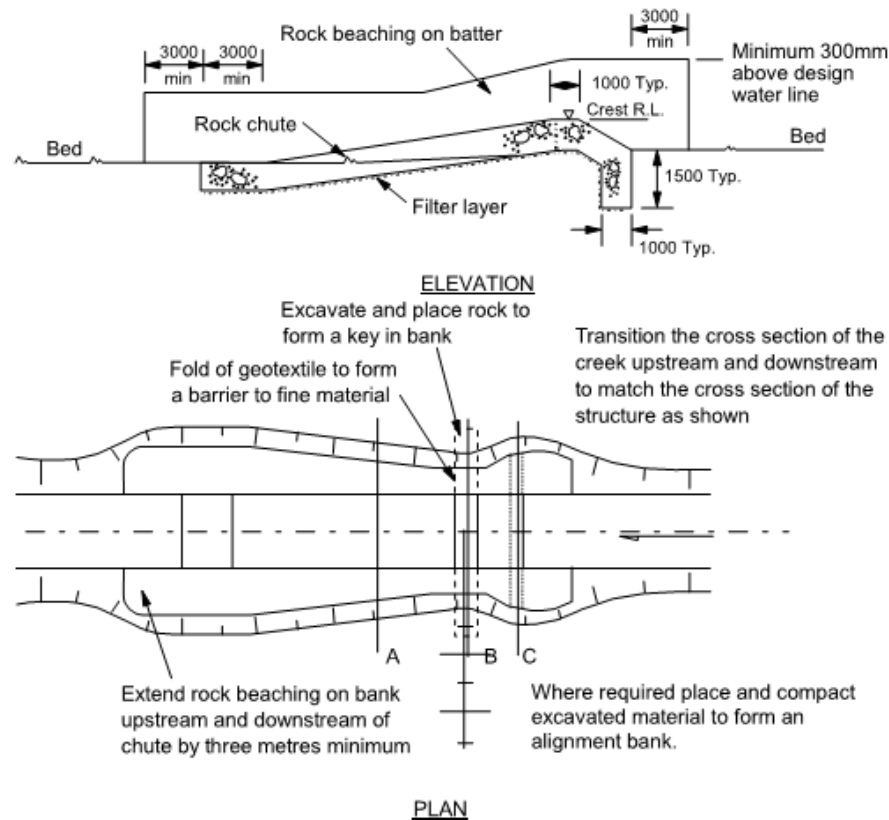
**The potential for further erosion of the creek can be reduced by altering the slope of the creek bed. Drop structures** consisting of adequately sized quarry rock can be installed at specified locations along the creek. The drop structure will allow water, and eventually sediment, to build up on the upstream side of the drop structure, effectively flattening out the alignment, which has the effect of reducing flow velocities in the creek. The drop structure could also be complimented and improved by **the planting of appropriate native vegetation.** An example of a rock drop structure is shown in Figure 6.

**Figure 6. Example of a rock drop structure (Guidelines for the Design of Rock Chutes using CHUTE – CRC for Catchment Hydrology).**

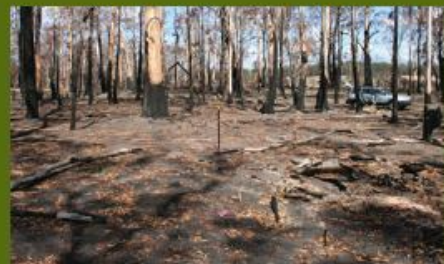
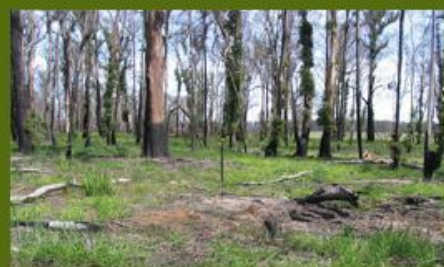
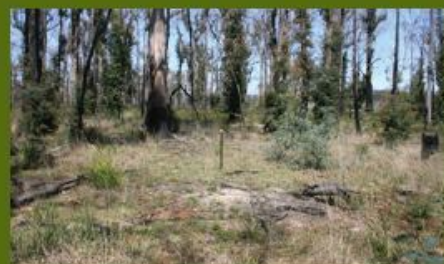
Above: Photopoint monitoring series of regeneration after a fire.

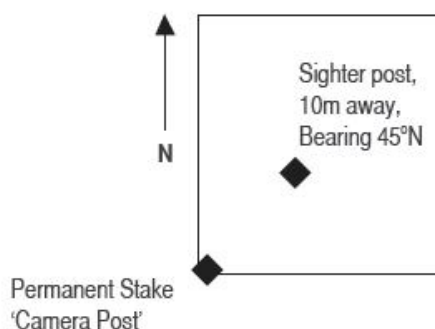
Figure 1: Example of Photopoint set up - aerial view

Ideally use the same type of camera with the same settings each time. A good choice is a SLR camera with 50mm lens. The 'auto' setting allows for ease of use and consistency, but if you use manual settings remember to record them. Zoom should not be used as it changes the width of the field of view. Turn on date stamping features on the camera if available and unlikely to obscure important elements of the picture (see *Hints and Tips* for more).

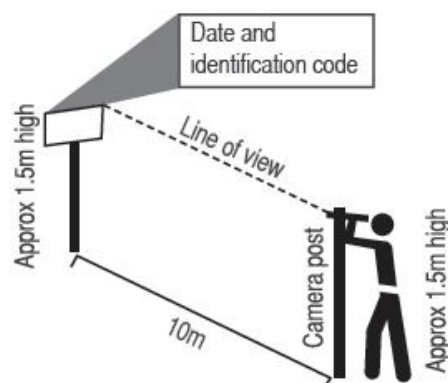
Figure 2: Example of Photopoint set up - side view

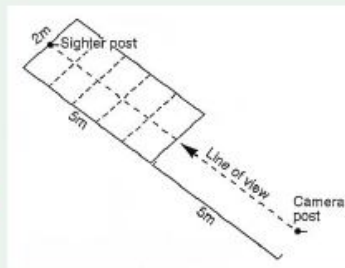
Figure 4: An example of photo quadrat monitoring for further vegetation monitoring data, aerial view.

There are several variations on photopoint monitoring using quadrats, please research the best one for your site. All methods require knowledge about plant species.
