18 July 2011

WRL Ref: WRL10086TDS L20110718

## Inspection of Clarence City Beaches following Winter 2011 Storm Events

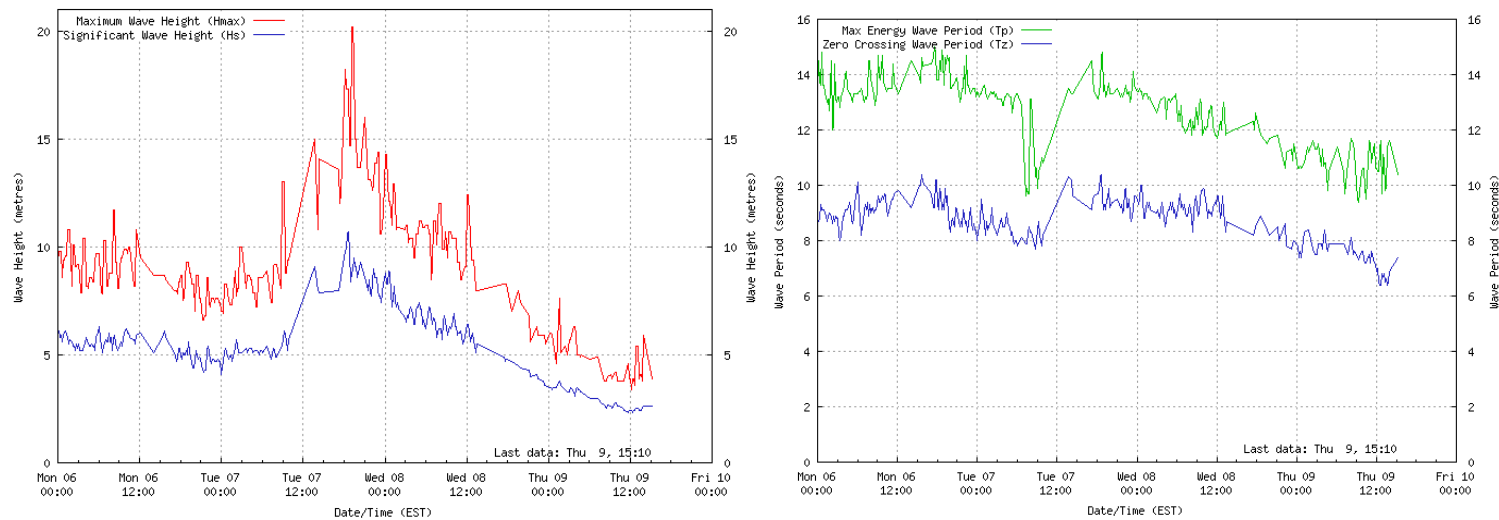
A small, intense low pressure system passed below Tasmania on 7<sup>th</sup>/8<sup>th</sup> June 2011. The system had a central pressure of 998 hPa with tight pressure gradients causing very strong south to south-westerly local winds (Figure 1). This resulted in a significant wave height ( $H_s$ ) up to 10.7 m and Peak Period of 14.5 s being recorded at the Cape Sorell Wave Buoy (Figure 2) located off the West Coast of Tasmania. Based on extreme values calculated for this location by Shand et al. (2011), this peak wave height has an average recurrence interval of approximately 8 years.

Based on a wave group velocity of  $11 \text{ ms}^{-1}$  for the spectral peak period of 14 s, the storm peak is likely to reach Frederick Henry Bay and the Clarence City Coastline 4 to 6 hours after being observed at the Cape Sorell wave buoy. The storm peak wave height is therefore likely to have reached the Clarence City Beaches in the early hours of Wednesday 8<sup>th</sup> June. The high astronomical tide was predicted to reach 1.29 m Hobart LAT (0.46 m AHD) at 0007 8 June 2011 (NTC, 2011; Figure 3). This predicted tide falls between a mean higher high water (MHHW) and mean lower high water (MLHW) tide (Australian National Tide Tables, 2009). Storm surge levels during the event have not been assessed but could be done at a later date after gathering additional data.

Figure 2 Wave height and period recorded at the Cape Sorell wave buoy 6 – 10 June 2011 (source: BoM, 2011)

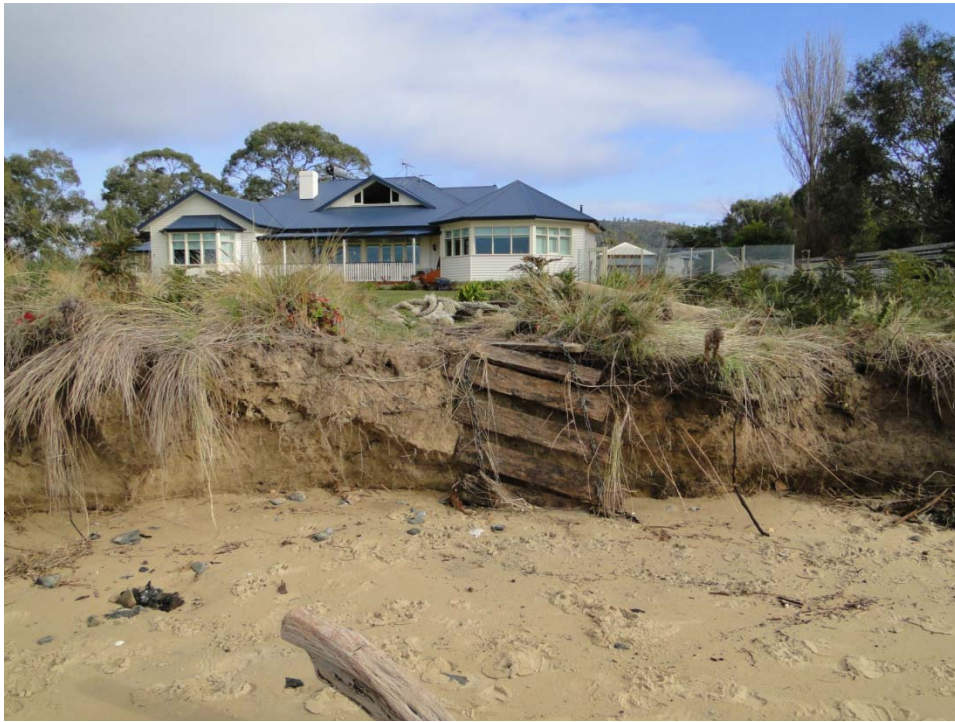
- Substantial runoff of the backshore vegetation between Bambra Reef and the Yacht Club (Photograph 1);
- Erosion to the north of Bambra Reef (Photograph 1) and evidence of large overtopping flows (Photograph 2). This is likely due to the combination of large waves and elevated water levels reducing the effectiveness of Bambra Reef in reducing transmitted wave energy;

*Photograph 1* Erosion north of Bambra Reef

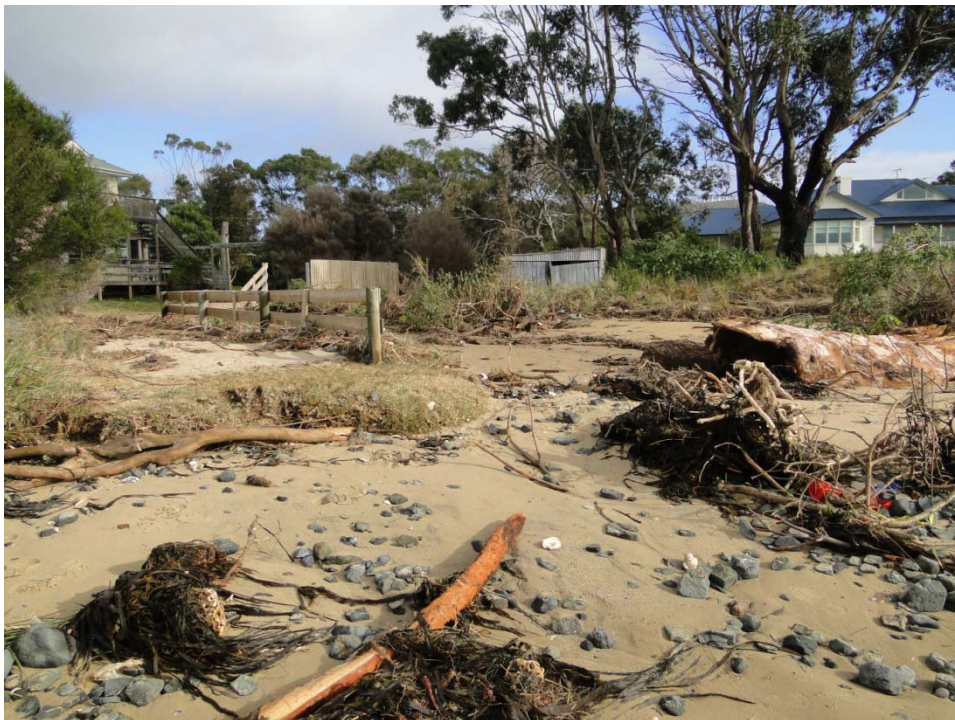
*Photograph 2* Wave overtopping north of Bambra Reef resulting from run-up

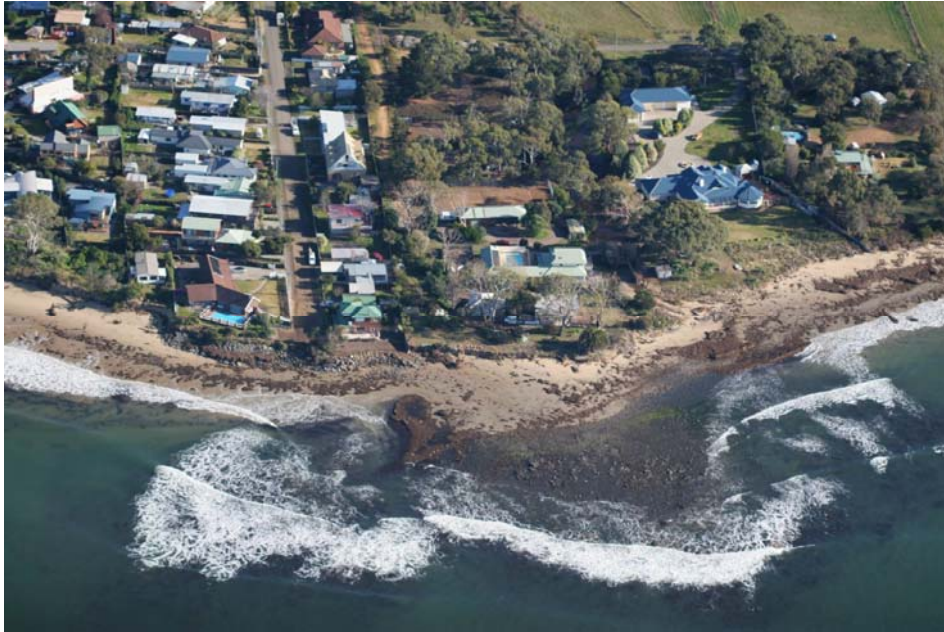
- Newly placed riprap rock at No. 1 Bambra St (Photograph 3). The structural integrity or appropriateness of wall design was not assessed within this inspection, although rock appeared slightly undersize and a geotextile underlay was not observed;

*Photograph 3* Bambra Reef and either newly placed riprap rock evident at end of Bambra St (photo: M. Dell, 15 July 2011)

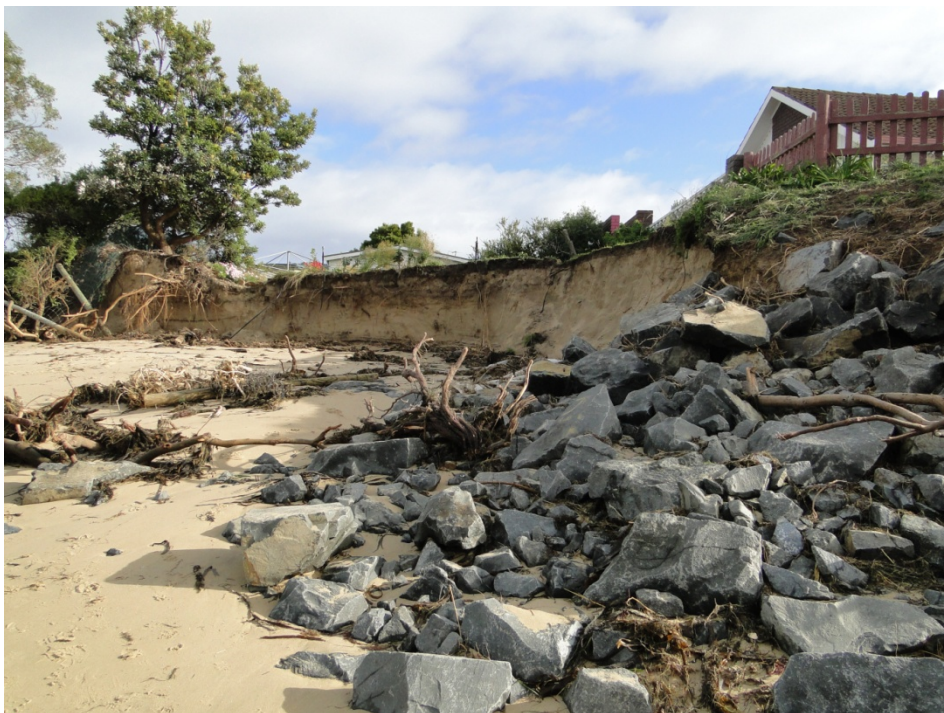
- Substantial recent erosion of land immediately south of the rock wall fronting No. 2 Bambra St. (Photograph 4) including where a small (undersize) sandbag wall was formerly located. This erosion scarp is up to 2 m high in places, and places the fence line and possibly other structures at No. 2 Bambra St within a zone of reduced foundation capacity;

*Photograph 4* Erosion immediately south of rock revetment fronting No. 2 Bambra Street

- Import sand to raise low points in dune crest along Roches Beach and revegetate with native grasses and sand binding species;
- Place sand (up to 10 m<sup>3</sup>/li m) in critically eroded locations such as adjacent to the Bambra Street revetments and immediately north of the southern revetment. This sand could be imported or obtained in limited quantities from deposits at the southern end of Roches Beach and north of Bambra Reef (estimated up to 500m<sup>3</sup> available at each);
- Limited 'repair' of southern revetment by pushing existing slumped materials into steeper slope (~1V:2H);
- Siting of beach access steps further landward to reflect new shoreline position;

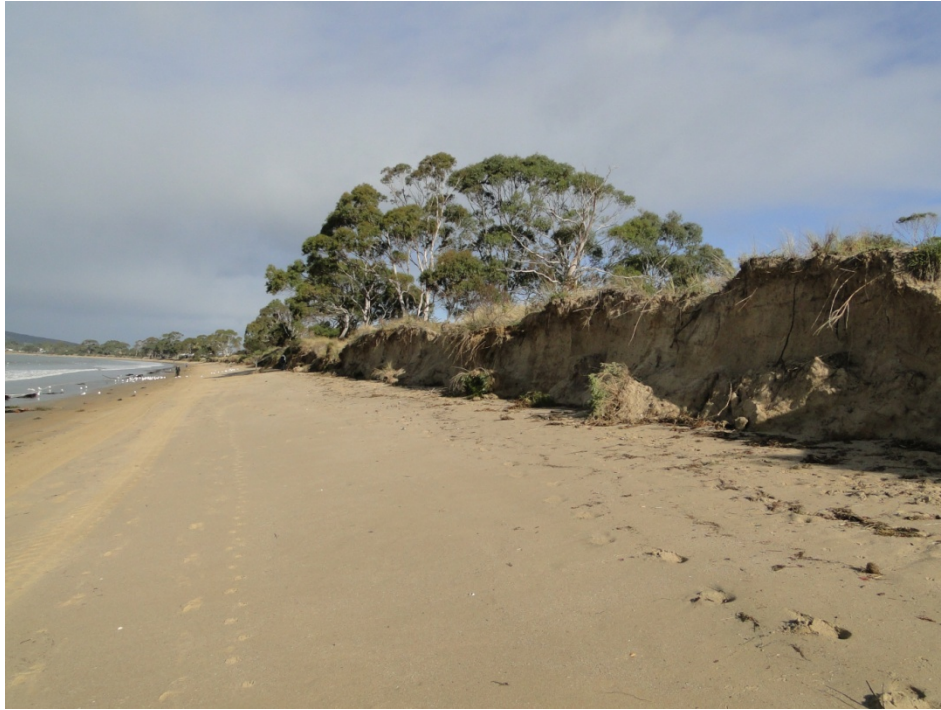
- Over-steepened dune scarps of up to 1.5 m high along much of Northern Roches Beach (Photograph 5) posing a possible stability hazard to pedestrians;
- Small hessian sandbags placed along dune crest at No. 118 Balook Street (Photograph 6). While these bags may assist in reducing overtopping volumes for smaller waves by elevating the crest level, they are substantially smaller than the 0.75 or 2.5 m<sup>3</sup> geobags typically used for coastal protection and are unlikely to survive large wave impacts. The Hessian material will also decay over time;

*Photograph 5* Over-steepened dune scarps of up to 1.5 m high along much of Northern Roches Beach

- Survey beach and analyse data to quantify change;
- Reduce hazard posed by over-steepened dune scarps along Cremorne and Roches Beach by a combination of limited beach scraping immediately in front of scarp (~0.5 to 1 m<sup>3</sup>/linear m of beach length) and pulling seaward of over-steepened scarp crest. This should be undertaken in a manner to preserve vegetation and root system where possible.

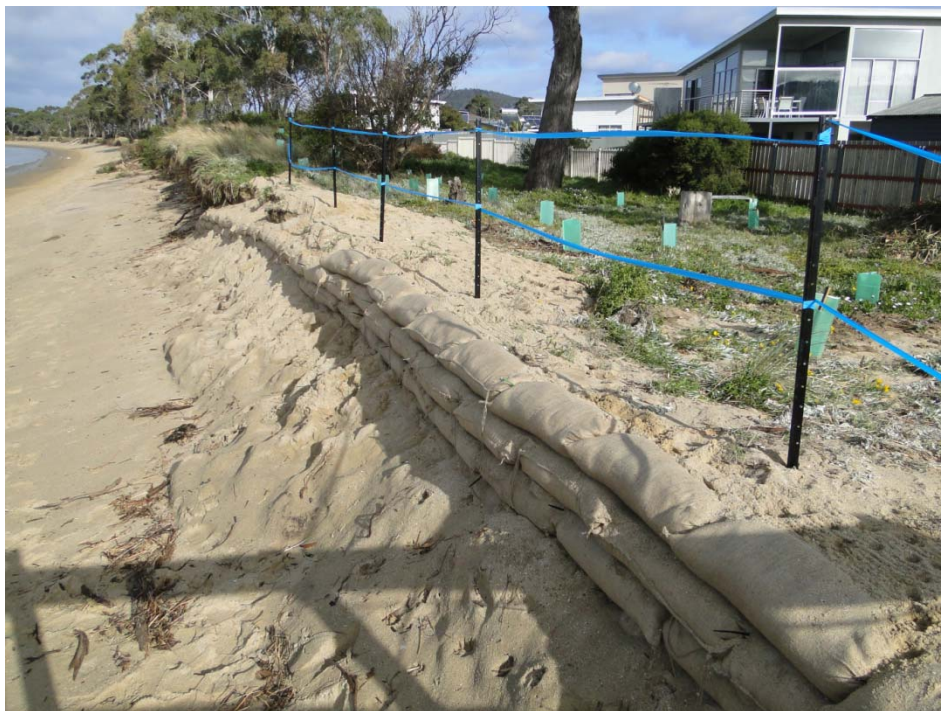
*Photograph 6* Small hessian sandbags placed along dune crest at No. 118 Balook Street

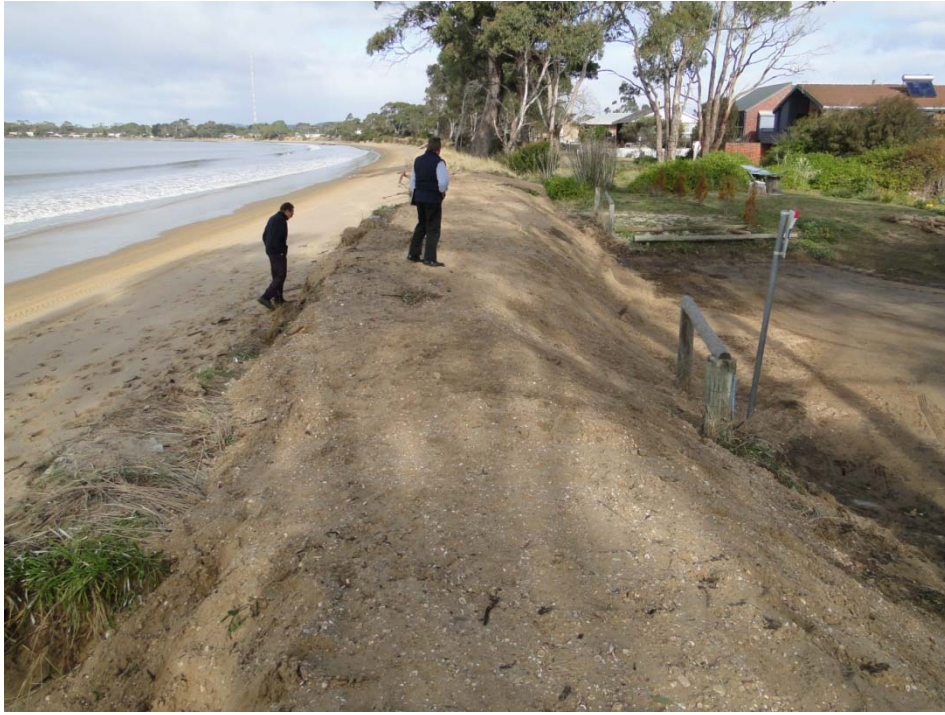
- Many areas of overtopping evident, particularly at low points in the dune crest. Particularly severe overtopping apparently occurred at Balanada Street where additional sand has since been placed to raise the crest level (Photograph 7);

*Photograph 7* Additional sand placed to raise the crest level at Balanada Street

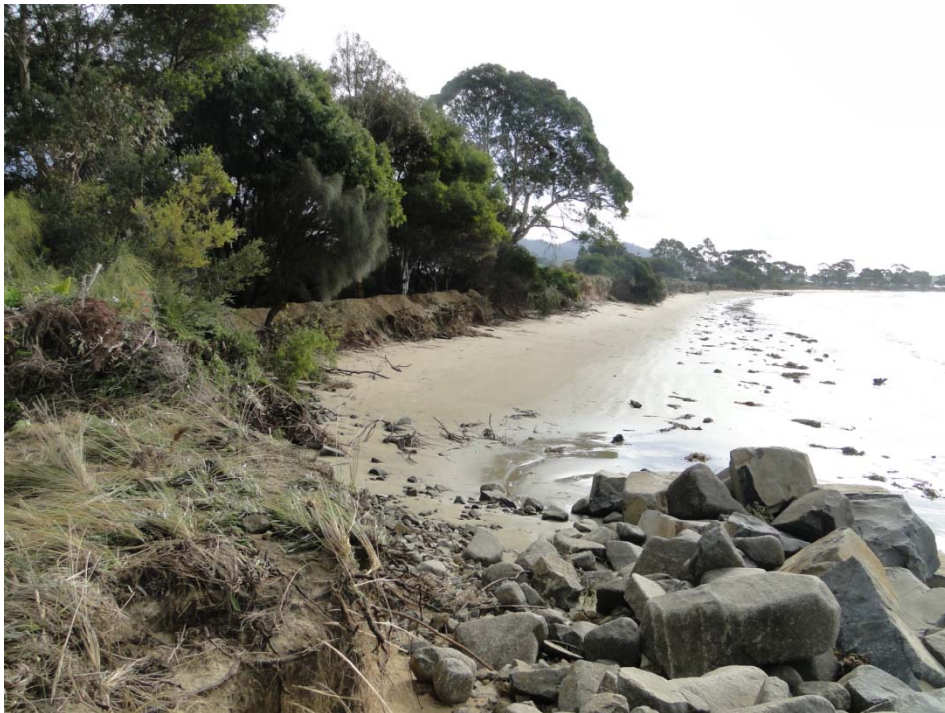
- Continued erosion and over-steepened dune scarps between the Lauderdale canal car park and the southern revetment;
- The southern revetment now holds land at least 5 m further seaward than the adjacent shoreline (Photograph 8);

*Photograph 8* Southern revetment now holds land at least 5 m further seaward than adjacent shoreline

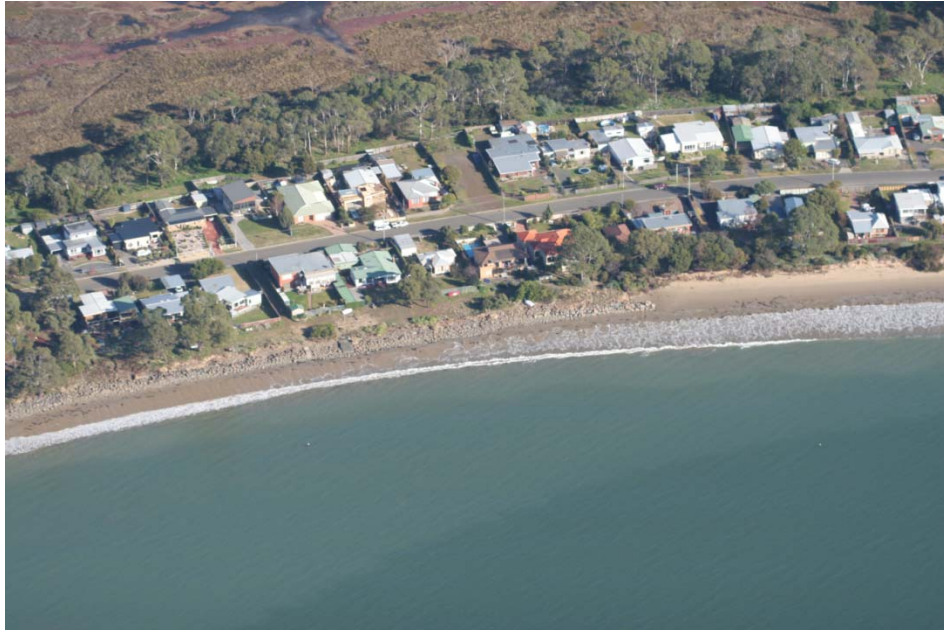
- The northern part of the revetment where rocks are generally larger appears to be structurally stable, although is in imminent danger of being outflanked by adjacent erosion to the north (Photograph 9);

*Photograph 9* Northern end of southern revetment with outflanking evident  
(Photo: M. Dell, 15 July 2011)

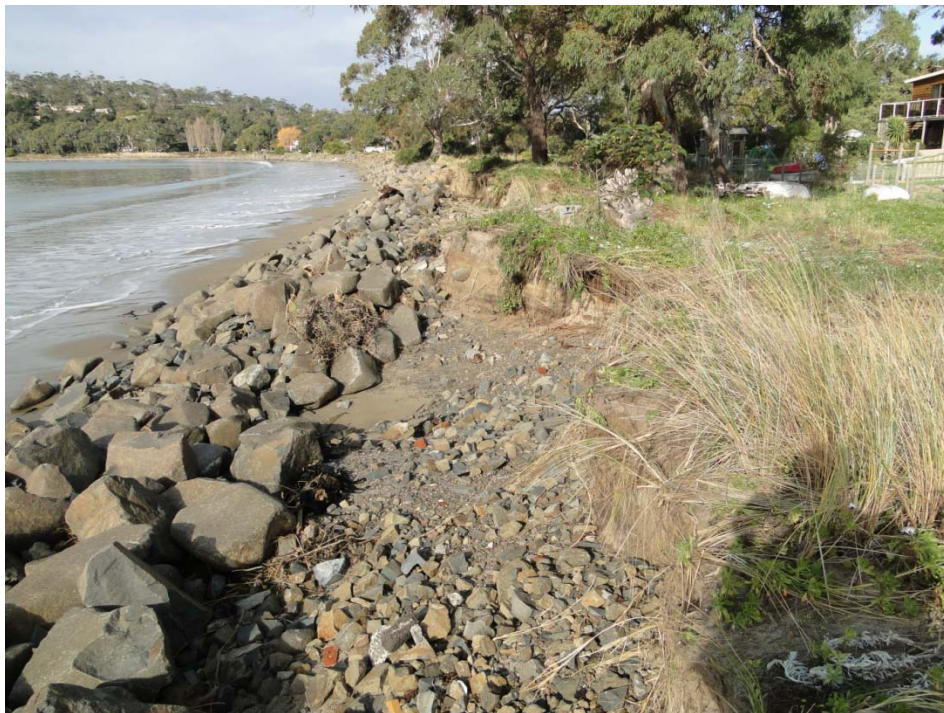
- Further south along the revetment, substantial slumping of the rock riprap has occurred due to undermining of the toe. Erosion of the backing land is evident where waves have overtopped the lowered wall (Photograph 10) and substantial overtopping flows were evident in the backshore. These overtopping flows have been particularly severe behind the concrete boat ramp which has assisted runup through minimal energy dissipation;

- Many of the riprap rocks appear to have broken during this and other past events, further reducing the average rock size and the structural integrity of the wall. While the wall appears to be largely fulfilling its intended purpose, it is progressively failing;

*Photograph 10* Erosion of land backing the southern revetment evident where waves have overtopped the lowered wall

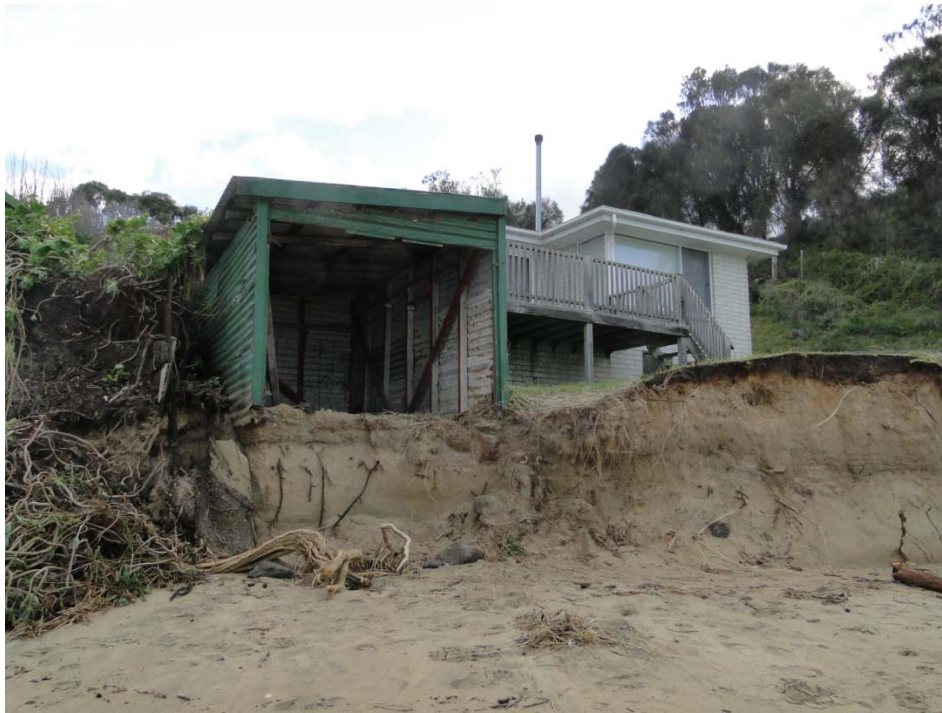
- Erosion of the dune has undermined a corner of a boat shed at No. 62 Frederick Henry Parade (Photograph 11);
- Concrete block and timber walls along Frederick Henry Parade damaged by wave runup (Photograph 12);
- Higher dune systems have limited most overtopping along the central and southern portions of the beach but over-steepened erosion scarps are evident reaching over 2 m at the southern end (Photograph 13);
- Difficult foot access around the southern end of Cremorne Spit with erosion continuing around the distal (southern) tip.

*Photograph 11* Erosion of the dune has undermined a corner of a boat shed at No. 62 Frederick Henry Parade

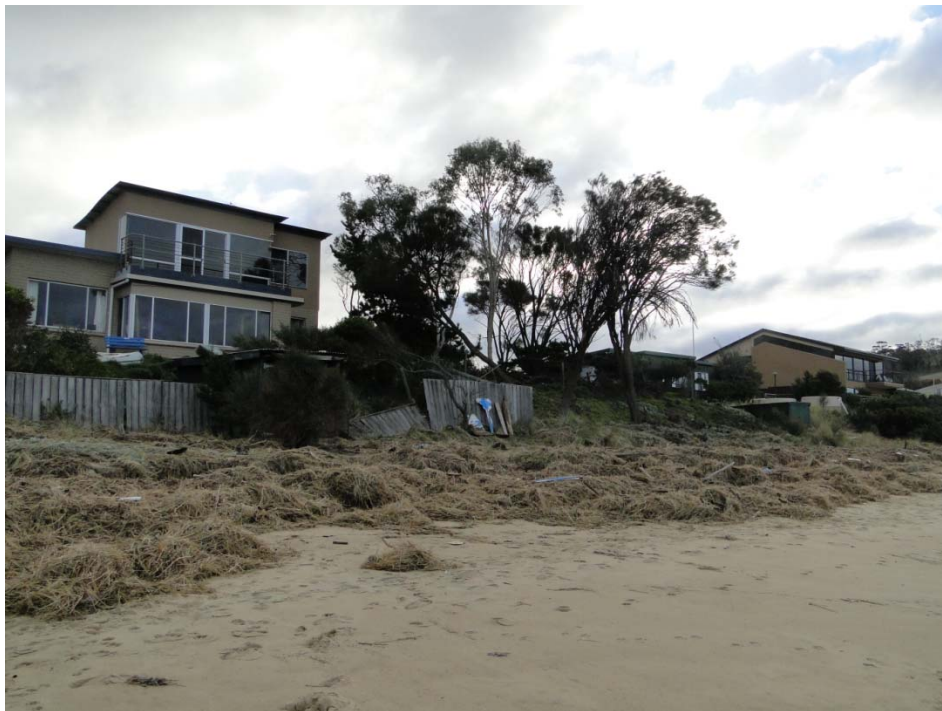
*Photograph 12* Timber wall along Frederick Henry Parade damaged by wave runoff

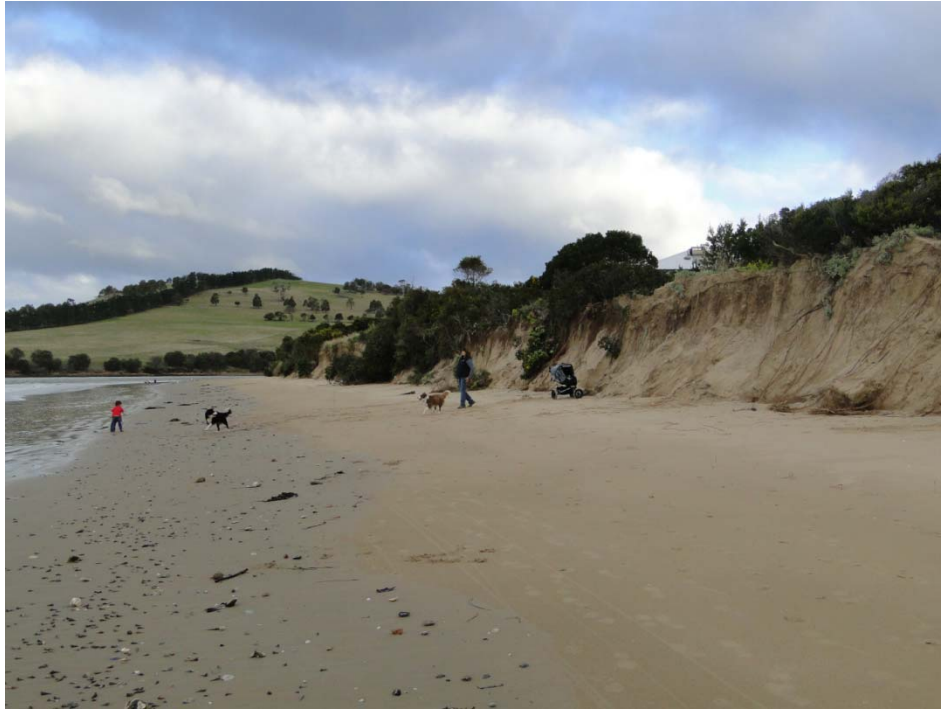
*Photograph 13* Over-steepened erosion scarps reach over 2 m at the southern end of Cremorne Beach
