Reserve Activity Plan

2019 - 2029

SEVEN MILE BEACH COASTAL RESERVE

ADVICE PREPARED BY
TASFLORA FOR
CLARENCE CITY COUNCIL
NOVEMBER 2018

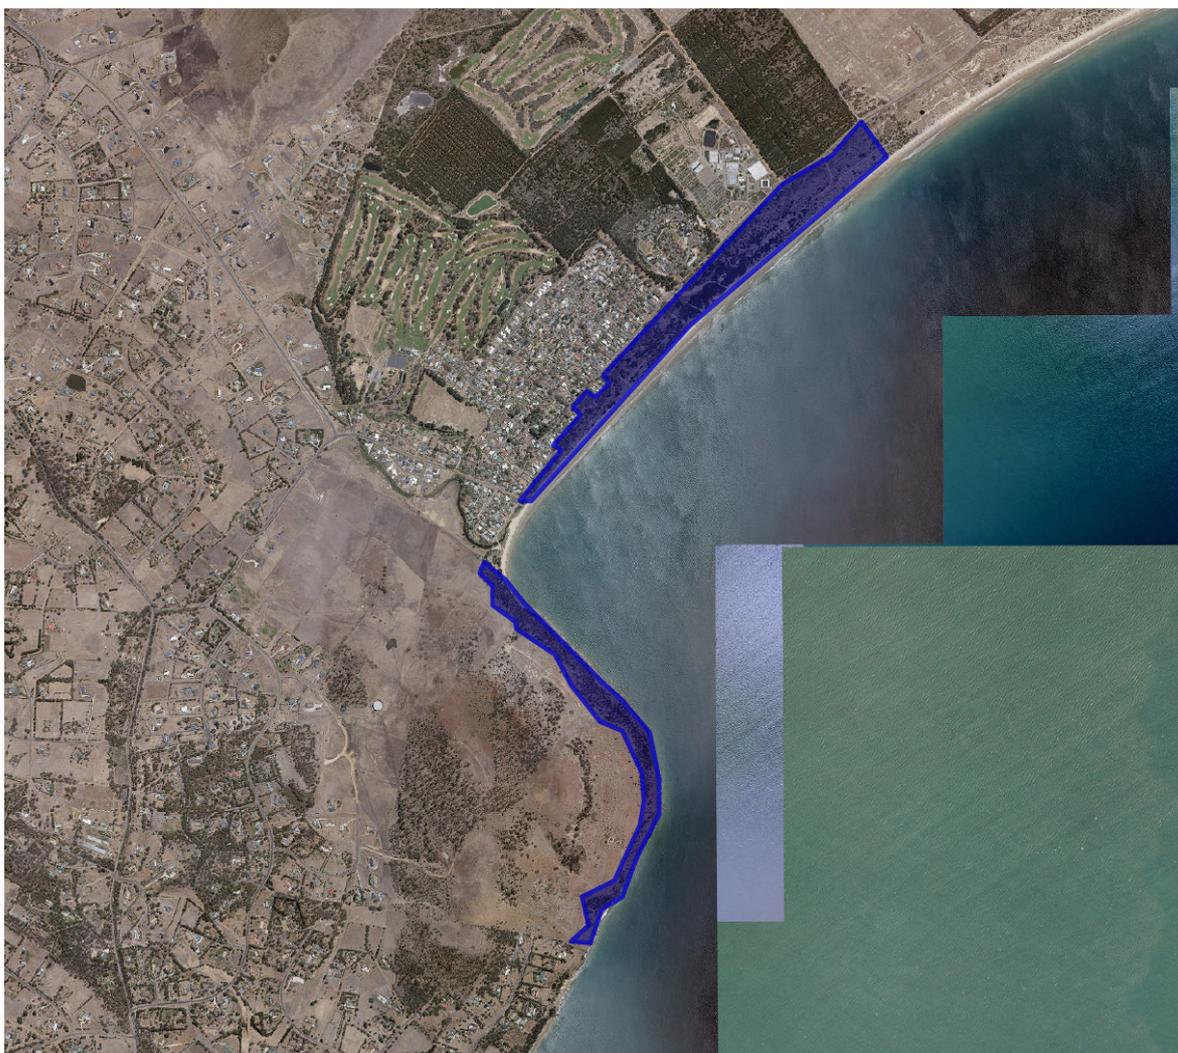
Figure 1: Area covered by the *Seven Mile Beach Reserve Activity Plan 2019-2029* (aerial photo sourced from the LIST).

The area covered by the *Seven Mile Beach Coastal Reserve Activity Plan 2019-2029* is illustrated in Figure 1.

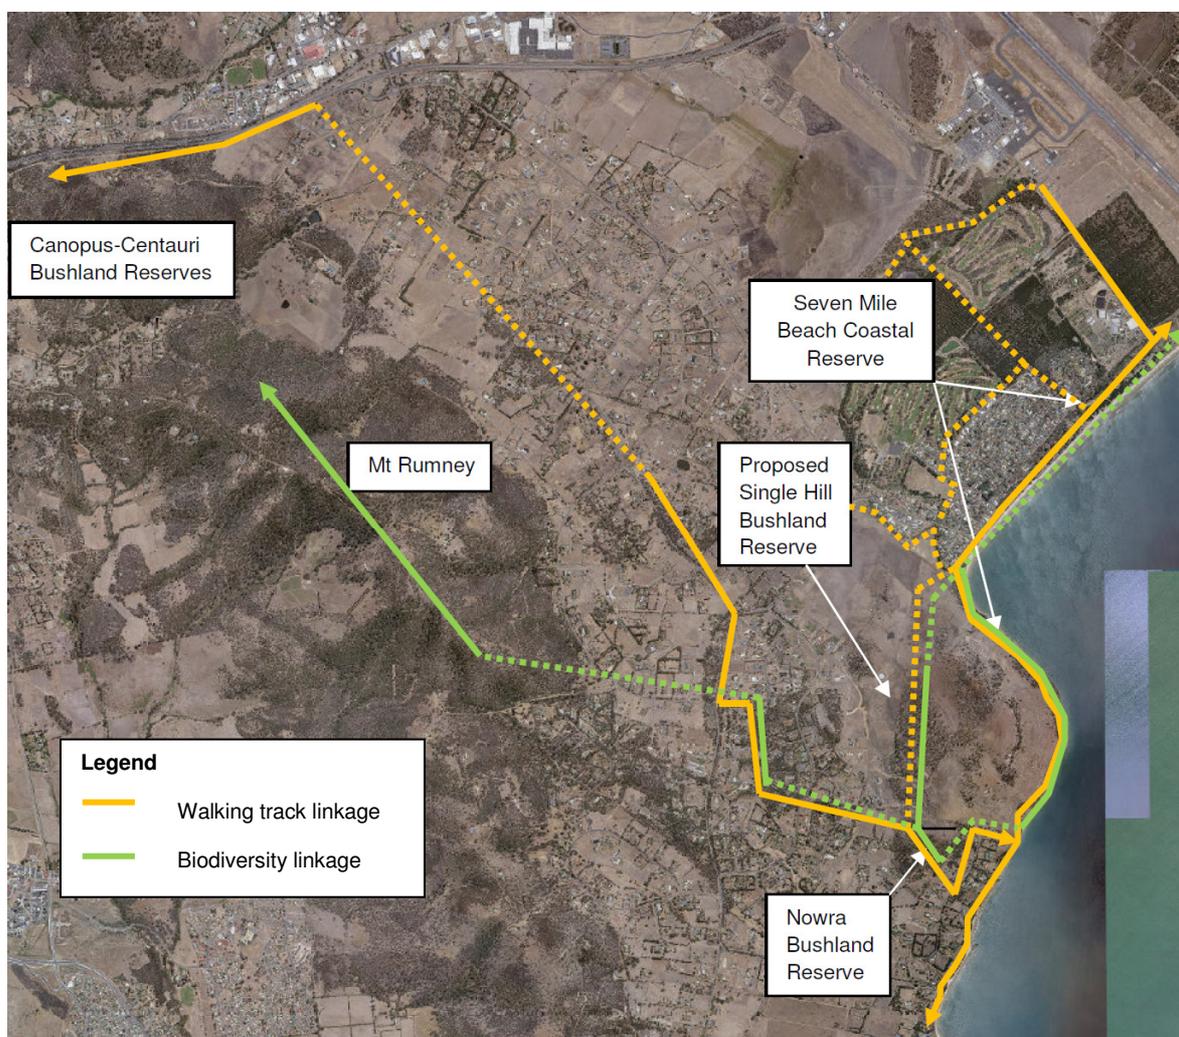
Figure 4: Connectivity between the Seven Mile Beach Coastal Reserve and other bushland areas (imagery sourced from the LIST).

coastal environments provides an important ecological link for flora and fauna to enable gene flow between populations and to allow animals to move across the landscape for foraging, nesting and breeding. Direct linkages currently exist from the Reserve along the coastal zone to the north east on Crown Land as well as to the south towards Roches Beach (refer Figure 4). Indirect linkages are also present via private land with the proposed Single Hill Bushland Reserve and the Nowrah Bushland Reserve.

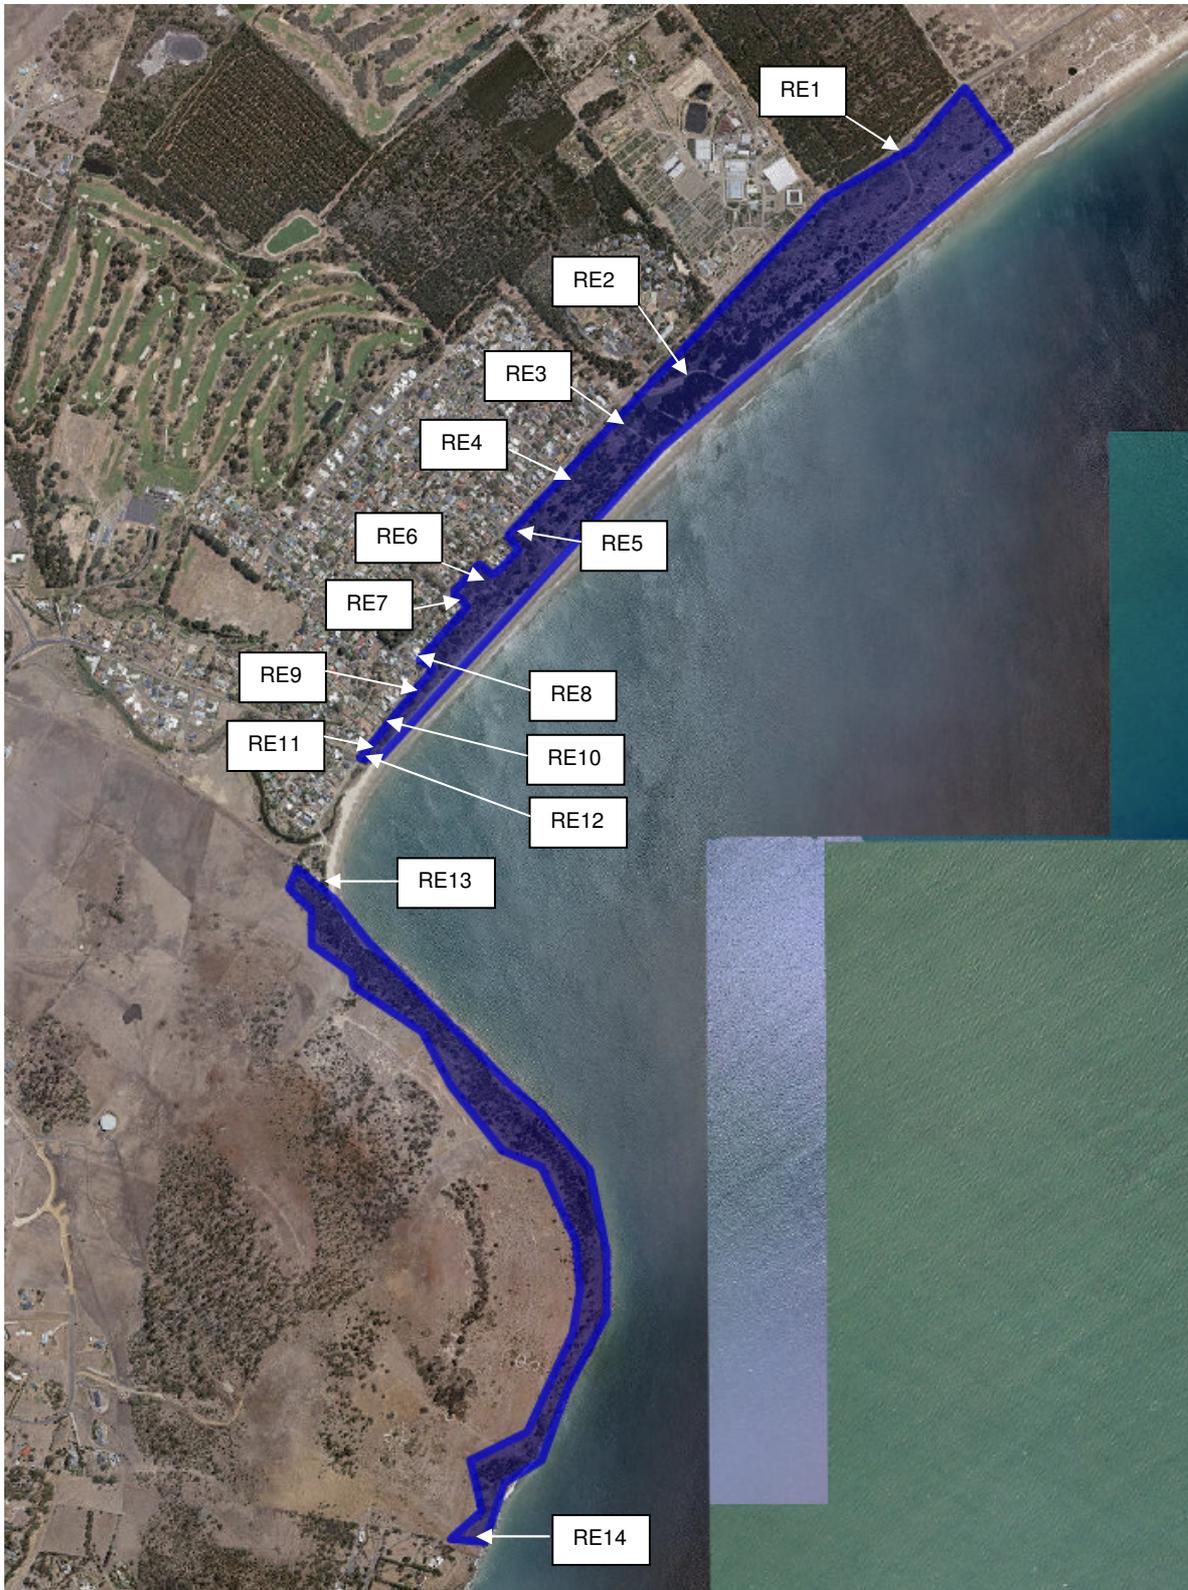
Figure 5: Main entrances to the Reserve (RE1-RE14).

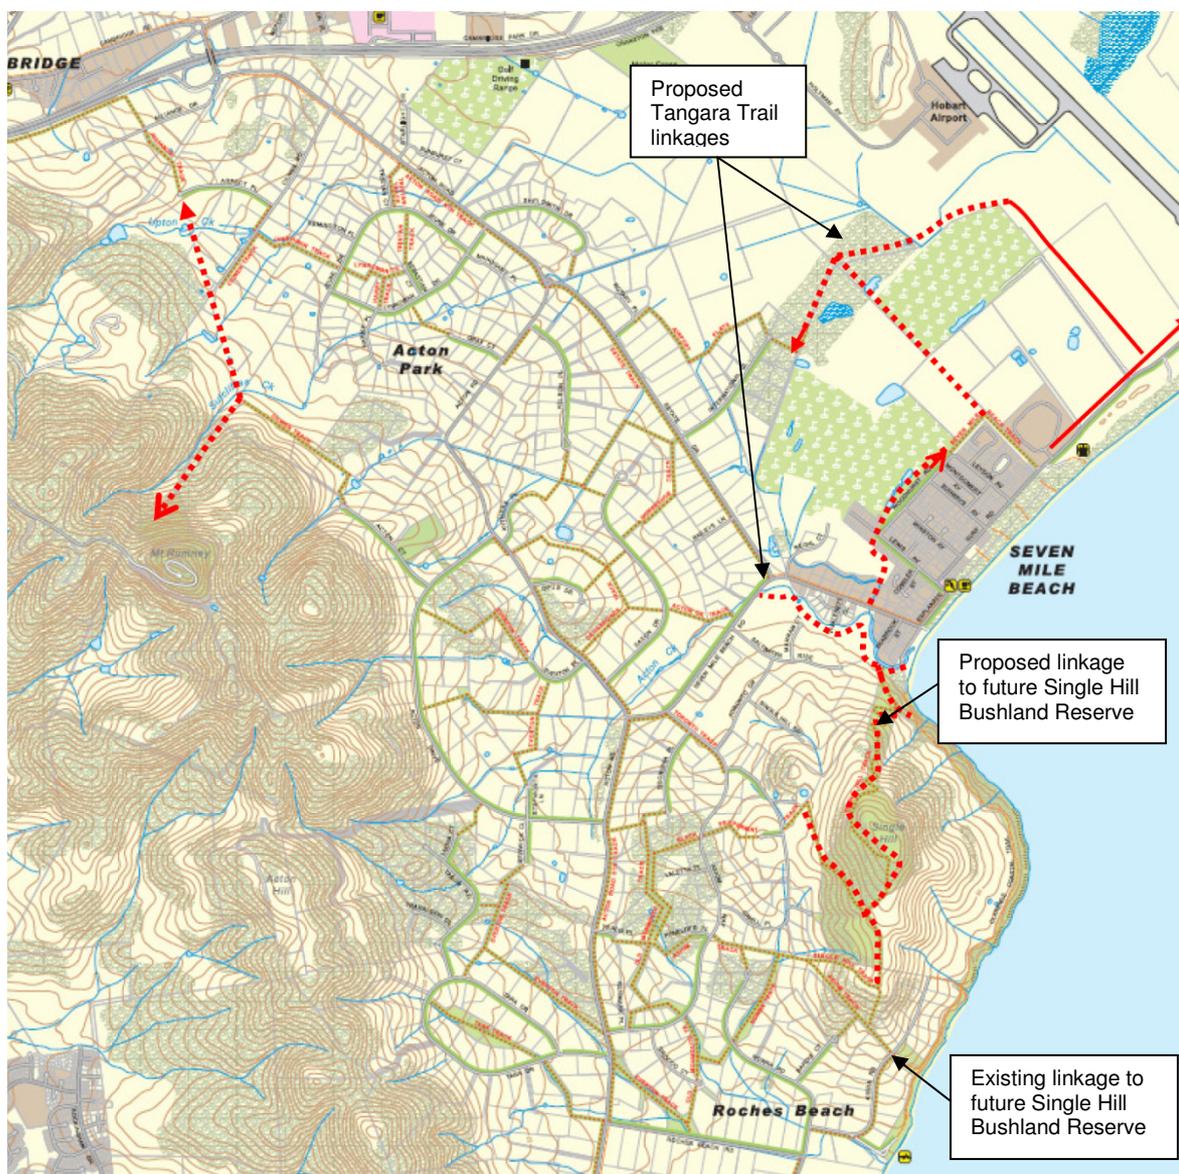
Figure 6: Proposed track linkage between the Reserve and the proposed Single Hill Bushland Reserve and Tangara Trails within the Acton area (map provided by Council).

range of users. Additional Tangara Trail linkages are also proposed (refer Figure 6).

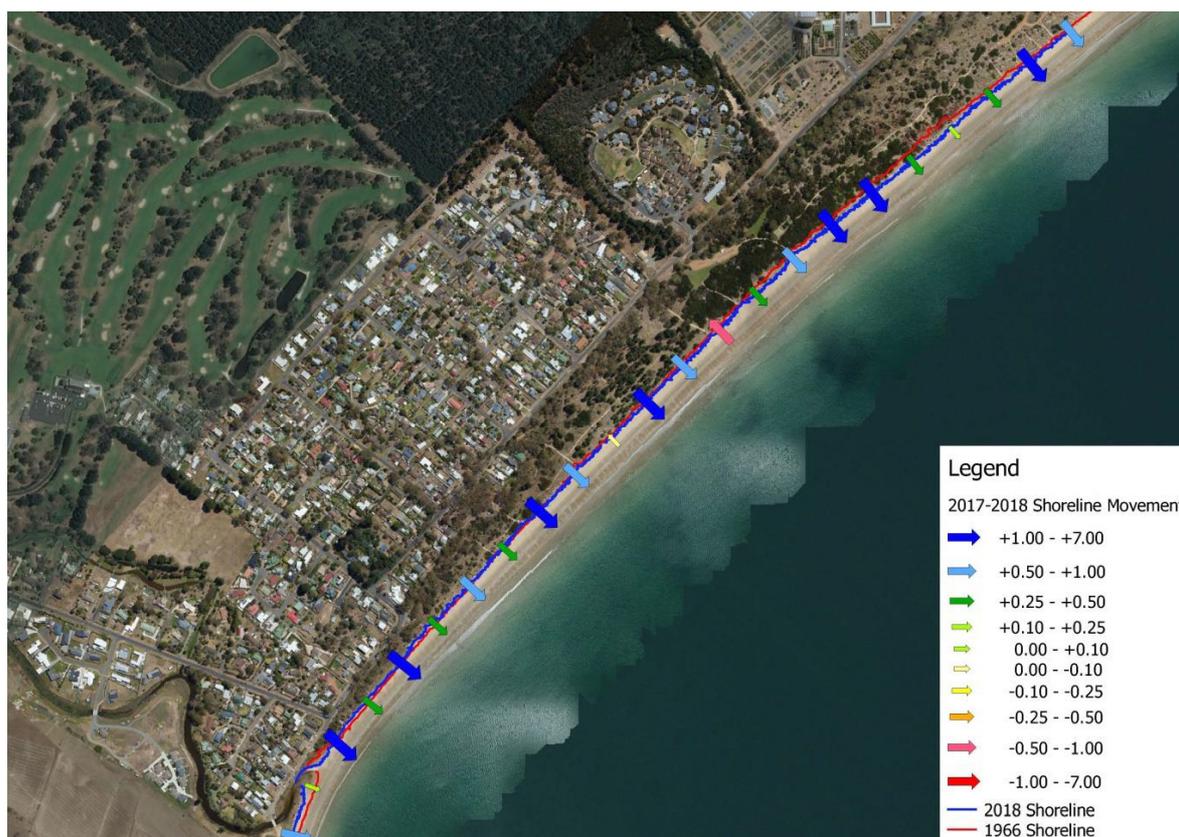
Figure 7: 2017-18 shoreline movement at Seven Mile Beach, including a comparison of shorelines in 1966 and 2018.²¹

Since 2011, Council has undertaken an annual shoreline monitoring program which documents changes in shoreline structure and position on numerous beaches within the Clarence municipality, including the western end of Seven Mile Beach. The objective is to obtain a set of accurate high resolution data which can be used to inform decisions on future planning requirements and adaptation measures. The 2017-18 survey includes coastal erosion and recession maps for Seven Mile Beach created using a time series of ortho-rectified aerial photos from 1966 to 2017 (refer Figure 7).²¹

Since 1966, the most significant recession has occurred at the western end of Seven Mile Beach near the mouth of Acton Creek, while seaward growth in excess of 1 m can be observed along much of the length of the study area. More recently, since 2016-17 incipient dunes (and associated marram grass growth) have expanded both in height and extent in a predominantly seaward direction (ranging from 6.6 metres growth to a recession of 54 centimetres).

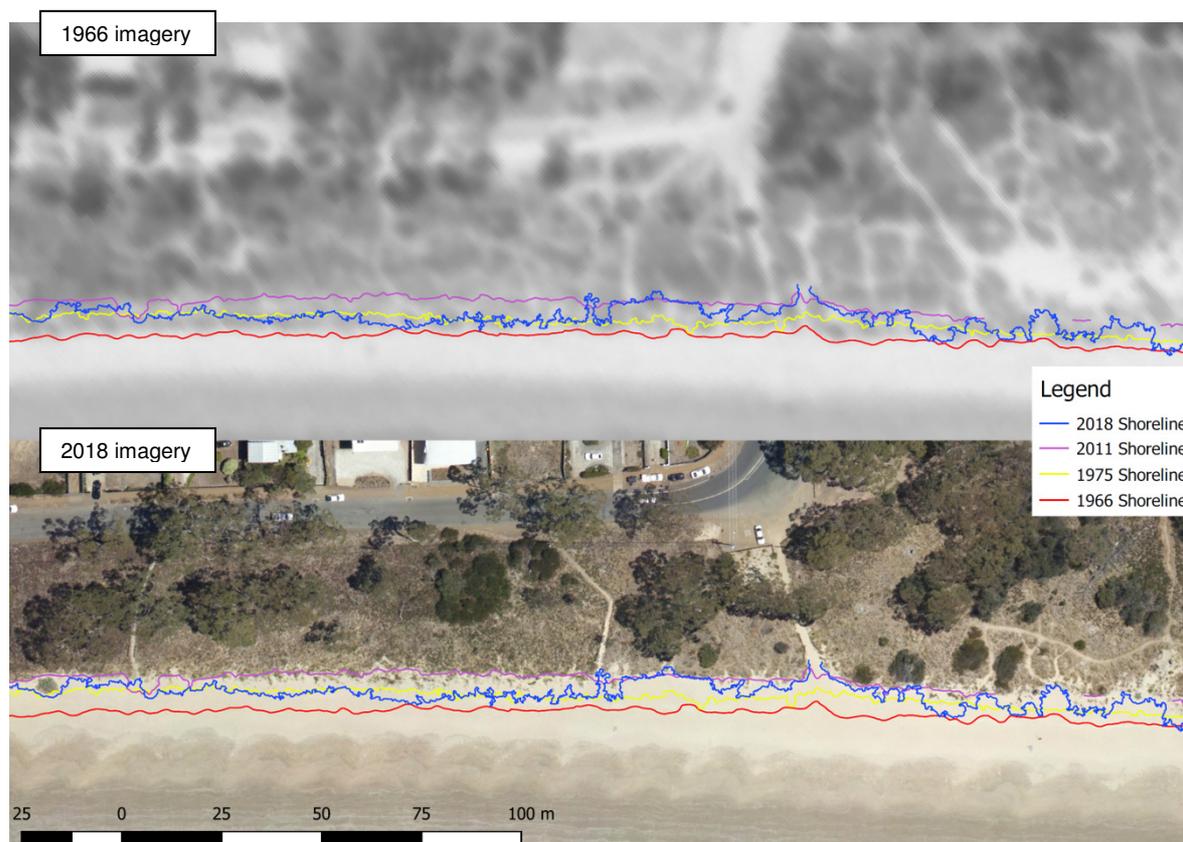
Figure 8: Trend in shoreline movement for a section of western Seven Mile Beach between 1966 and 2018 (imagery and analysis provided by Matt Dell).

A closer resolution of a subsection of this monitoring area is provided at Figure 8, which shows in closer detail the changes in shoreline observed between 1966 and 2018. This resolution demonstrates the importance of the annual high resolution aerial beach monitoring program for planning future management activities along the Seven Mile Beach shoreline.

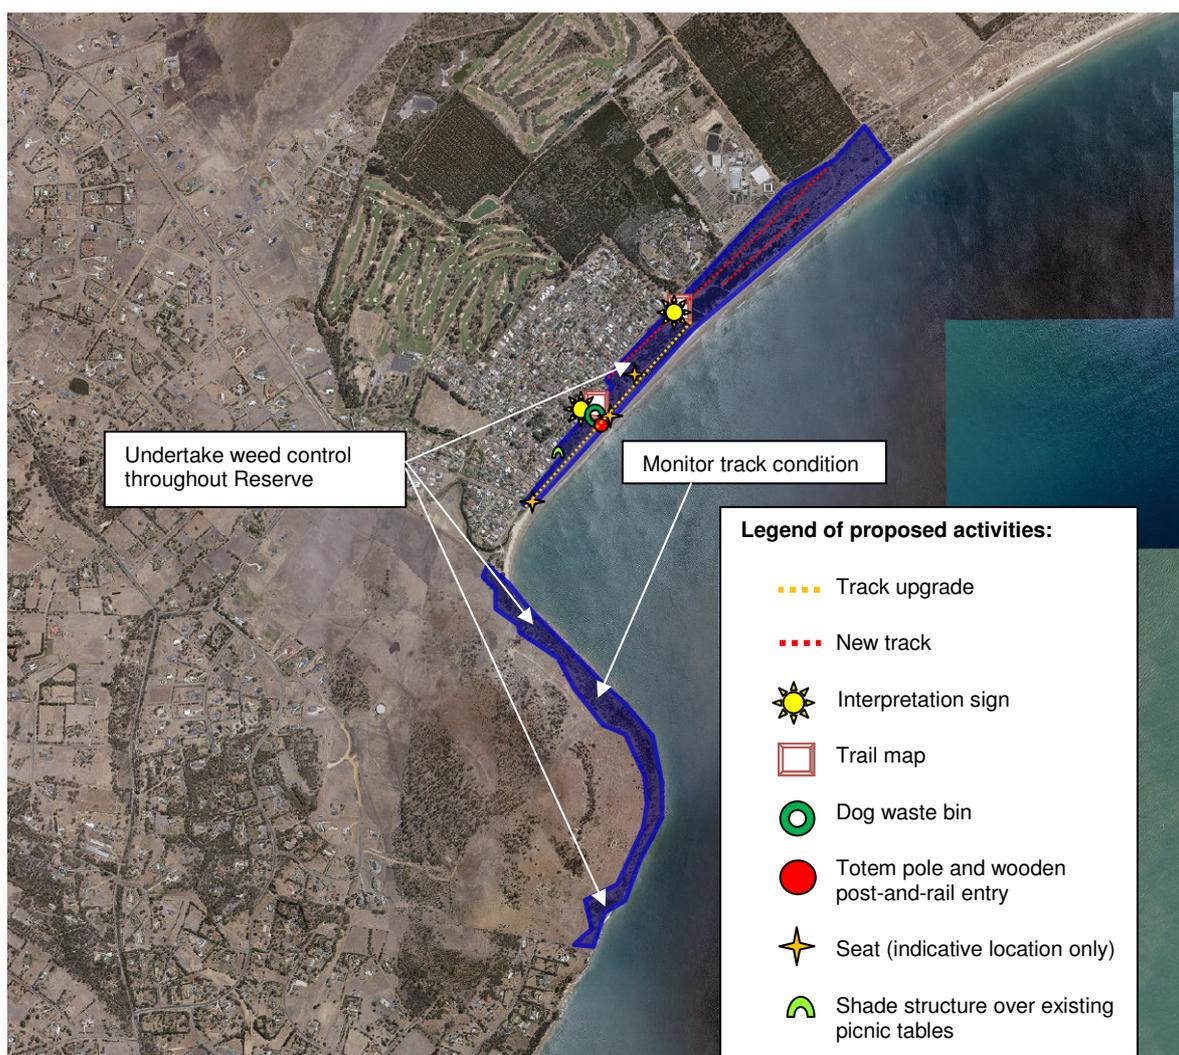
Figure 9: Overview of key proposed on ground management activities in the Seven Mile Beach Coastal Reserve (aerial photo from the LIST).

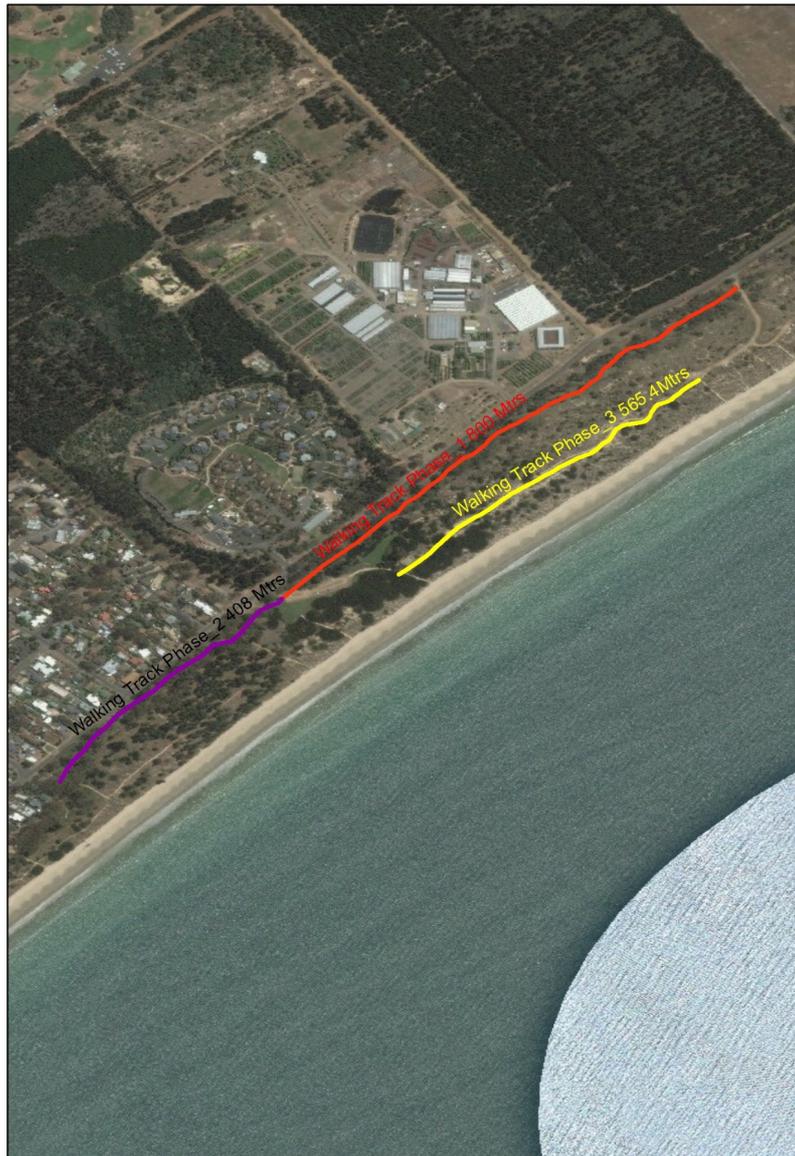
Figure A7.1: Proposed three stage walking track linkage between Sunways Avenue and Day Use Area 1.

This proposal, developed by the Seven Mile Beach Coastcare Group, is for a three stage development of multi-use tracks in the Seven Mile Beach Coastal Reserve between Surf Road and the beach (refer Figure A7.1).
