Clarence City Council Shoreline Monitoring Program 2011-2020

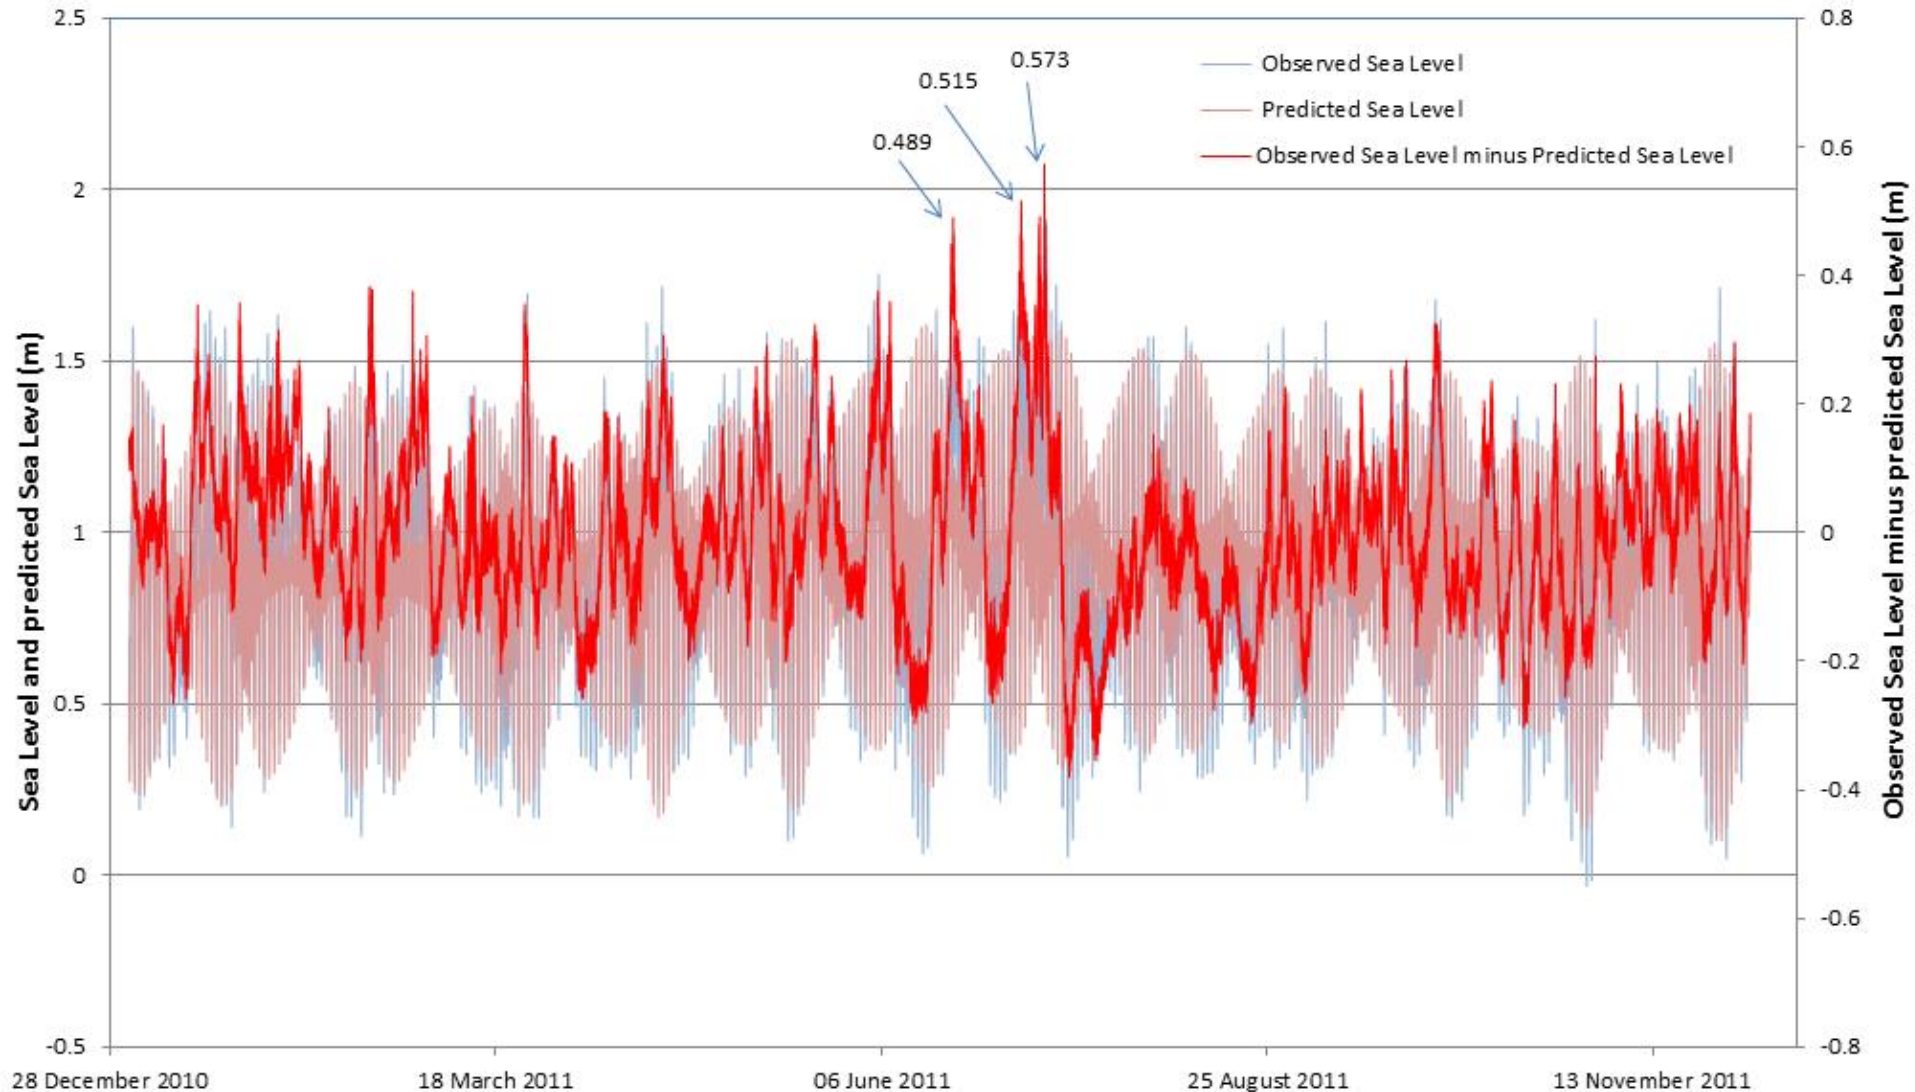
Storm Tides – 2011 event

Measured Storm Tides July 2011
Height (m) above predicted sea level

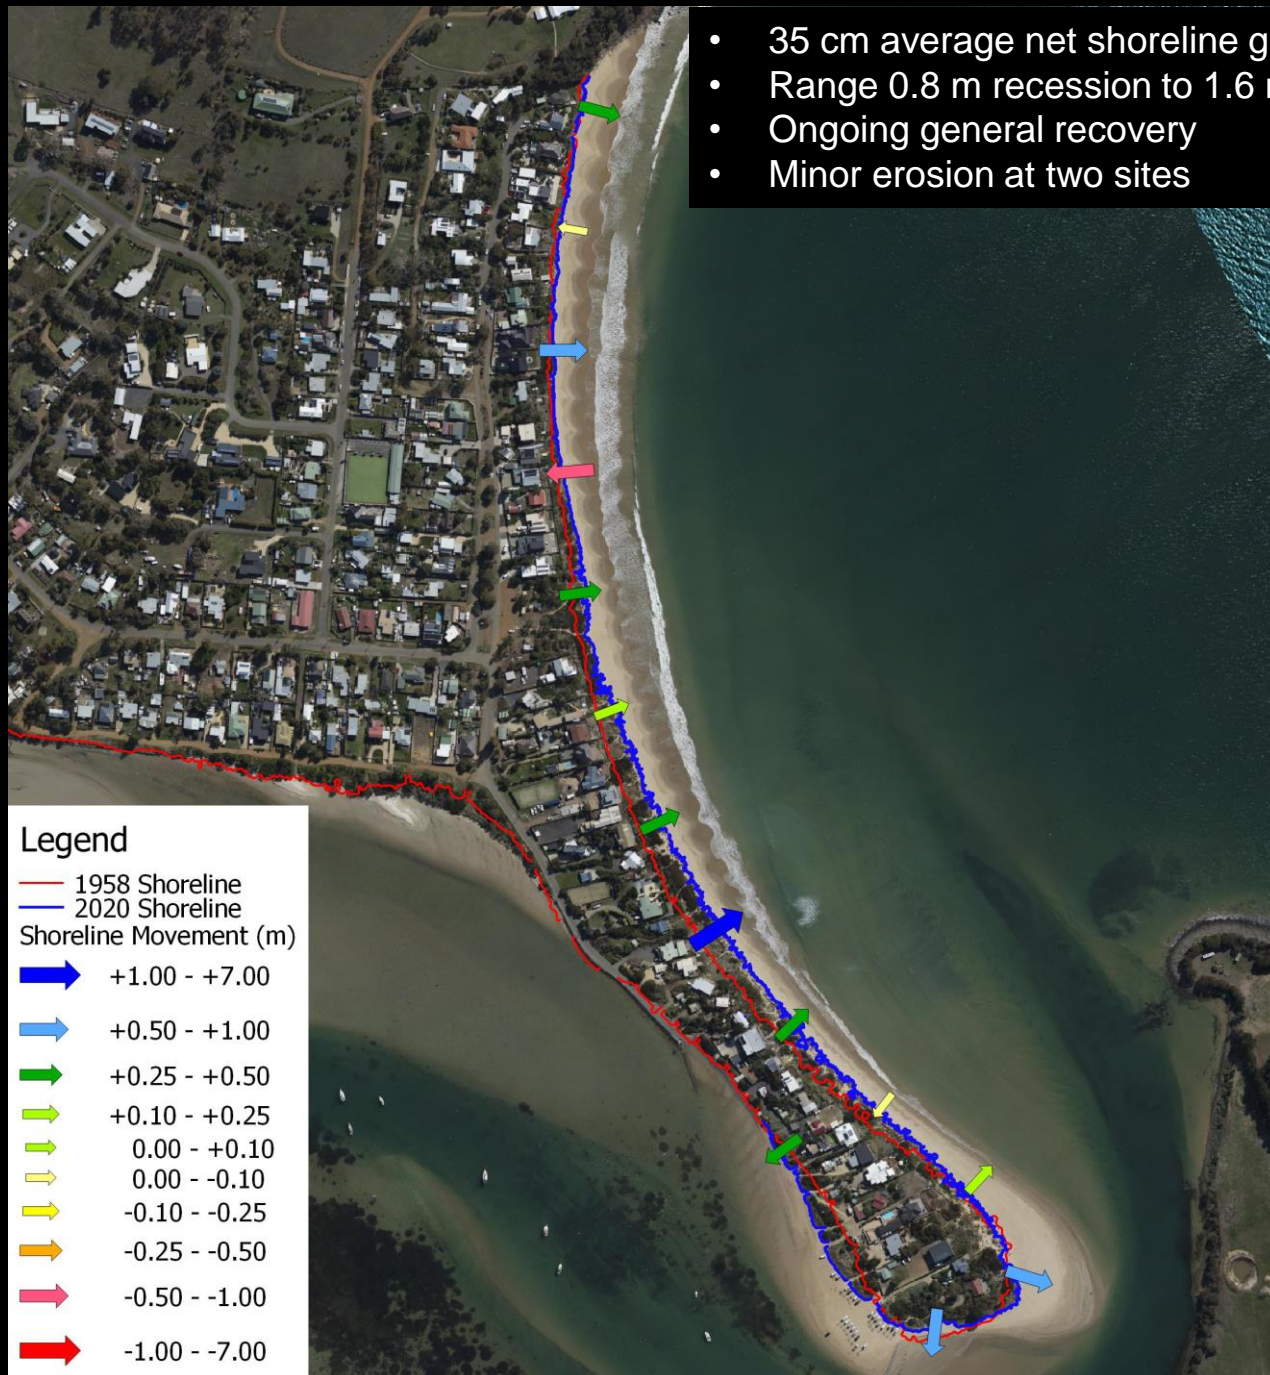
Cremorne 2019-2020 – Moderate shoreline growth

- 35 cm average net shoreline growth
- Range 0.8 m recession to 1.6 m growth
- Ongoing general recovery
- Minor erosion at two sites

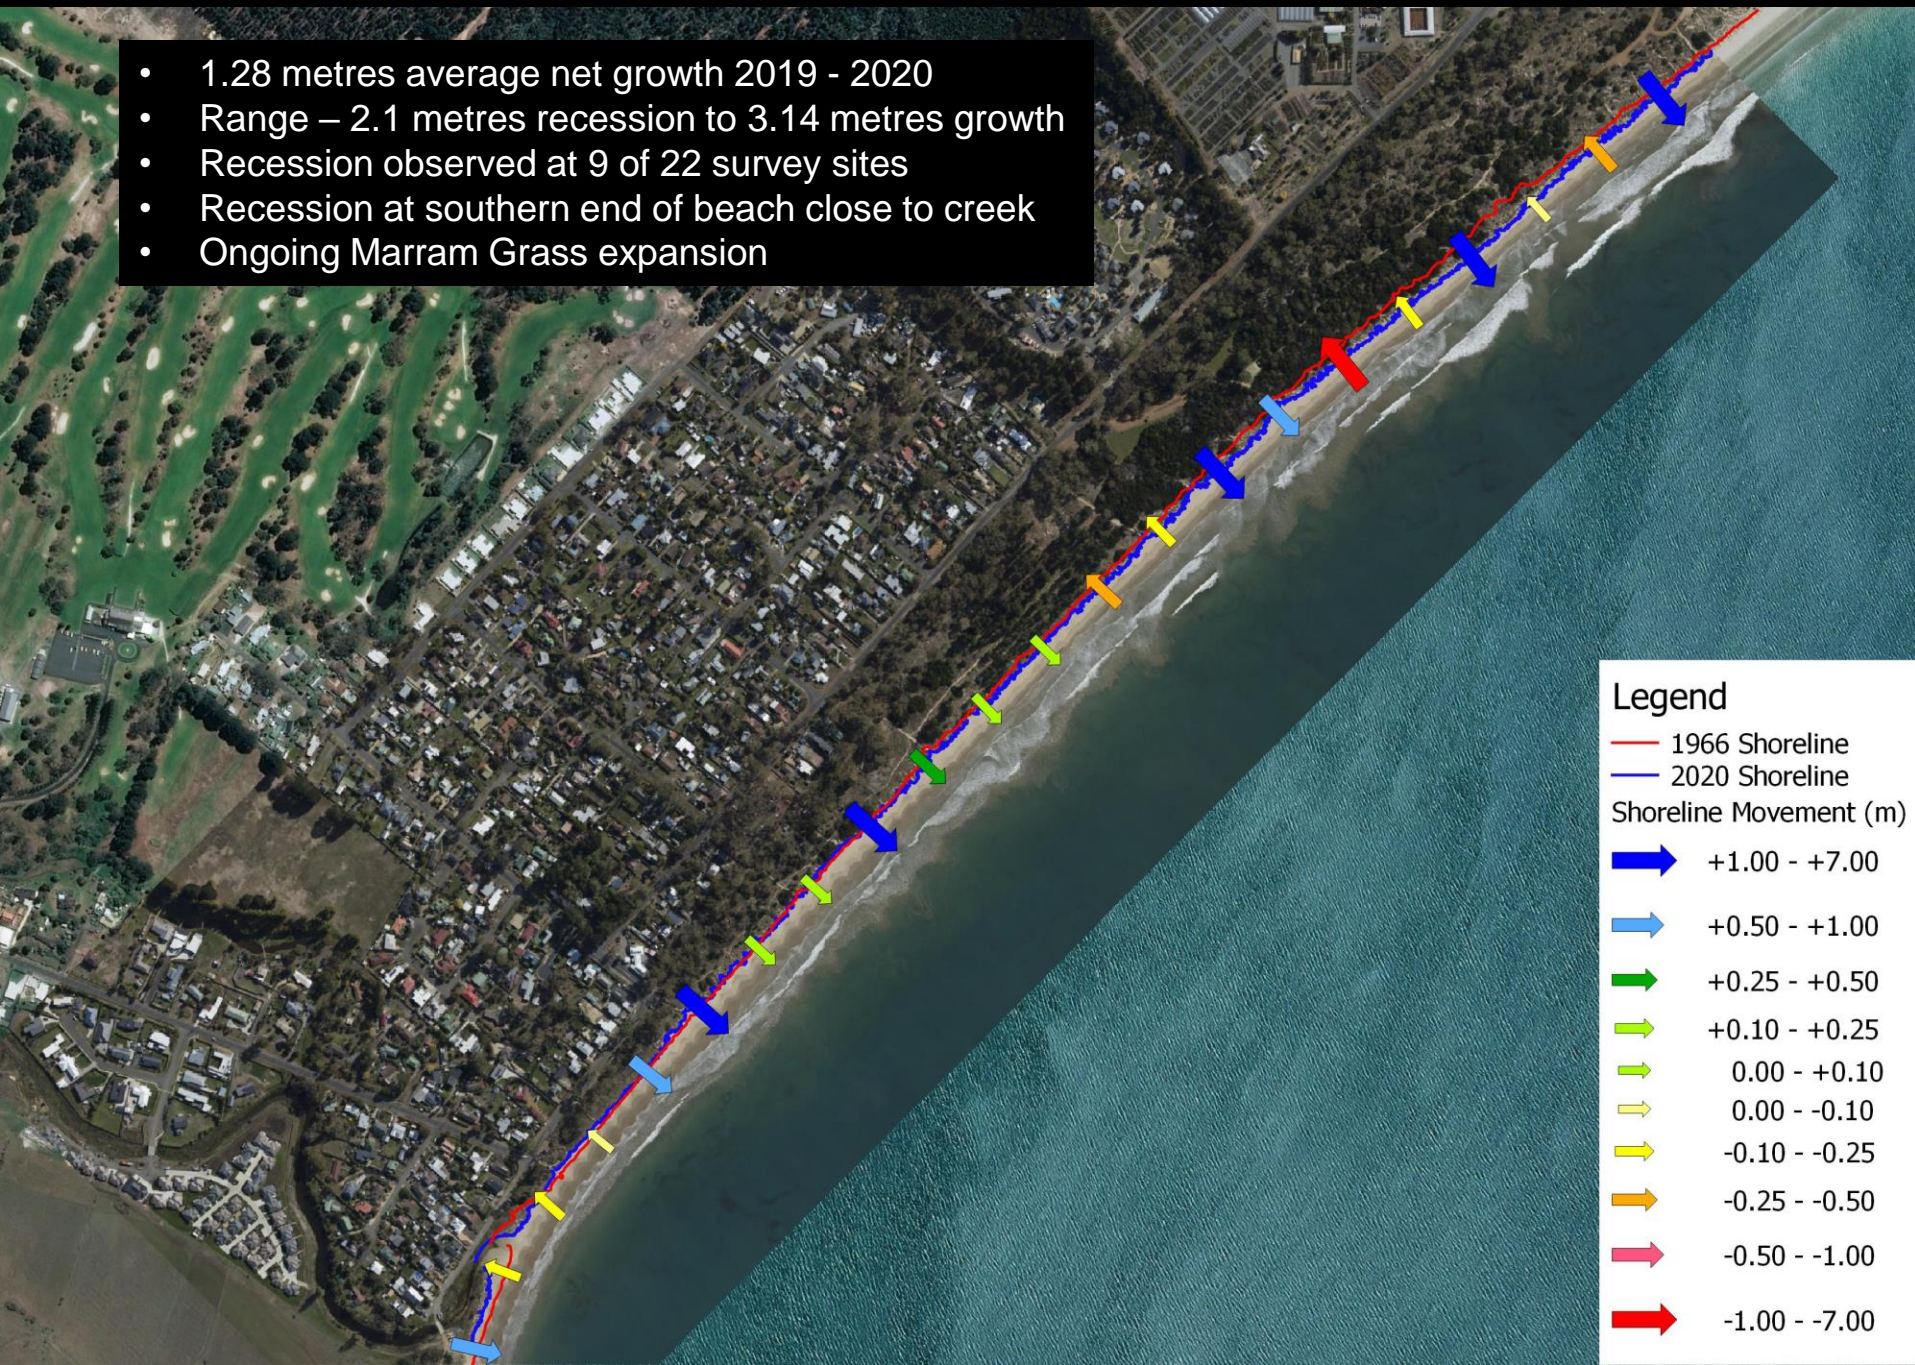
Seven Mile Beach 2019-2020 – Recovery Trend

- 1.28 metres average net growth 2019 - 2020
- Range – 2.1 metres recession to 3.14 metres growth
- Recession observed at 9 of 22 survey sites
- Recession at southern end of beach close to creek
- Ongoing Marram Grass expansion

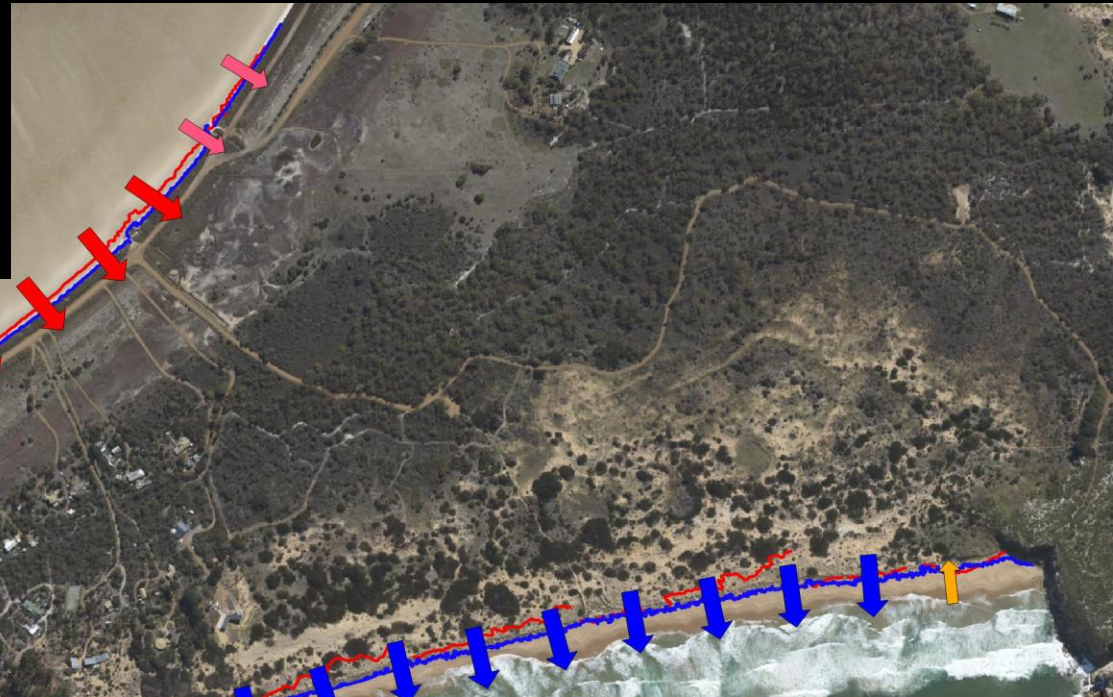
Clifton-Pipeclay 1948-2020 – Mixed recession signal

- 1948-2020 6.09 metres average recession
- Range – 34 cm to 10.5 metres recession
- Longterm gradual recession signal
- 2011-2020 Average net recession 10 cm

- 1948-2020 10.15 metres average net growth
- Range – 6.9 metres recession to 45 metres growth
- 2011-2020 50 cm average net growth
- Sand dunes in eastern half stabilised by marram grass and emergent bushes and trees
- Potential erosion hazard at site 1/3 away along beach

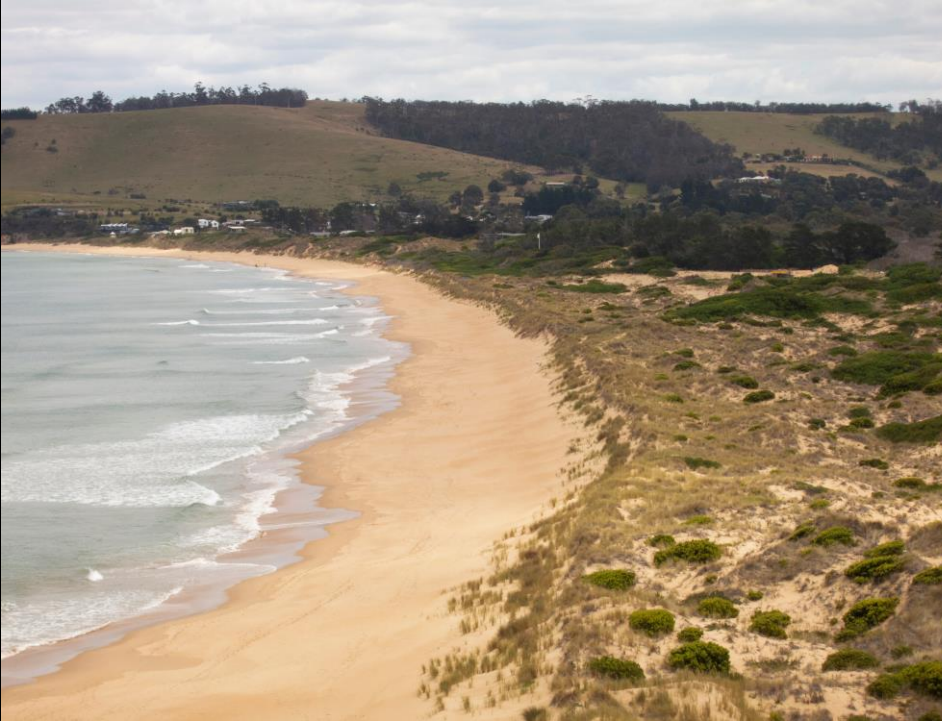
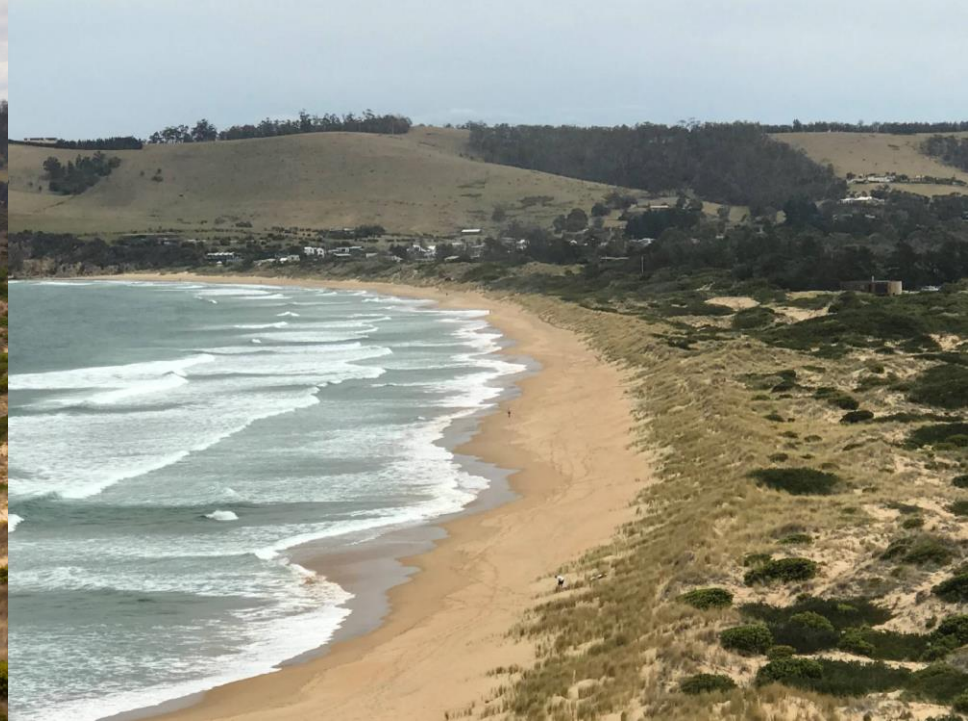
Clifton Beach – 2016-2020

- Transition from steep to low profile
- Growth of back dune vegetation
- Beach has remained relatively shallow for a few years
