## **Clarence City Council Shoreline Monitoring Program**

*Prepared by Matt Dell*

2022

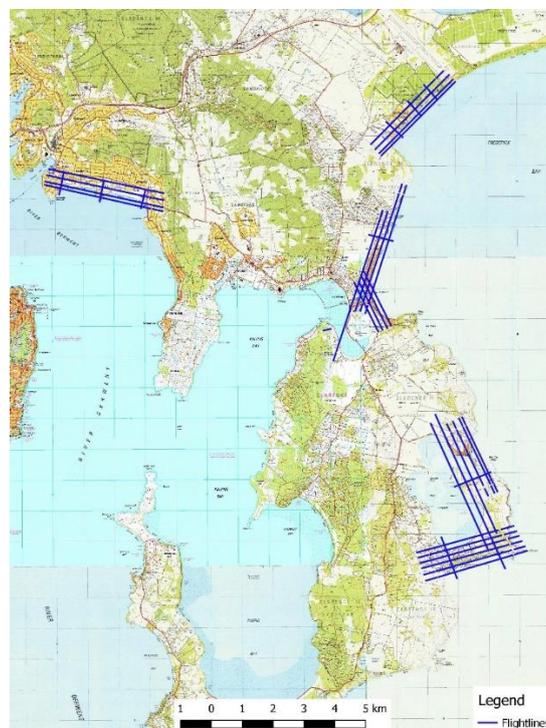
Figure 2 - Study area and 2021-2022 flight lines for the *Clarence City Council Shoreline Monitoring Program*. Photos were captured for all the blue flight lines.

The 2021-22 survey (Figure 2) aimed to cover most of the densely populated sandy beaches that experience substantial wave action within the Clarence Municipality.

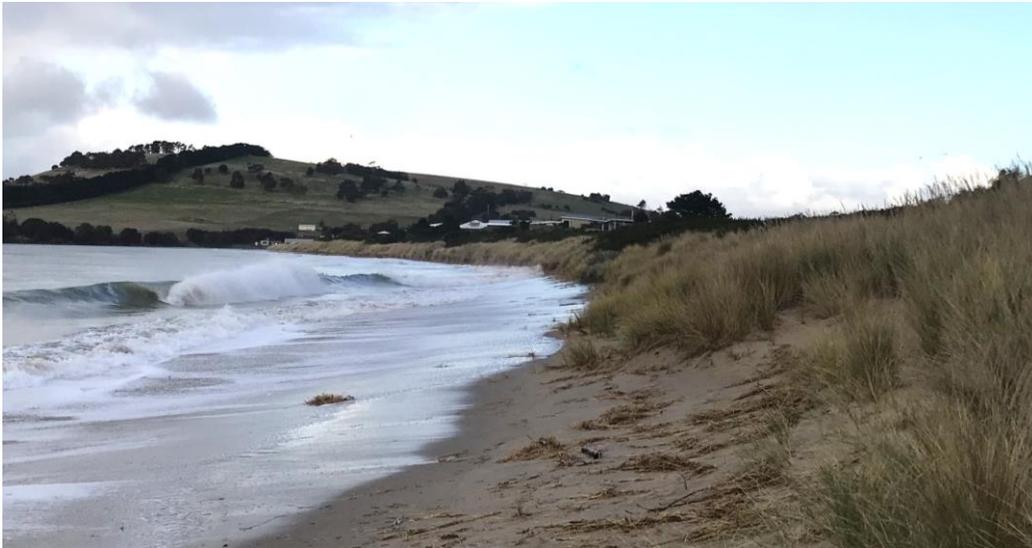
During the June 2022 swell event the beach to the north of the Lagoon Channel sustained an additional moderate level of erosion due to the swell angle and the astronomical high tides. The most active erosion was centered around Site B on Figure 5, compounding the shoreline recession that was recorded during the previous twelve months. Figure 6 shows the waves actively eroding the primary dune on the evening of the 22<sup>nd</sup> of June 2022.

Figure 6. Wave action at Cremorne beach 10<sup>th</sup> of June 2022.

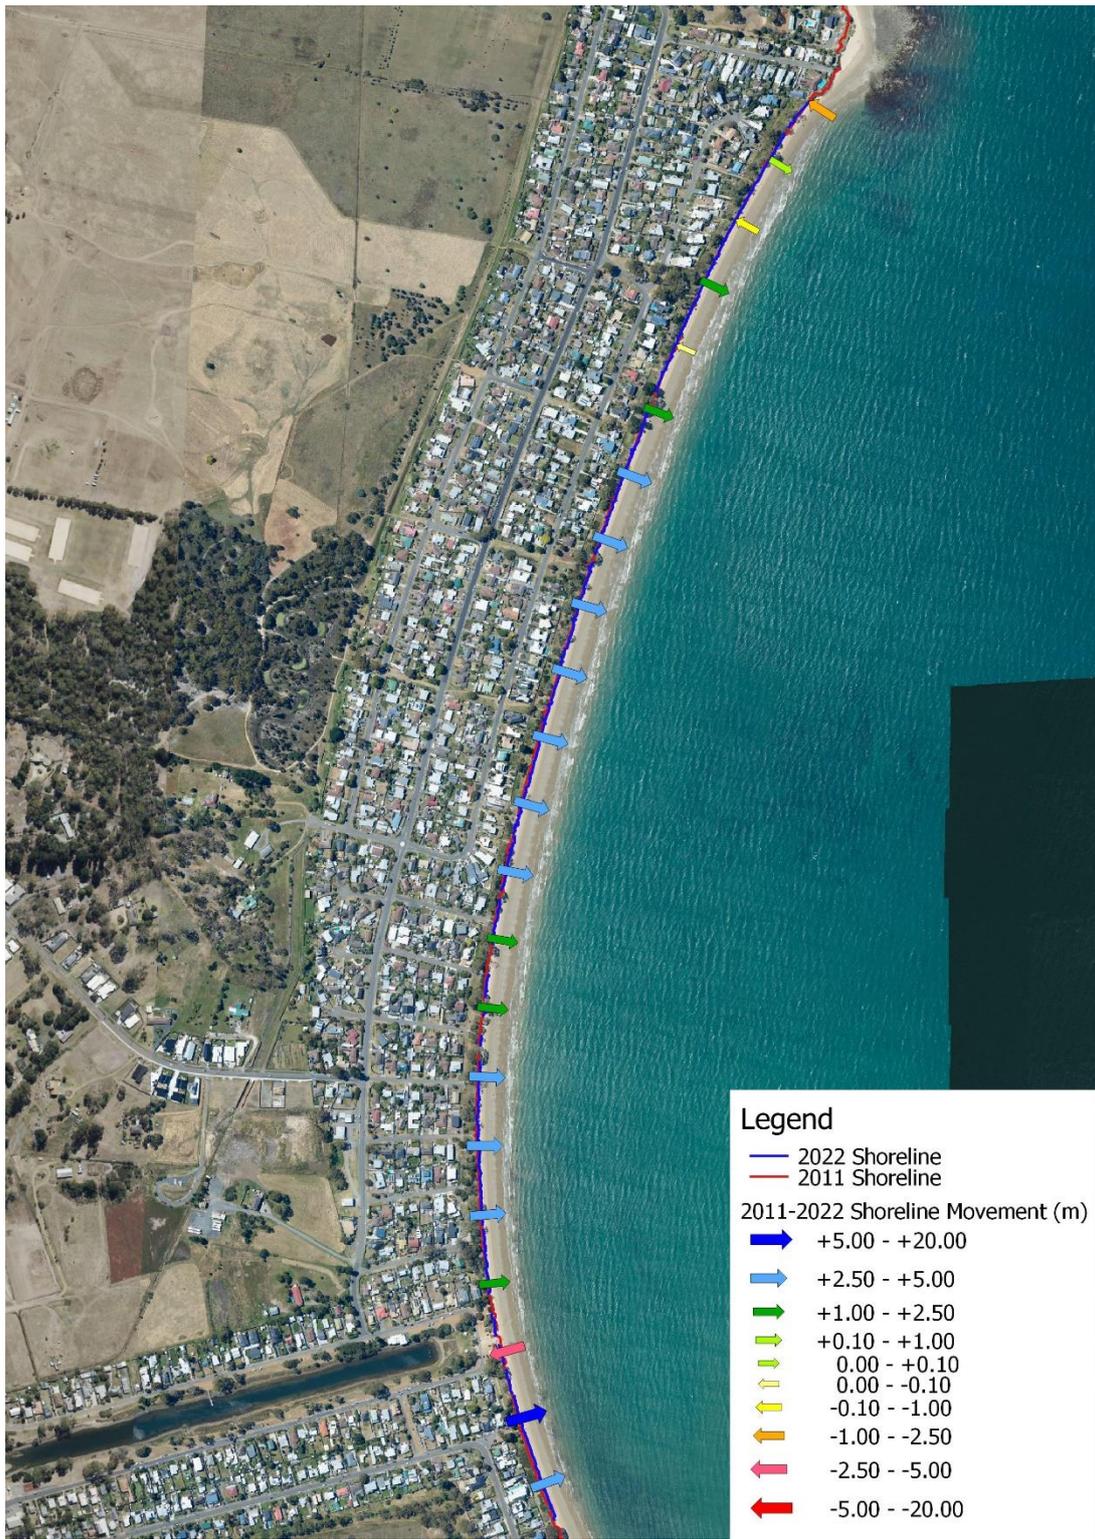
Detailed analysis of the net shoreline position at Roches Beach observed between 2011 and 2022 shows a slight net gain in seaward shoreline position in 16 of the 20 sites surveyed (Figure 8). This is in a large part due to ongoing beach replenishment program and dune stabilisation program. The recovery is in line with the stabilisation of the storm bite observed at the other surveyed beaches in the aftermath of the large erosion event in 2011.

Figure 8 – Shoreline movement at Roches Beach, 2011-2022.

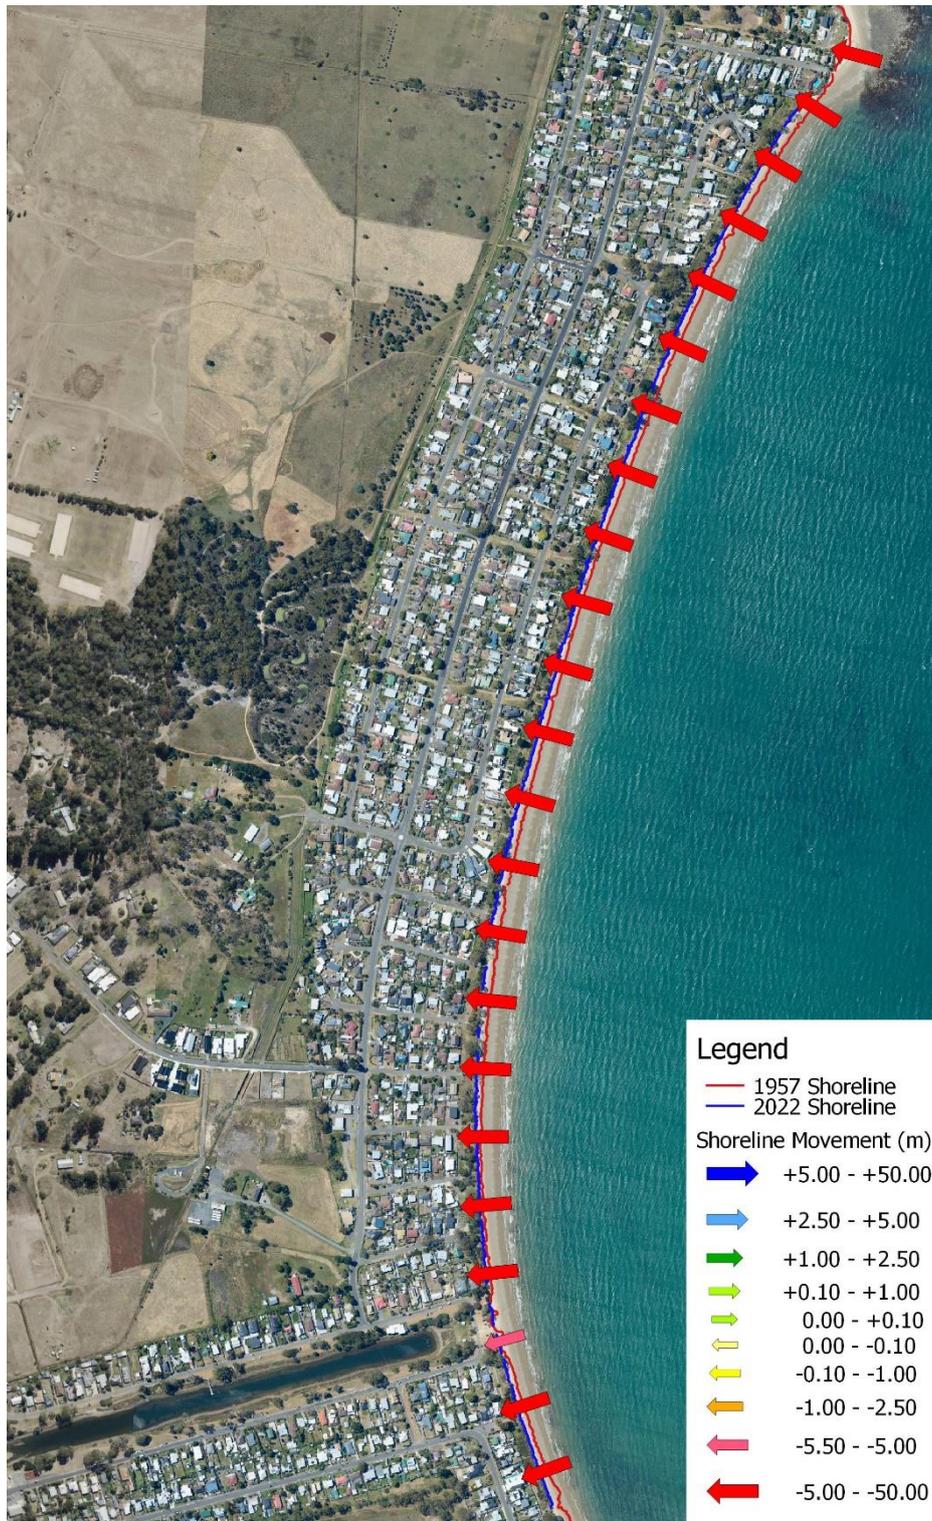
Analysis of the Net shoreline position since 1957 reveals a very strong recession signal with an average net recession of 8.4 metres ranging from 4.4 to 13.5 metres (Figure 9). This clear ongoing recession

trend was exacerbated by the very strong erosion event immediately prior to the 2011 survey from which the beach has shown very little to no natural recovery.

Figure 9. Net Shoreline Movement 1957-2022.

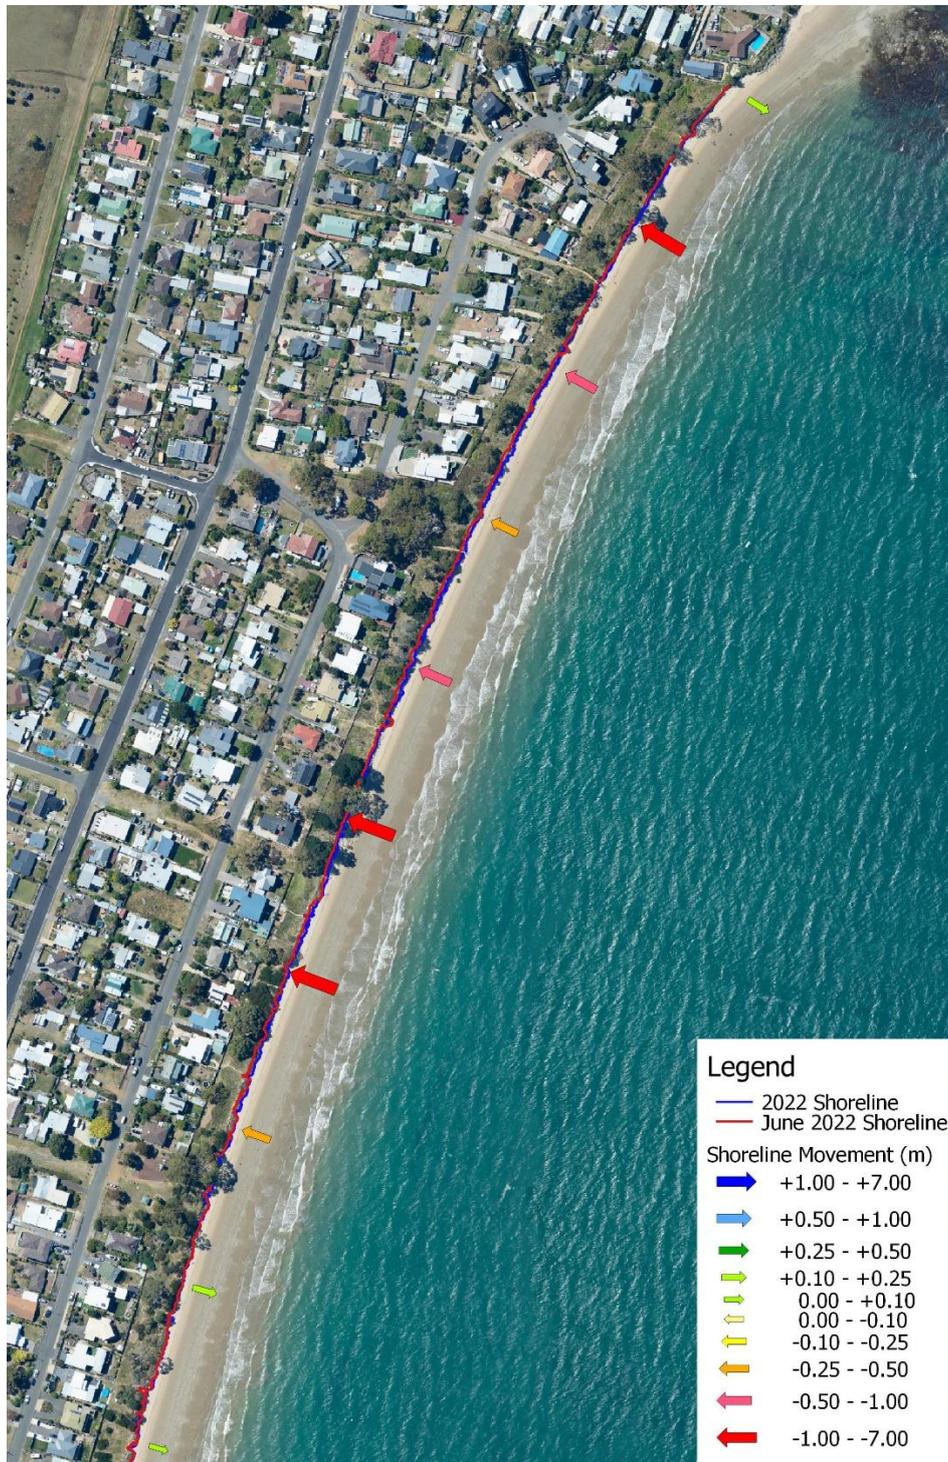
During early June 2022 a long duration moderate to large swell event impacted many of the shores of the Clarence Municipality. Wave heights exceeded seven metres on and off for a period of over

two weeks. This increased wave action combined with astronomical high tides resulted in considerable erosion particularly on the northern end of Roches Beach. Shoreline recession in excess of 4.5 metres was observed at several places along the beach (Figure 10).

Figure 10 – Shoreline recession at northern Roches Beach after June 2022 swell event.

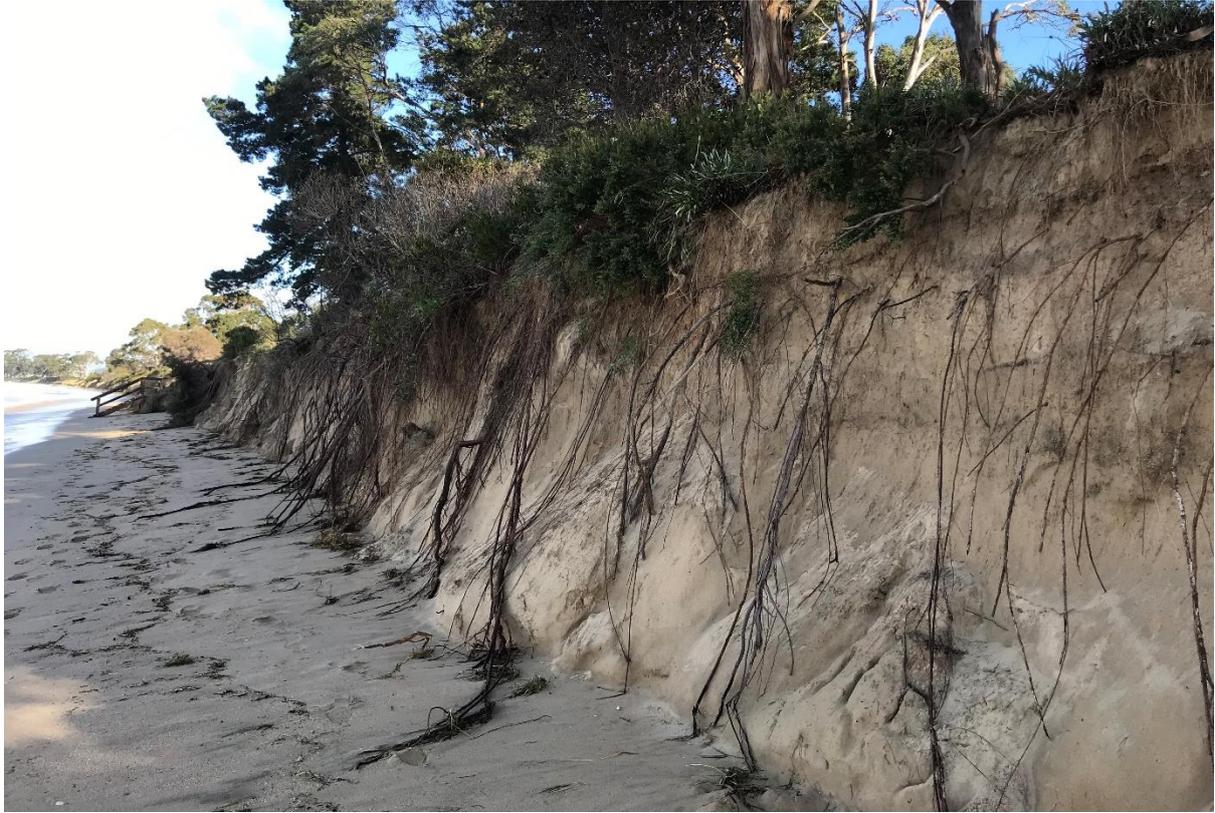
The observed impacts of this swell event were greatest at the Northern end of Roches Beach extending 800 metres South from Bambra Street. Erosion scarps from one to three metres high were created

and for the most part its position was well behind the scarp created during the 2011 Swell event. Examples of the damage to the beach can be seen in Figures 11 and 12.

Figure 11. Erosion at northern Roches Beach, June 2022.

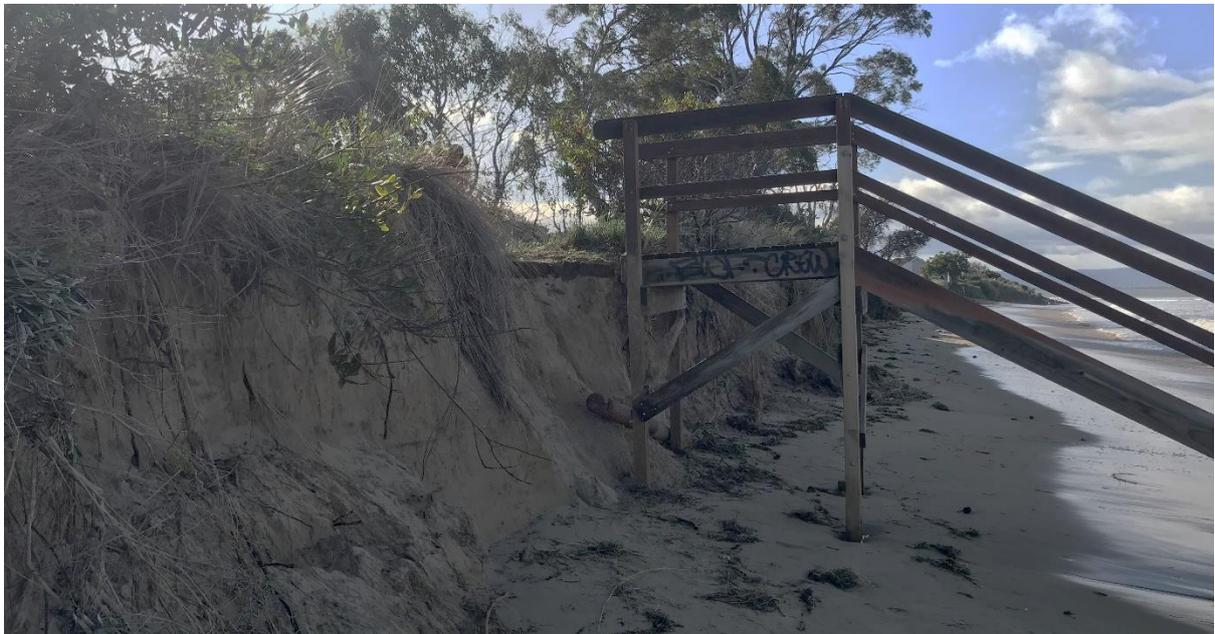
Figure 12. Erosion and infrastructure impacts at Roches Beach, June 2022.

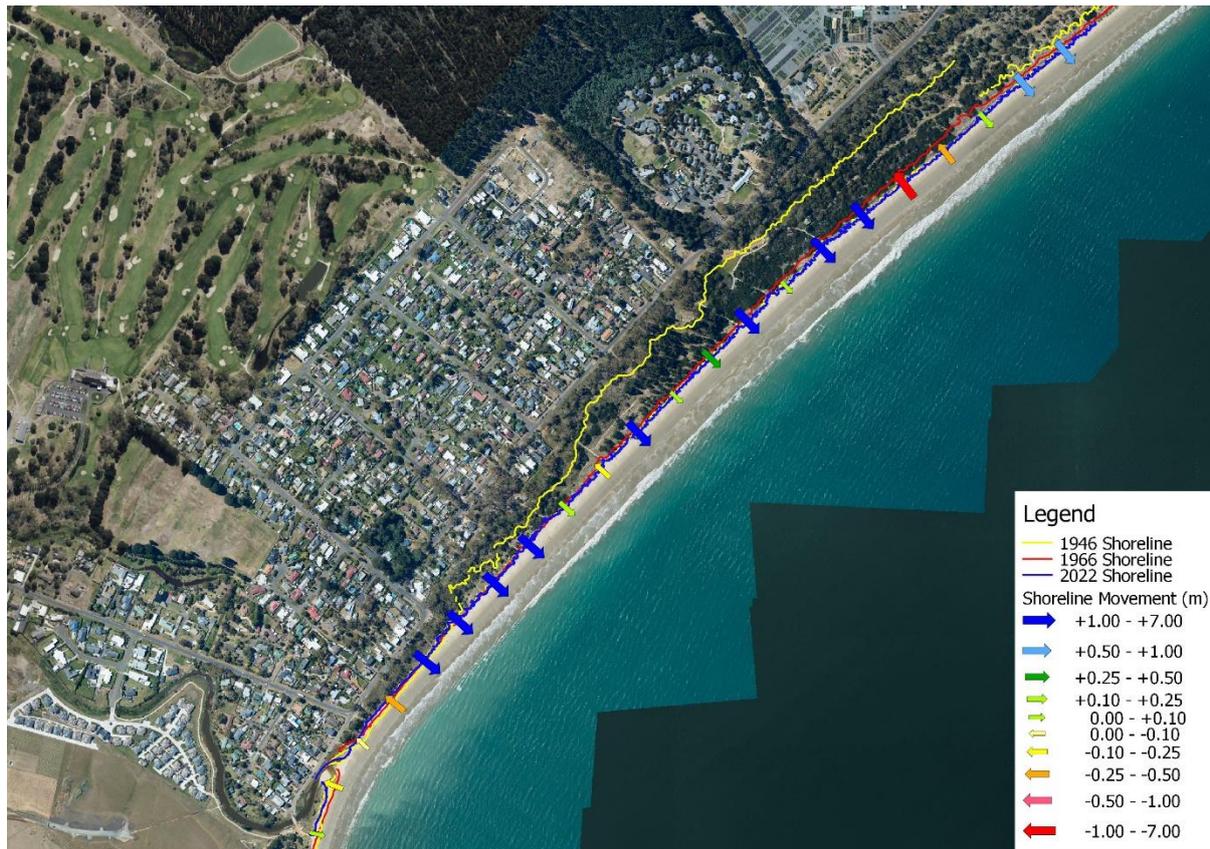
At the Seven Mile Beach survey site an average seaward growth of the shoreline averaging 0.81 meters was recorded, ranging from 1.07 metres recession to seaward shoreline growth up to 4.2 metres (Figure 13). Shoreline recession was limited to areas adjacent to the Acton Creek at the southern end of the beach and two sites of marram grass leader truncation at the northern end of the study area. Ongoing strong seaward growth of the shoreline ranging from 5 cm to 1.57 metres is observed at the remaining seventeen survey points.

Figure 13 – Shoreline movement at Western Seven Mile Beach, 2021-2022.

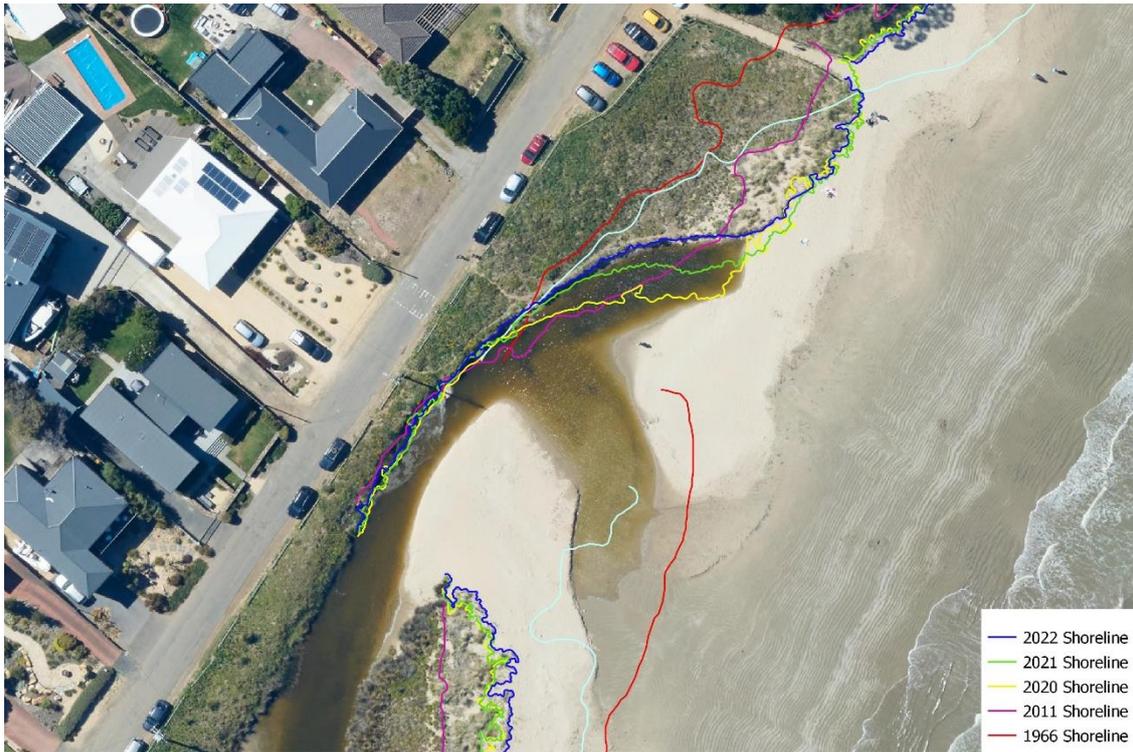
In keeping with the trend since 2011, marram grass and recently emergent coastal saltbush is consolidating and growing the dune vegetation seaward. The observed erosion generally only occurs around the Acton Creek mouth at the southern end of the beach where variability is expected (Figure 14) or close to well used beach access points.

Figure 14 – Shoreline position at the mouth of Acton Creek Seven Mile beach 1966-2022.

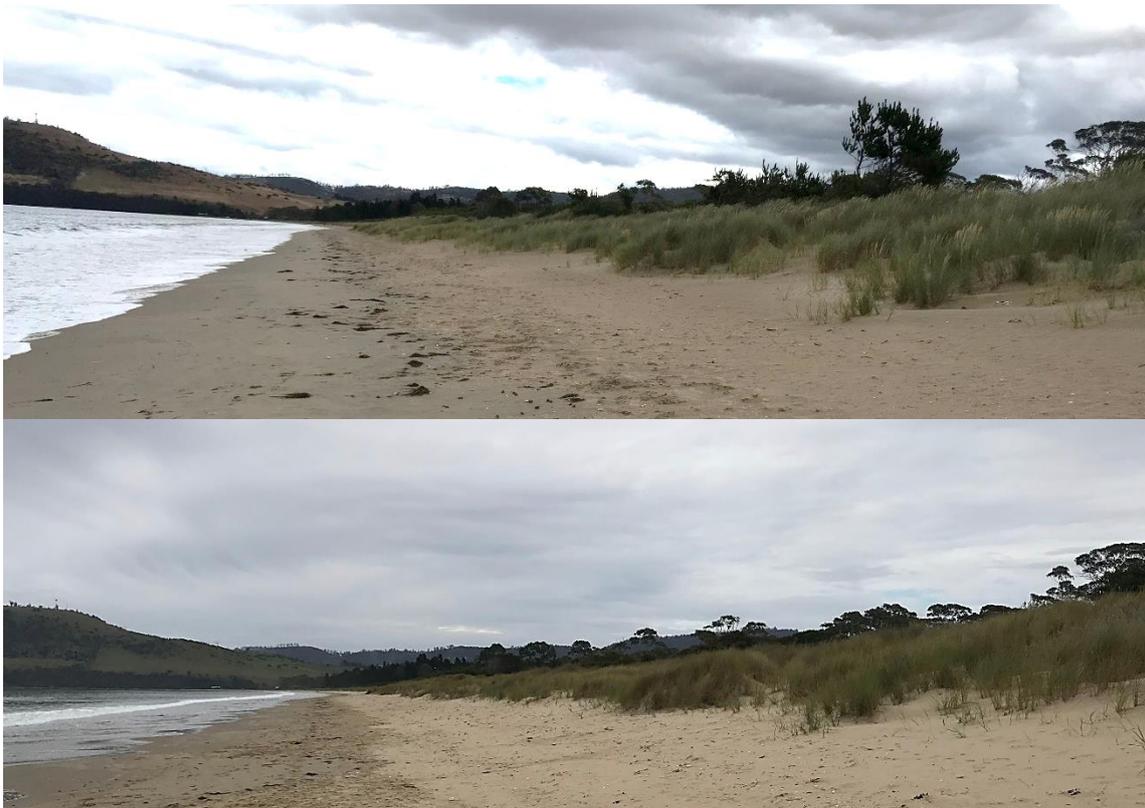
The otherwise stable nature of the beach is well illustrated in Figure 15, with site photos capturing the shoreline at the northern end of the study site, looking south and taken a year apart in December 2020 and 2021. The photos show the low foredune stabilised by the marram grass, which sits in front of the 2011 storm bite scarp. The photo also illustrates the ongoing removal of the Radiata pine trees along the beach continues to have no effect on beach recovery.

Figure 15. Stable low beach profile and emergent Marram Grass at Northern Seven Mile Beach Study Site at 2021 above and 2022 below.

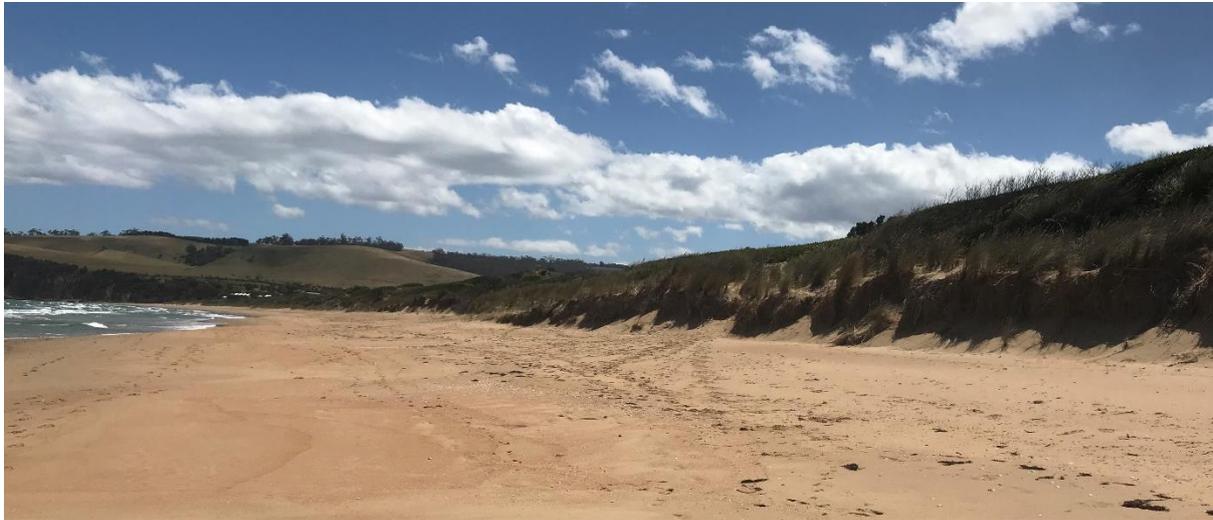
Figure 25. Erosion scarp at Clifton Beach looking south from Point B on Figure 24.

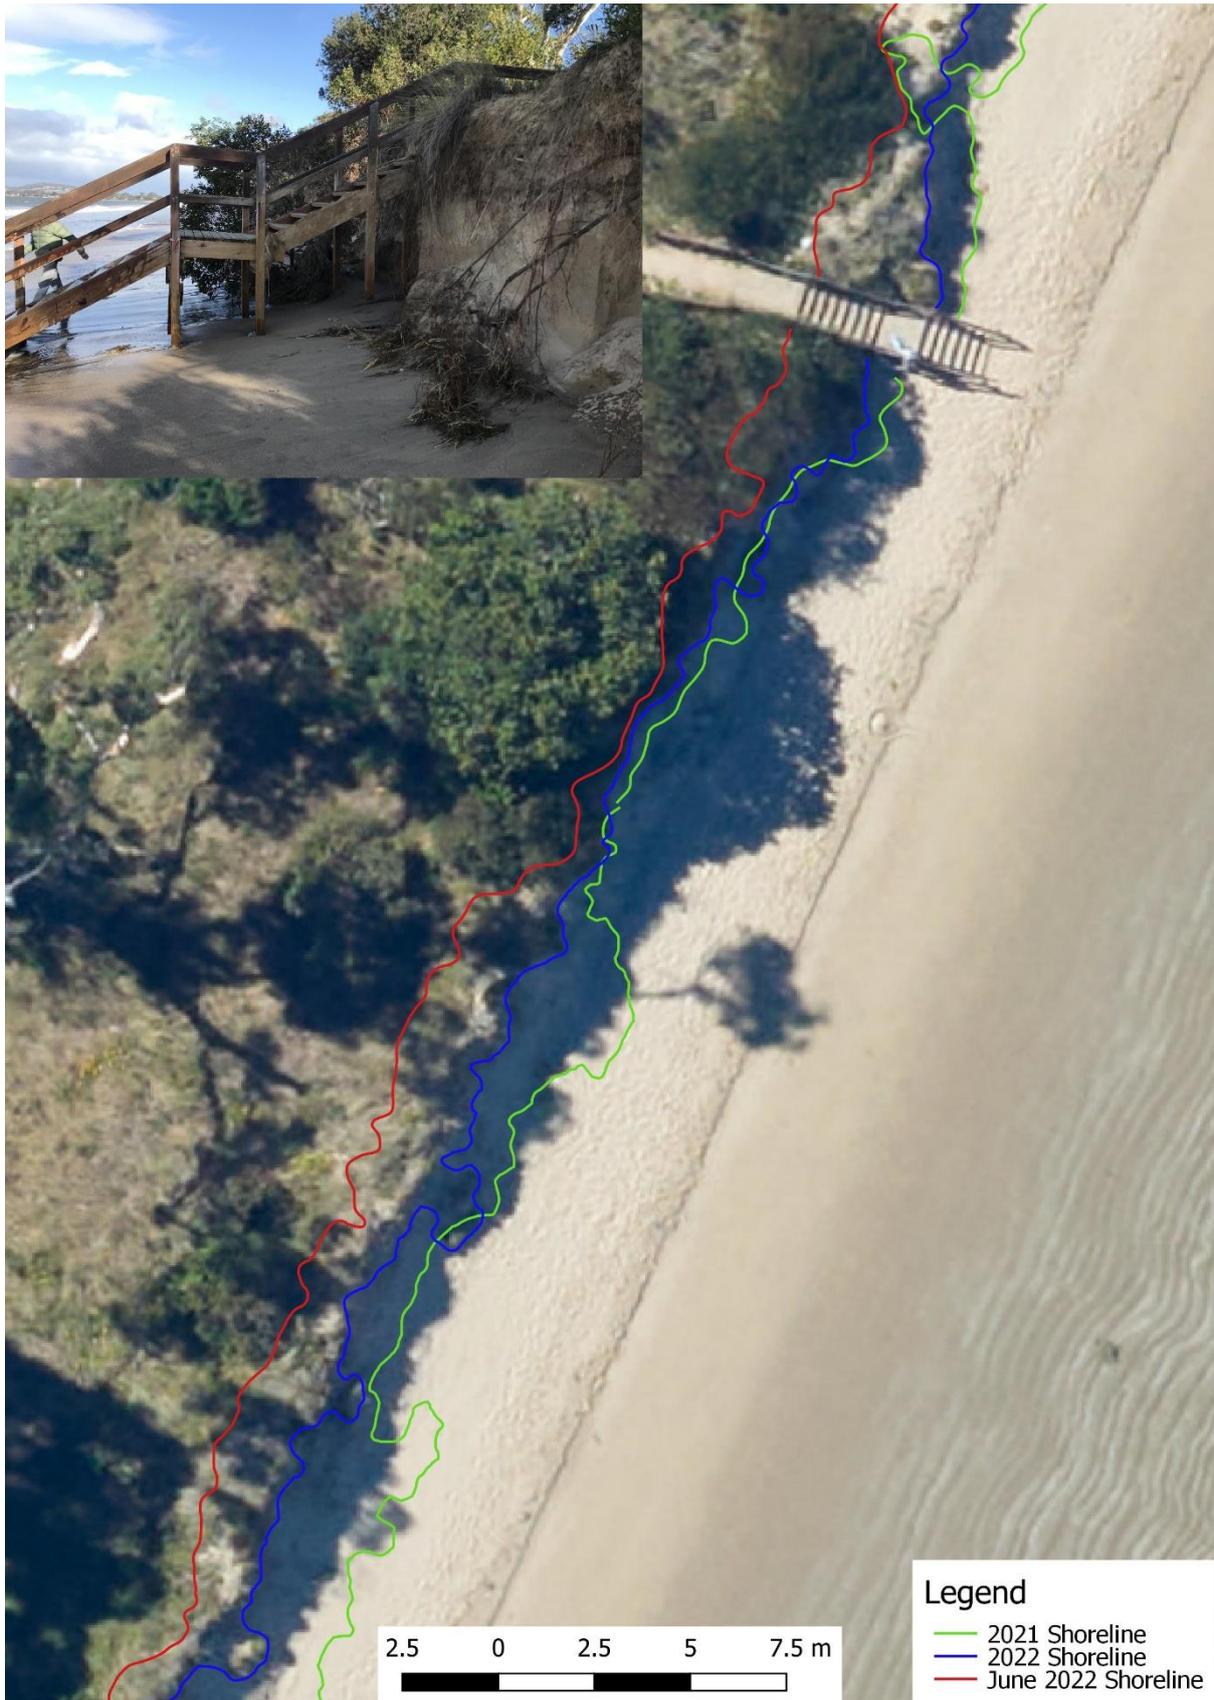
Roches Beach continues to exhibit a long-term recession trend despite the comprehensive beach replenishment program, and is becoming increasing vulnerable to moderate to large swell events. This is evidenced by the dramatic erosion observed after the June 2022 swell event. Total shoreline recession at the northern end of Roches Beach from the 2021 survey through to June 2022 exceeded five metres at several locations. An example of this recession can be seen in Figure 29.

Figure 29. Significant shoreline recession at northern Roches Beach showing shoreline from the 2020-21, 2021-22 and June 2022 Surveys. Inset is photo of the stairs taken on the 22<sup>nd</sup> of June 2022.

While there has been a stabilisation of recession at some of the study sites, a number of beach sections surveyed as part of this study are still exhibiting, or starting to exhibit a clear ongoing long-term recession trend. It is recommended that where this recession is occurring close to dense residential areas or within areas containing valuable infrastructure that ongoing annual aerial surveying be undertaken. These beaches include Roche's, Bellerive, Pipeclay Lagoon, Rokeby and Seven Mile. This will help develop an accurate picture of the shoreline movement and will identify beaches exhibiting similar characteristics to Roche's Beach which has shown an ongoing recession trend since 1977.
