Richmond Bridge Vegetation Management Plan

Site Analysis for Vegetation Management Plan

Arboricultural Survey – Richmond Bridge February 2015

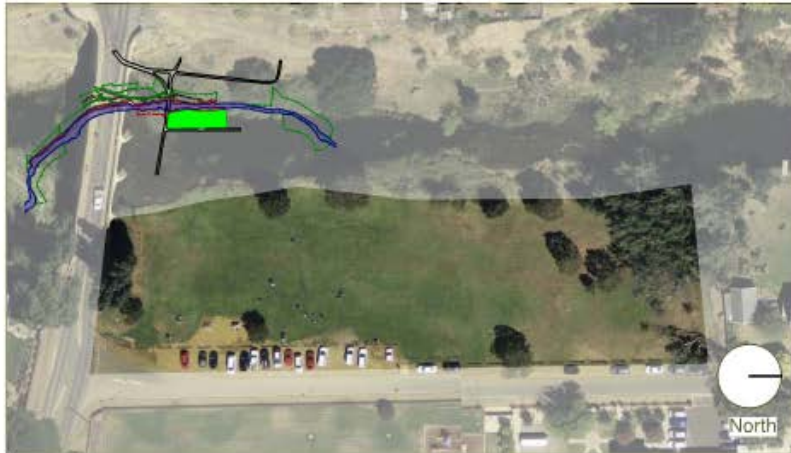
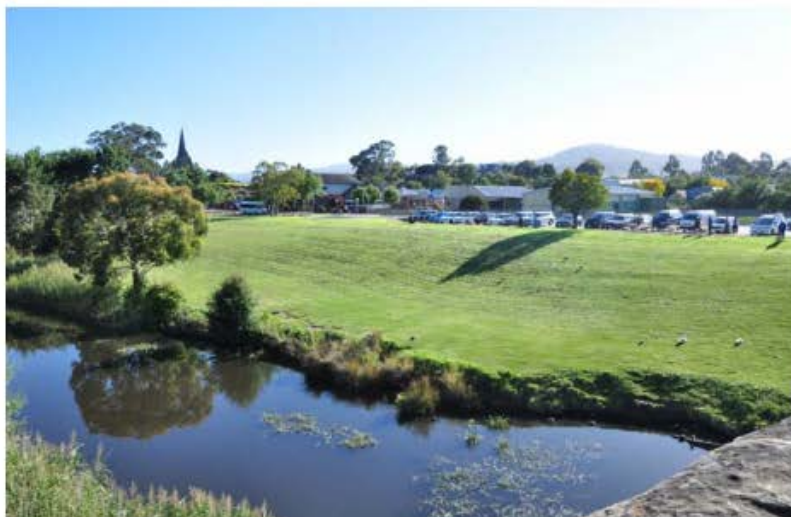
Zone A Priority: High

- Lombardy poplars beside bridge are noted on Heritage Register.
- CMP 2010 Priority Works/Actions (7.7.11) reference the suckering of poplars and the potential impact on the bridge structure.

- Commence planning and consultation for the replacement of Lombardy Poplars within the next 10 years. The recommended action is to fell all of the mature poplars and replace with the same species (*Populus nigra 'Italica'*) but propagated from minimal-suckering root stock (e.g. Flemings Nursery). Felling all of the trees will enable removal of 'old' root stock to prevent future suckering, and enable the installation of a root barrier between the trees and the bridge buttress.
- Gradually replace white poplars along northern boundary with *P. canadensis* or *U. procera*. *Zelkova serrata* is also recommended (see planting palette).
- Removal of selected trees as per the Action Plan (Appendix 2).

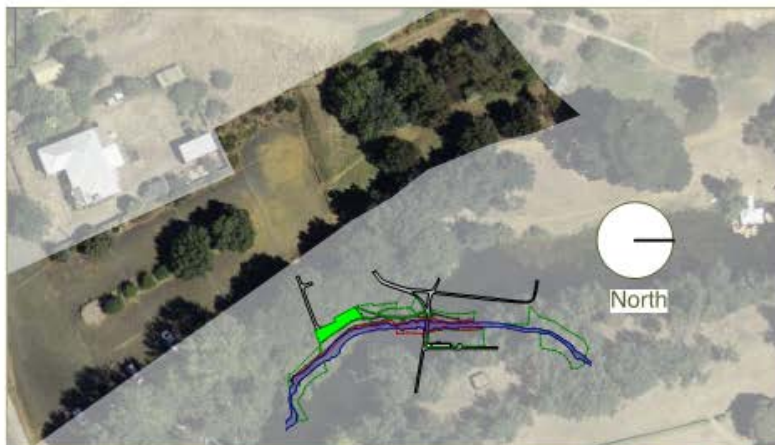
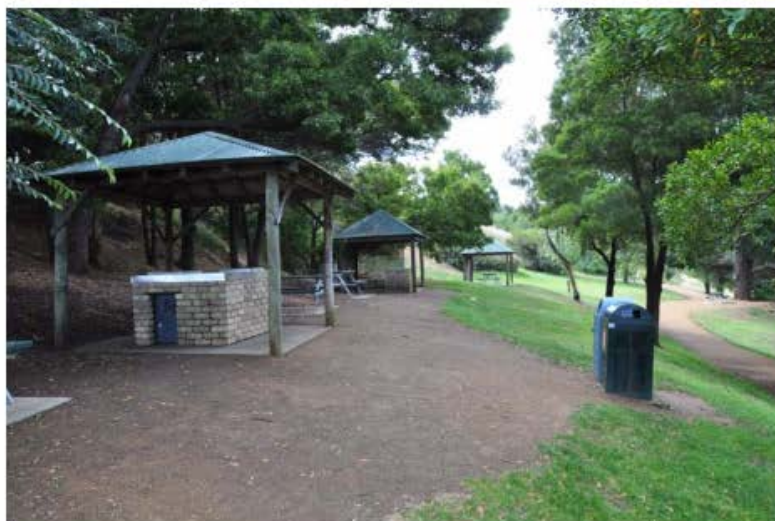
Zone H Priority: Low

- Feb 2015 arboricultural assessment identified no general issues with the trees in this area.
- Stump removal and re-grading/topdressing of lawn areas.
- This area would benefit from a re-design of 'hard' landscape elements to rationalise paths and other facilities. This would facilitate better vegetation management, particularly of lawns.
- Remove ivy from central garden bed to carpark area and replace (in the long term, after ivy control has been complete) with *Correa alba* or similar.

- Maintain trees in good condition to ensure public safety and high aesthetic appeal.
- Some grading and top-dressing of lawn areas to improve trafficability for mowing.
- 'Garden bed' area beside the concrete steps to the north west of this zone needs re-designing to ensure a better 'fit' with the locality.

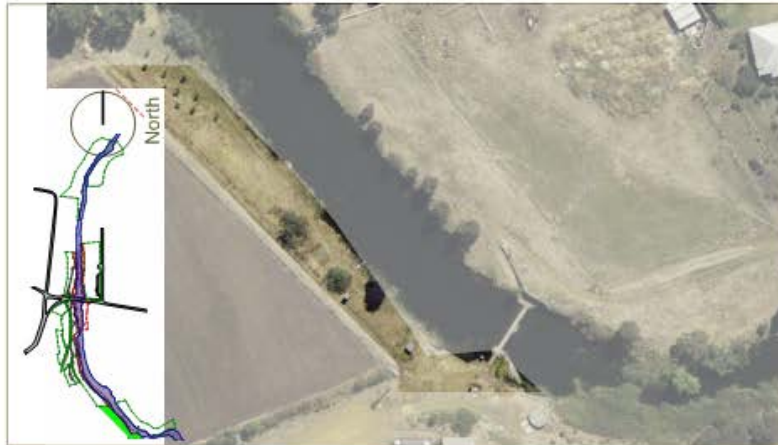
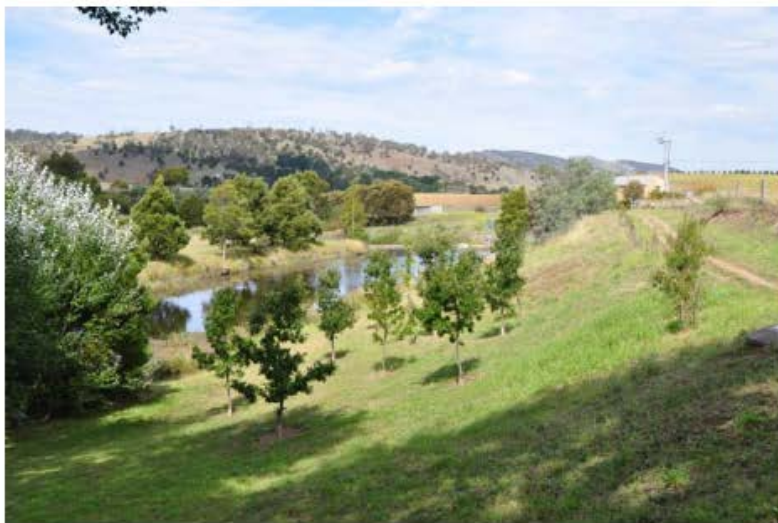
Zone J Priority: High

- The recently planted (last 5 years) Turkish oaks are not representative of species found elsewhere in the study area and therefore have no historic reference. However, oaks were commonly planted through the district historically, and their form and colour is complimentary to this setting. They should be retained and this species adopted for other plantings in the precinct as a succession strategy. Relying too heavily on Elms could place the landscape at risk in the future should Dutch Elm Disease or Elm Leaf Beetle take hold in the future.
- Transform the upper track along the western boundary into an 'avenue' by planting a row of blackwood between the track and boundary fence.

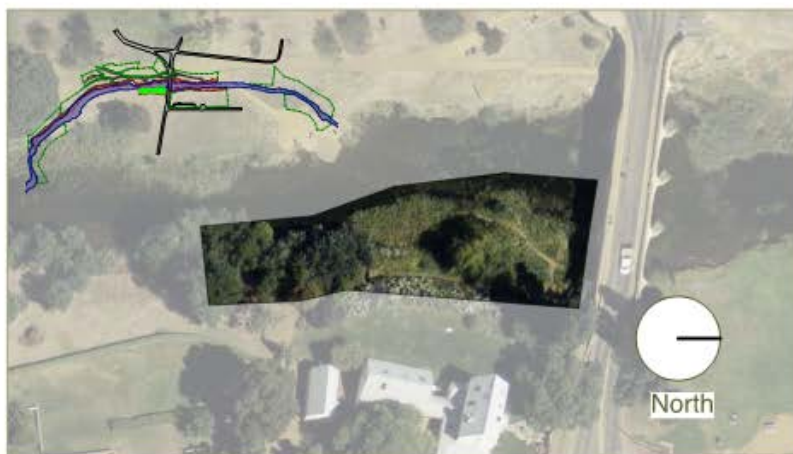
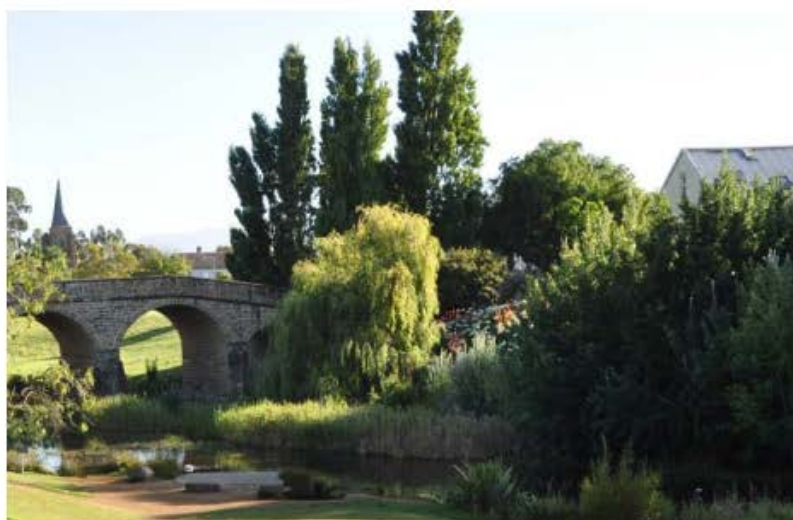
Zone R2 Priority: High

- Crack willow suckers/re-growth from previously controlled trees is occurring through this site.
- Large expanses of *Phragmites* could spread as sedimentation up-stream of the bridge continues.
- Isolated specimens of weed such as boxthorn, gorse, marshmallow, blackberry, fennel.
- Good regeneration of blackwood (*Acacia melanoxylon*) on banks. This may need to be thinned and/or some trees removed if their density increases to the extent that views are blocked.

- Some trimming of *Phragmites* is required to 'open up' views to the bridge from the bank near the old Cypress tree (a key vantage point for views to the bridge).
- Weed control required including boxthorn, gorse, marshmallow, blackberry, fennel.
- Thinning of Blackwood seedlings.

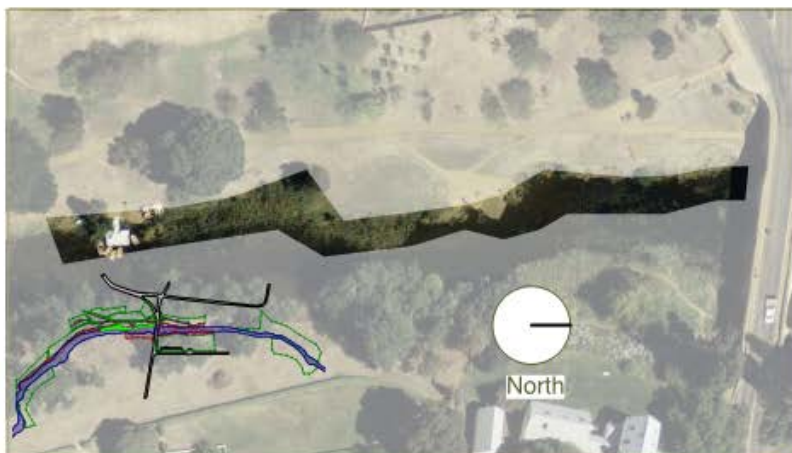
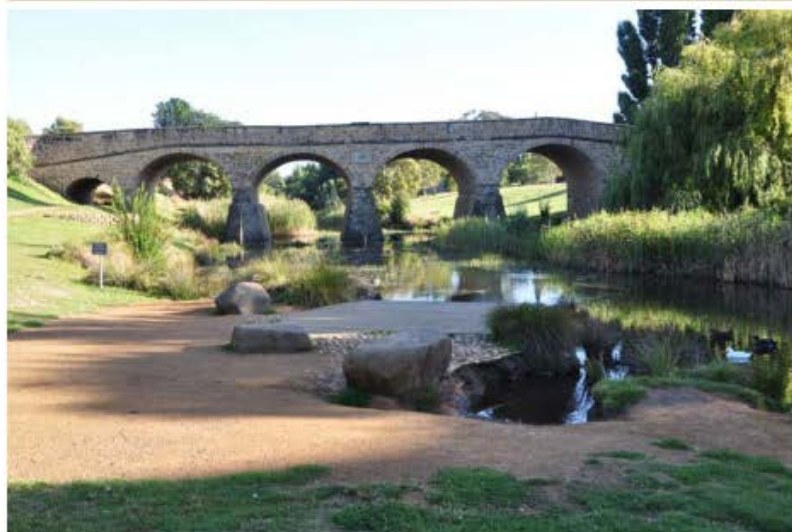
Zone R4 Priority: High

- Low overhanging branches of white poplar impede use of the river by paddle boats and canoes.
- Low overhanging branches may cause a build up of debris and exacerbate flooding and flood impacts both upstream and downstream.
- Ducks are impacting on grass cover on some areas of the banks, contributing to erosion.
- Some isolated crack willow suckers are establishing themselves.

- Gradual removal of all white poplars from the riparian zone.
- Allow the gradual replacement of white poplars with Elm suckers.
- Adjacent to Zone J, plant new Elm and Oak trees (to continue the 'English woodland' theme of Zone J).
- Adjacent to Zones B and K, establish indigenous reeds and rushes on banks to minimise erosion.
- Control suckers of white poplars.
- Ongoing weed control throughout this Zone, prioritising the control of crack willow, gorse, hawthorn, prunus sp., fennel, blackberry.

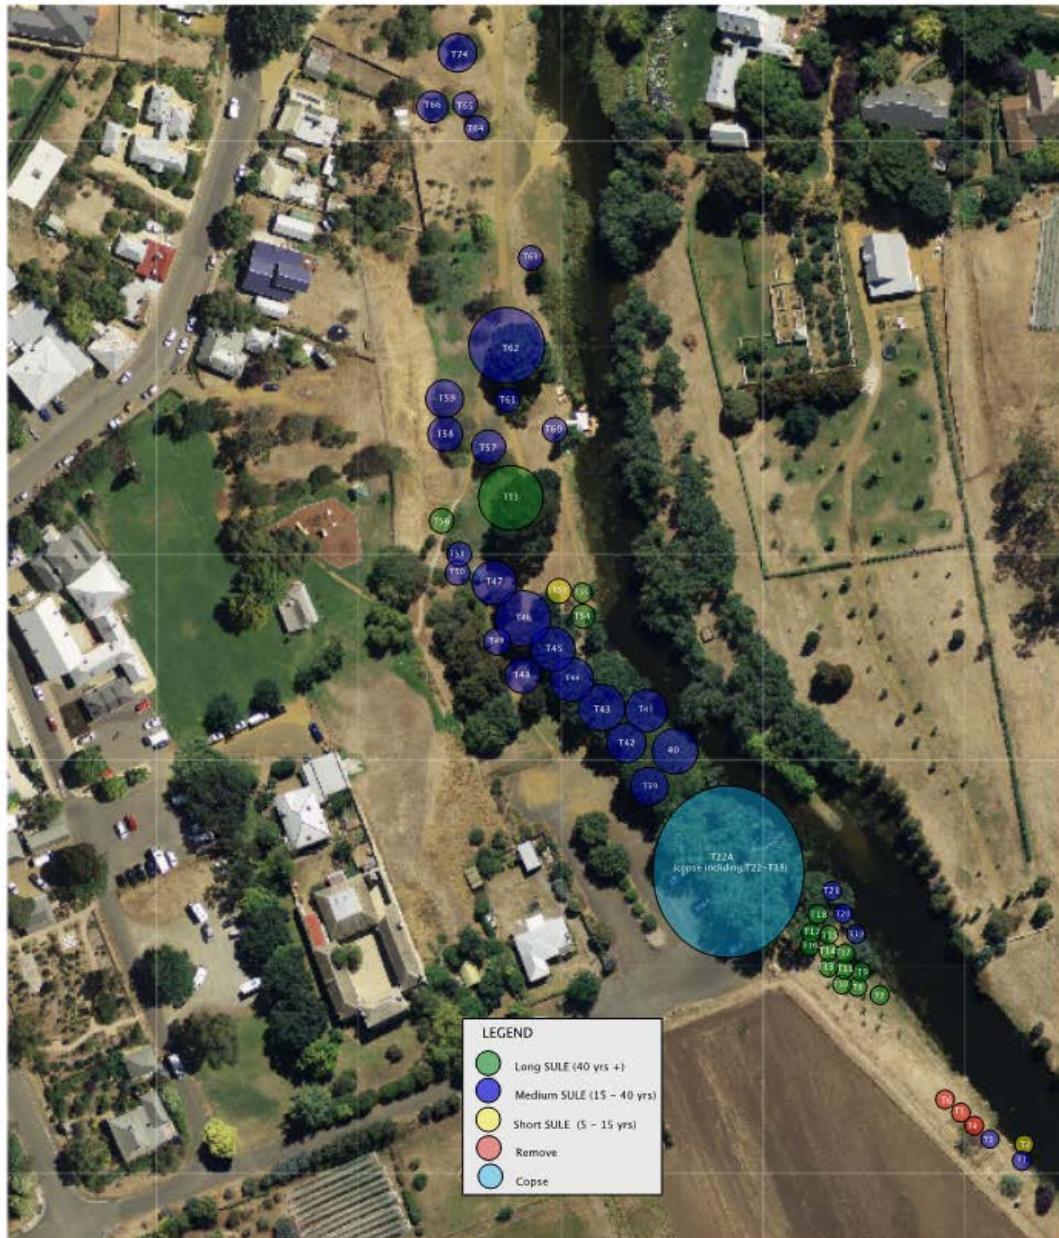
PLAN A: Trees T1-T74

Photo 1: Trees T22-T28 within group T22A. Trees numbered in red are to be removed
